COST Action no. TU1402 Quantifying the value of Structural Health Monitoring
1st Workshop, 4-5 May 2015, DTU Copenhagen Denmark

STRUCTURAL HEALTH MONITORING & STRUCTURAL RELIABILITY ASSESSMENT

Assoc. Prof. Serdar Soyöz
Department of Civil Engineering
Boğaziçi University
www.shm.ce.boun.edu.tr

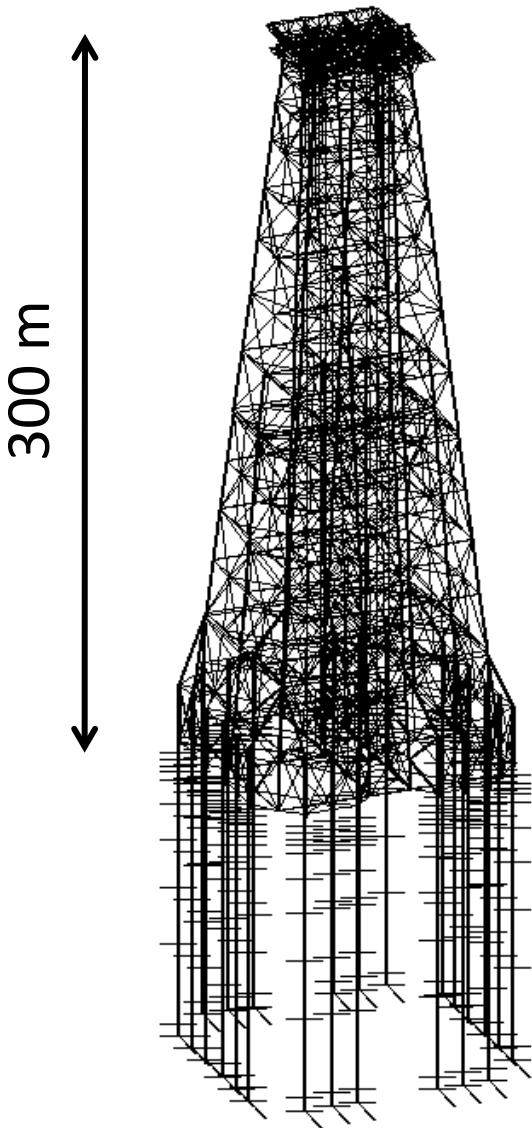
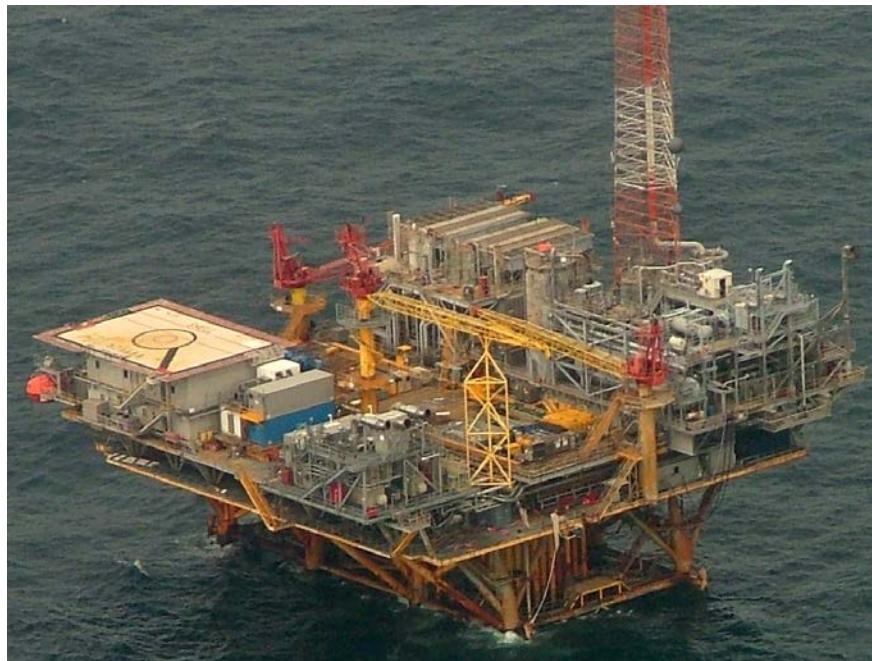
SSI Effects-2: Platform Cognac

T1 (X-dir) (Sec)	T2 (Y-dir) (Sec)	T3 (Tor) (Sec)
Measured Periods	4.13	3.86	2.07
Original Model	6.10	5.95	3.03
Mass Reduction (10%)	5.92	5.77	2.99
Jacket Stiffening (10%)	5.68	5.55	2.87
Soil Stiffness (~twice)	4.19	4.05	1.88

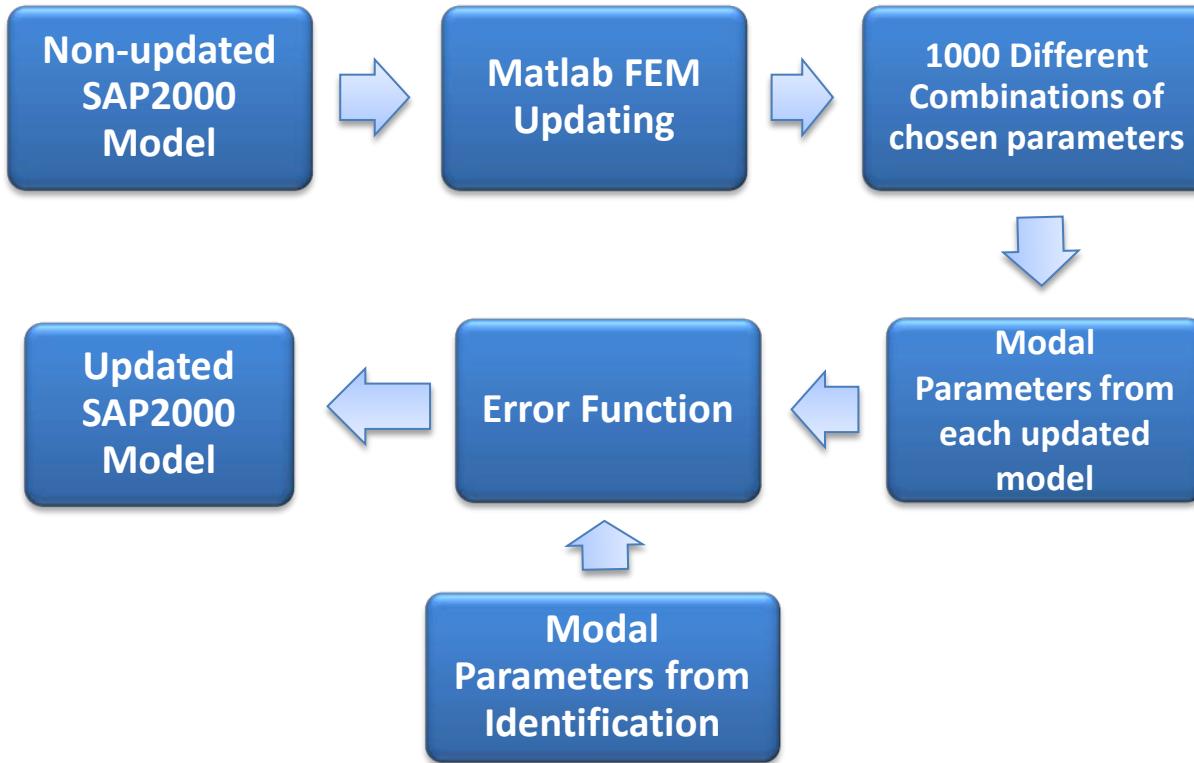
FEM Updating

Error function
$$E = \sum_{i=1}^4 \left(k_i \cdot \left[\left(f_i^* - f_i \right) / f_i^* \right]^2 + h_i \cdot [1 - MAC_i]^2 \right)$$

(Modal assurance criteria)
$$MAC = \frac{|\psi_*^T \cdot \psi|^2}{(\psi_*^T \cdot \psi_*) \cdot (\psi^T \cdot \psi)}$$

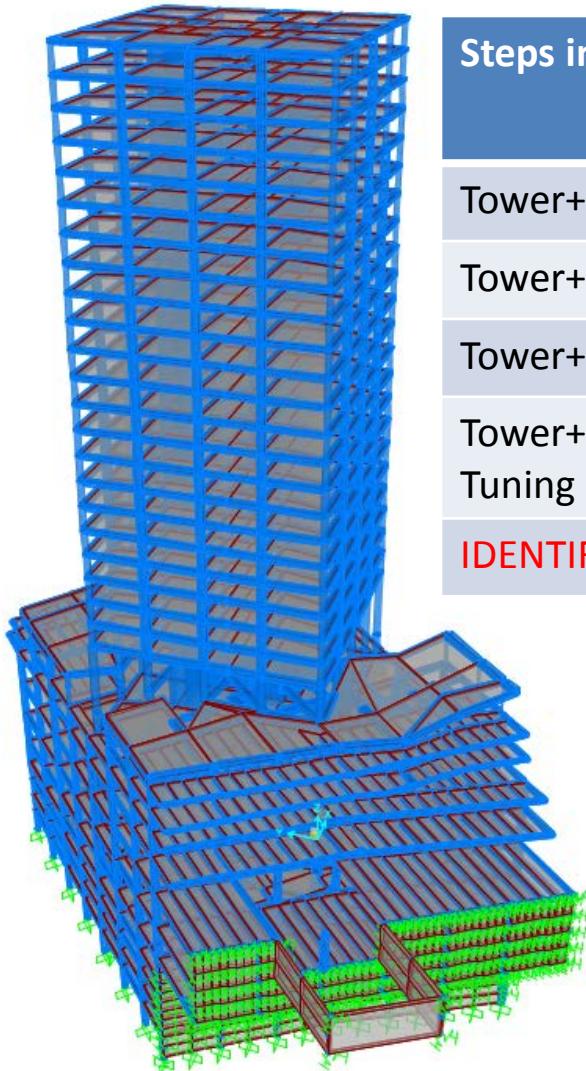
FEM Updating

Steps in the FEM	Frequency of 1st Mode
Tower+ Surrounding Structure	0.47 Hz
Tower+ S.S. + Soil Springs	0.50 Hz
Tower+ S.S. + Soil Springs + Seismic Gaps	0.57 Hz
Tower+ S.S. + Soil Springs + Seismic Gaps + Parameter Tuning	0.59 Hz
IDENTIFICATION	0.59 Hz

Mode Number	System ID	Updated FEM	NonUpdated FEM
1	0.59	0.59	0.50
2	2.15	2.03	1.77
3	3.81	3.18	2.62

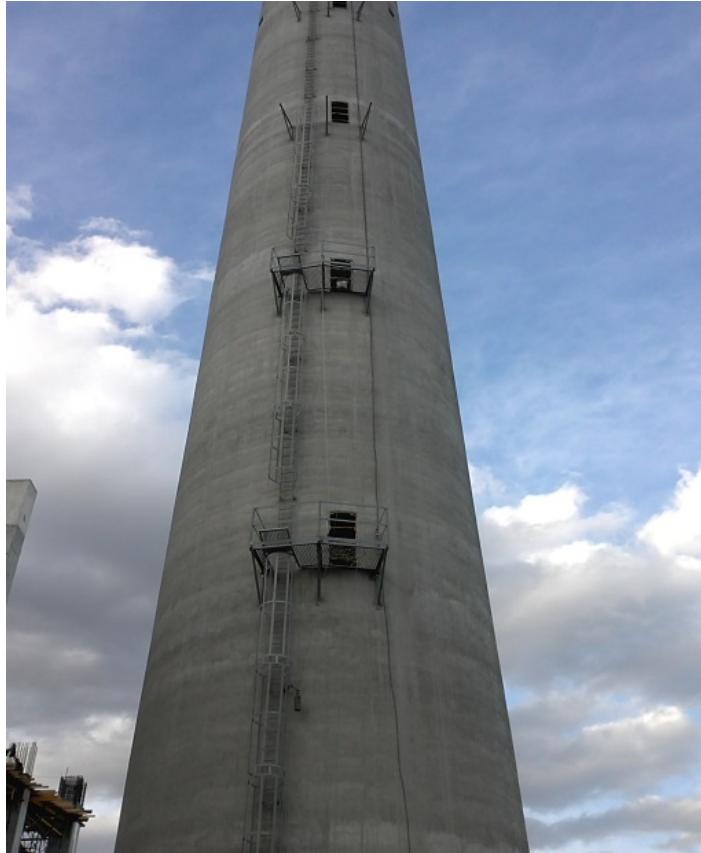
SID and Reliability Estimation of a Chimney

L=100.5 m height

Diameter=9700 mm at base

5750 mm at top

Concrete Class= $f_c=30\text{ MPa}$

*Part of seismic and wind analysis
of an industrial chimney at Bilecik*

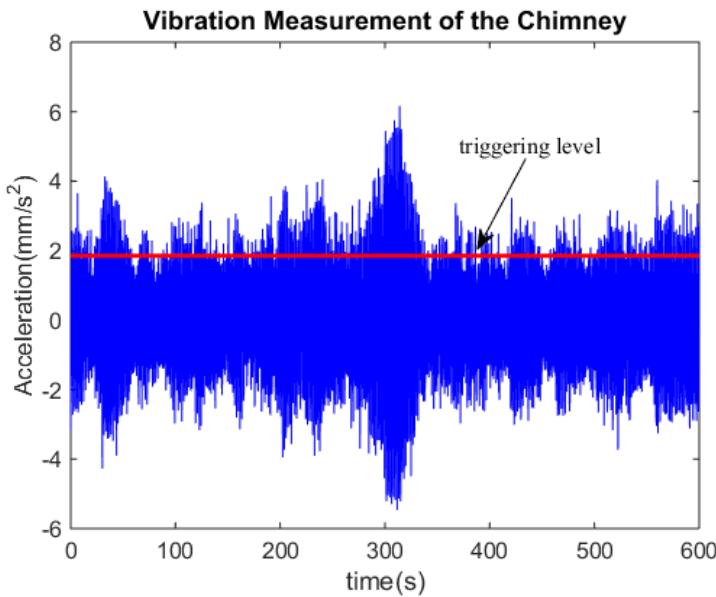
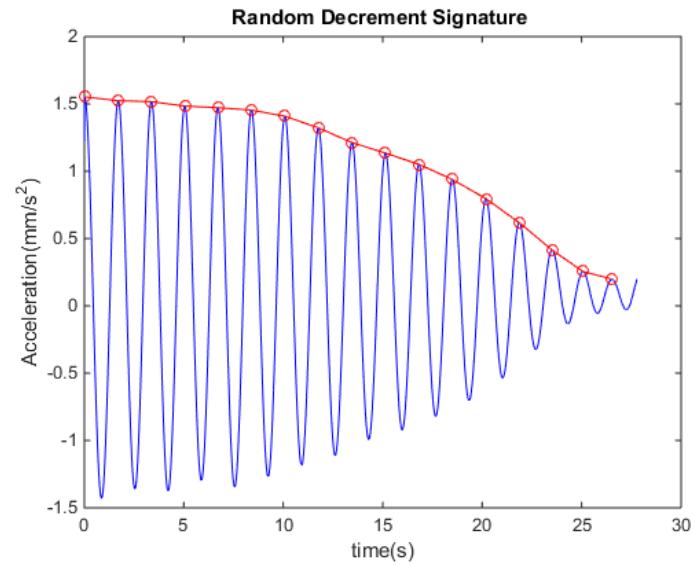
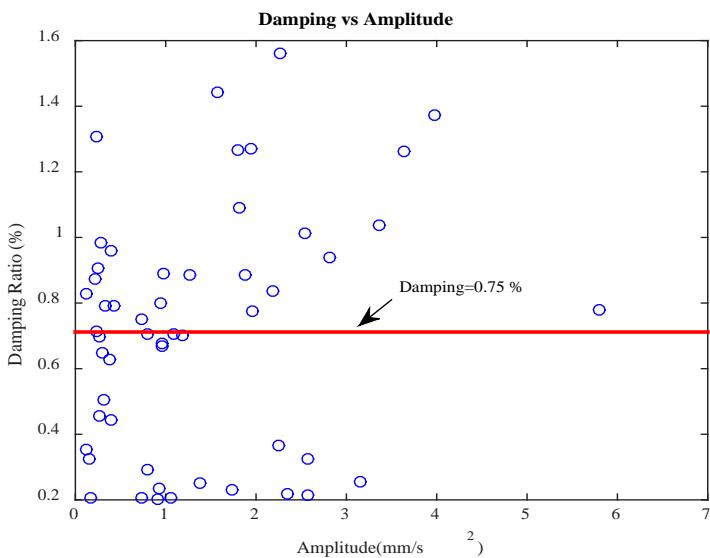
Random Decrement

DAMPING RATIOS (Concrete,Lined,Foundation on Gravel)		
CICIND	EUROCODE	Identification
1.51	1.11	0.75

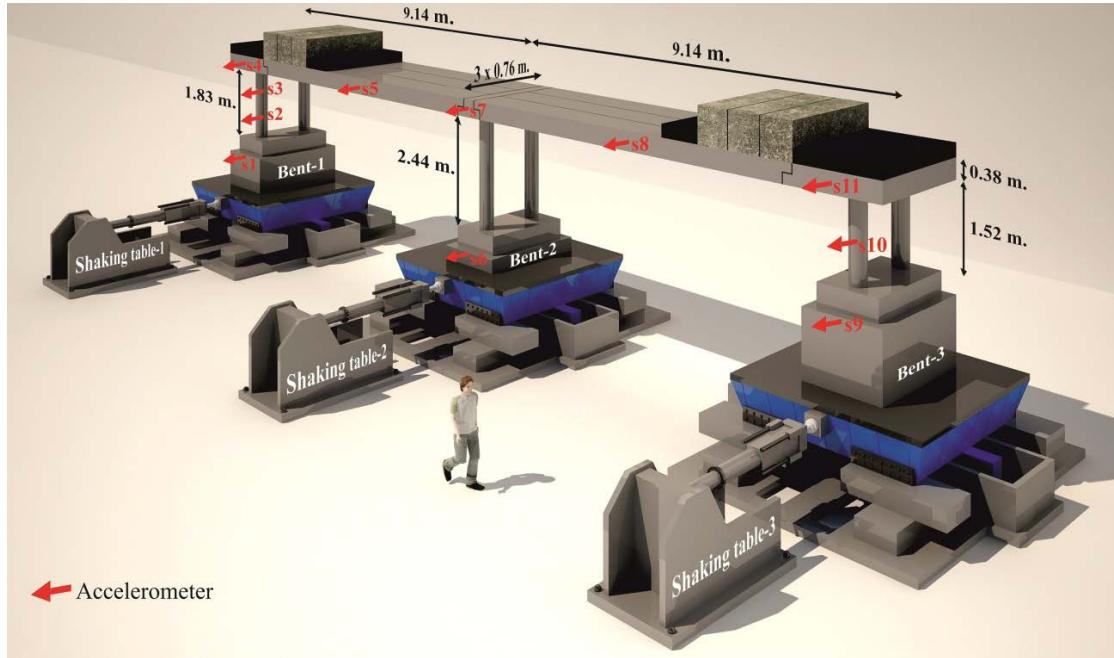
Vibration-based Seismic Reliability Estimation of a Bridge

The shaking table test were conducted at University of Nevada, Reno in conjunction with Prof. Saidii's and Prof. Sander's NSF-NEES project.

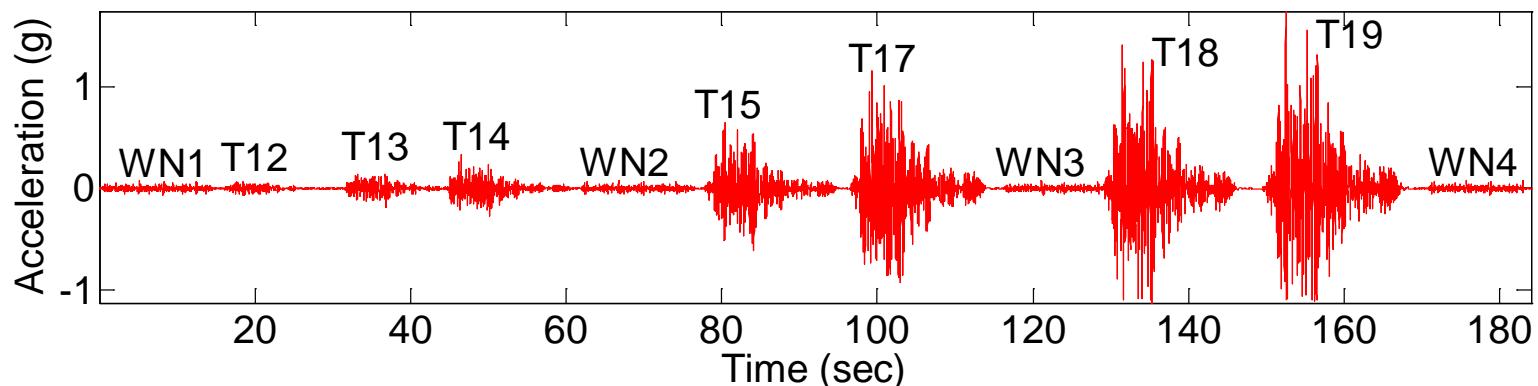
Test Procedure

Test	Ground Motion Description	PGA (g)	Damage Description
WN-1	White Noise in Transverse		
T-13	Low Earthquake in Transverse	0.17	Bent-1 yields
T-14	Moderate Earthquake in Transverse	0.32	Bent-3 yields
WN-2	White Noise in Transverse		
T-15	High Earthquake in Transverse	0.63	Bent-2 yields
WN-3	White Noise in Transverse		
T-19	Extreme Earthquake in Transverse	1.70	Bent-3 steel buckles
WN-4	White Noise in Transverse

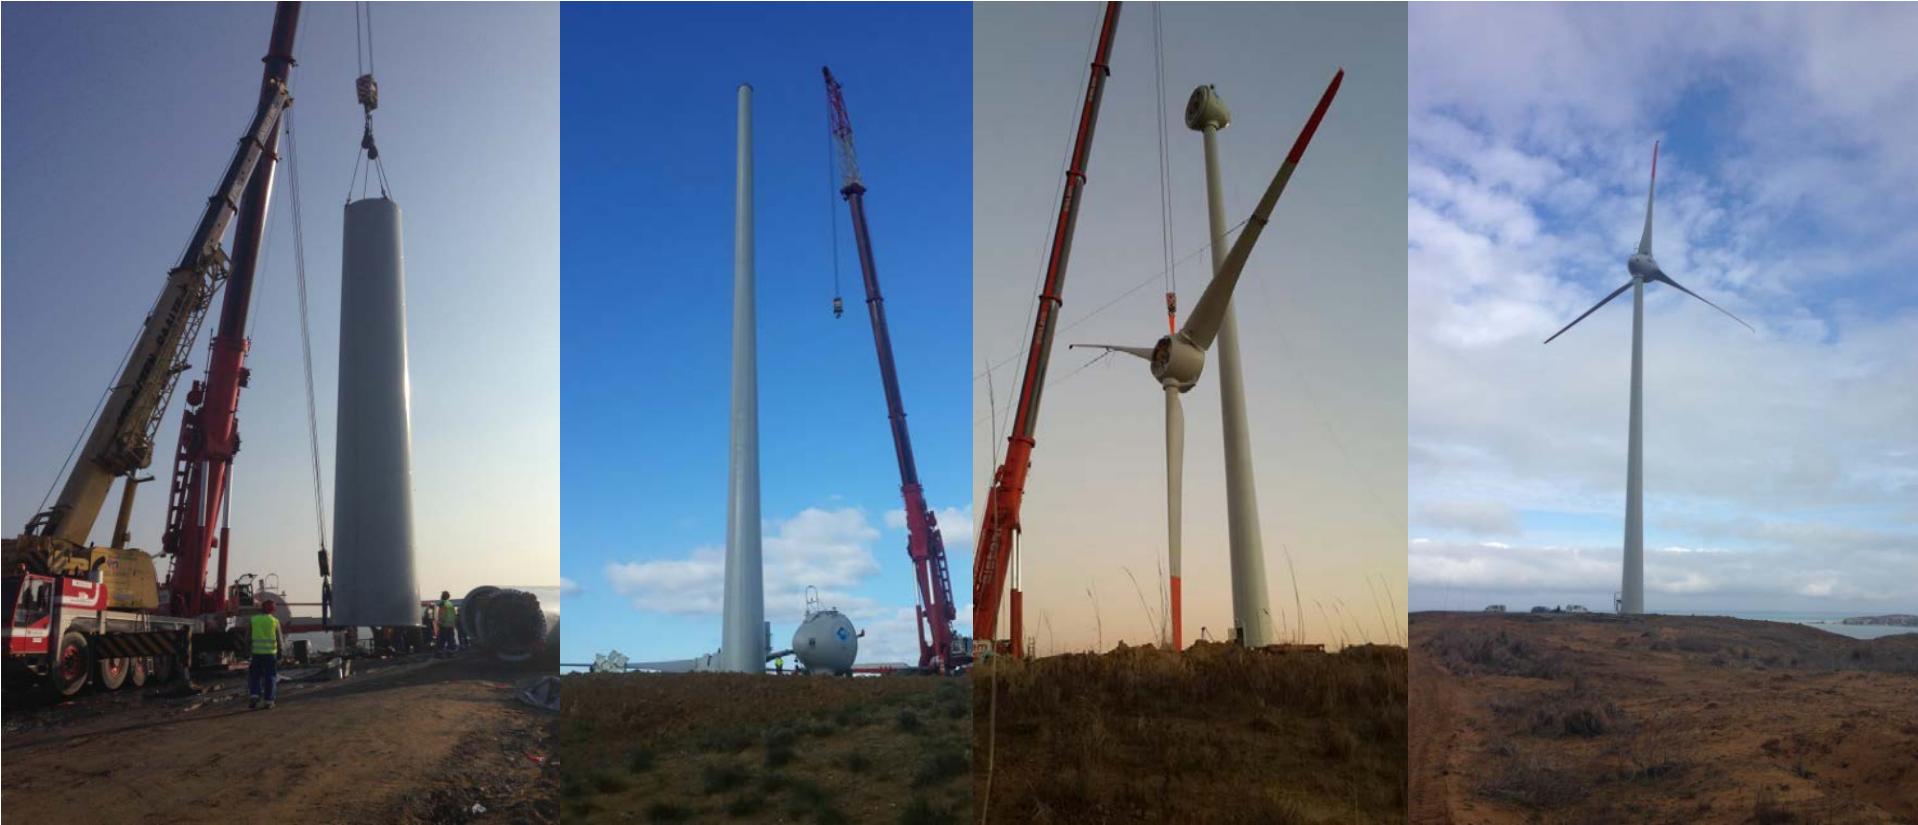
SHM of a Wind Turbine

1MW Turbine

Hub Height: 55 m

Blade: 20m

Bottom Diameter: 3 m

Sensors

Tower Acceleration

Tower Dynamic Strain

Pile Strain
