# Smart Structures for Smart Maintenance

Lessons learned from ongoing monitor initiatives

W.M.G. Courage, A.J. Bigaj-van Vliet, W.H.A. Peelen & G.T. Luiten (TNO)  
R. Drieman (Fugro GeoServices)  
The Netherlands

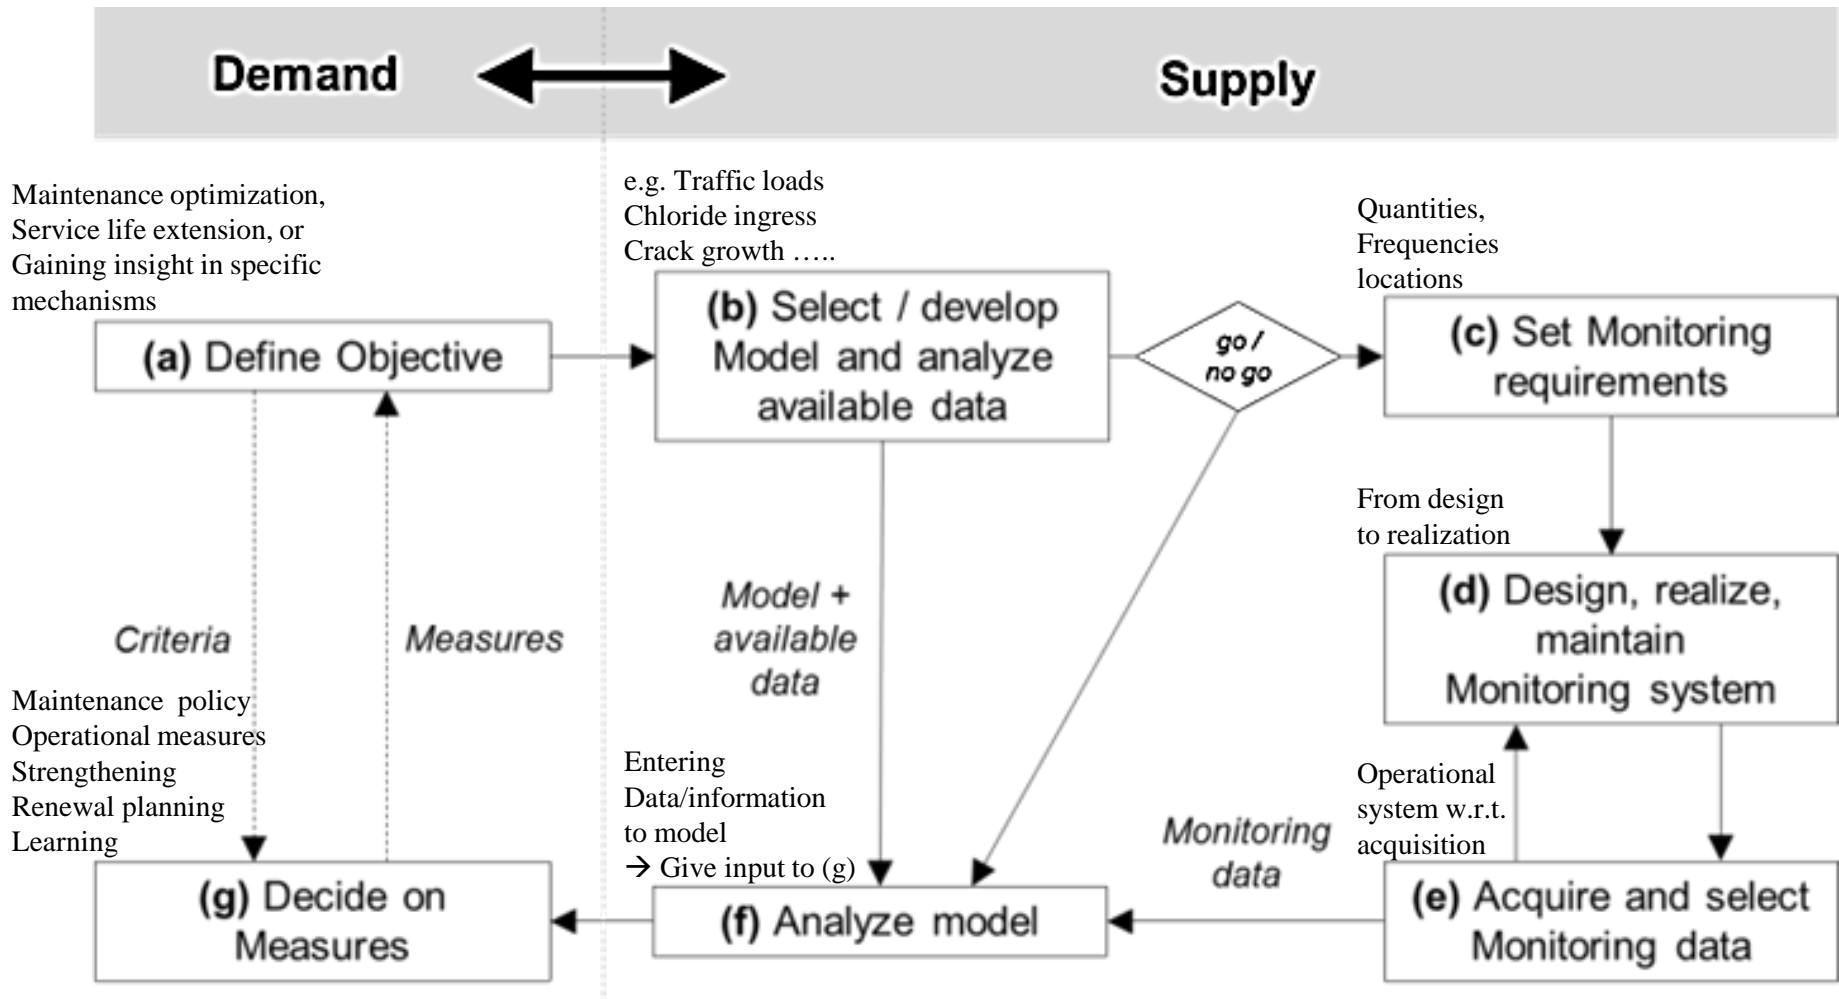
- **Interests/needs (owner/user objective)** – including reflection on the higher-level (societal/economic).
- **Opportunities and threats** – efficiencies/successes found enabling upscaling SHM?  
factors may hindering large scale application of SHM?
- **Time horizon** – e.g. temporary, indefinitely?)
- **Cost-benefit** – qualitative and quantitative incl. (initial) single costs/benefits versus upscaling,
- **Data management** – readiness of organisation to deal with data management; coupling to existing information
- **Technology Readiness Level (TRL)** –to what extent the system is technically ready for repeated or organization-wide application

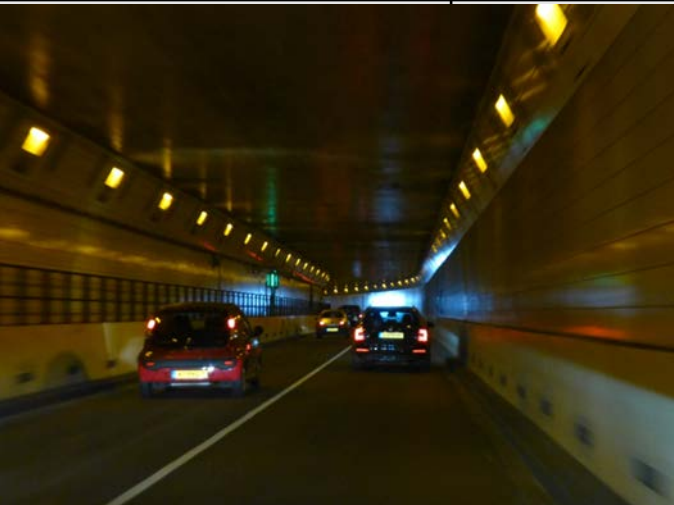
Project	Objective	Status	Success?
Light intensity, Maas Tunnel, Rotterdam

Project	Objective	Status	Success?
<b>Light intensity, Maas Tunnel, Rotterdam</b>	Optimize cleaning frequency	On hold; system designed (c) but no decision on project taken yet	Seems possible and feasible, but not yet executed
<b>Joint, viaduct highway A73, Venlo</b>	Optimize maintenance frequency with early warning system	Go/no-go decision pending (b) / system tested in lab (d)	System works satisfactorily in lab conditions
<b>Identification of objects of National Road Authority, Eastern part of The Netherlands</b>	Optimize inspection process by better identification of objects with RFID chips	System installed (d)	Identification with RFID chips works satisfactorily; actual use still has to start
<b>Chloride penetration in concrete, feasibility study</b>	Assess non-destructively the structural health of corroded reinforced concrete structure	Feasibility study until preliminary system design (d)	Right sensors do not (yet) exist

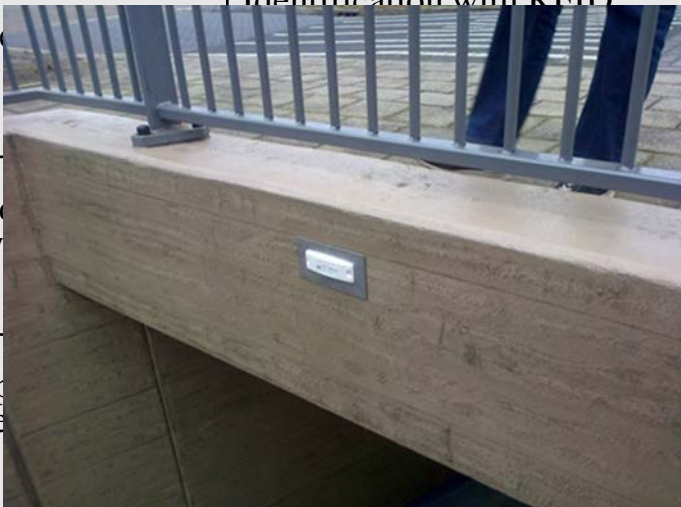
System designed Decision on yet	Seems possible and feasible, but not yet executed
Joint, viaduct highway A73, Venlo		Decision pending tested in lab (d)	System works satisfactorily in lab conditions
Identification of objects of National Road Authority, Eastern part of The Netherlands			Identification with RFID
Chloride penetration in concrete, feasibility study	Assess non-destructively the structural health of corroded reinforced concrete structure	Feasibility study preliminary system (d)

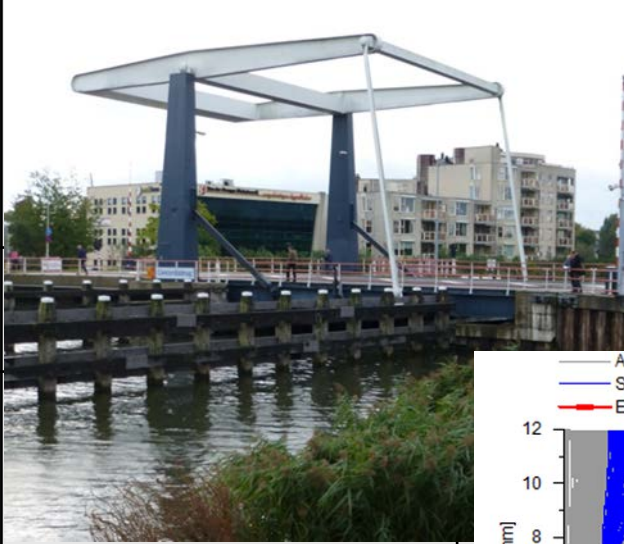
Project	Objective	Status	Success?
<p><b>Moving abutments, Concordia bridge, Gorinchem</b></p>

Project	Objective	Status	Success?
<b>Moving abutments, Concordia bridge, Gorinchem</b>	Gain insight in mechanisms for displacements of abutments to guarantee safe service of the bridge	Analyzing the fail mechanisms based on existing data proves more difficult than expected (b)	So far, the analysis did not result in conclusive answers. Added value of monitoring could not be established
<b>Bridge joint, Martinus Nijhof bridge, Zaltbommel</b>	Extend service life of joints safely by early warning system	Concluded (g)	Yes, maintenance delayed for one year without safety warning
<b>Steel deck, Van Brienoord bridge, Rotterdam</b>	Study feasibility of extending service life of steel bridge decks	Running (f), (g)	Yes, when combining measured data and models actual service life can be predicted
<b>Alkali Silica reaction (ASR) deterioration, viaducts highway A59</b>	Extend service life of affected concrete by assessing structural safety	Running (f), (g)	Although the fail mechanism is not yet understood completely, the consequences can be managed safely

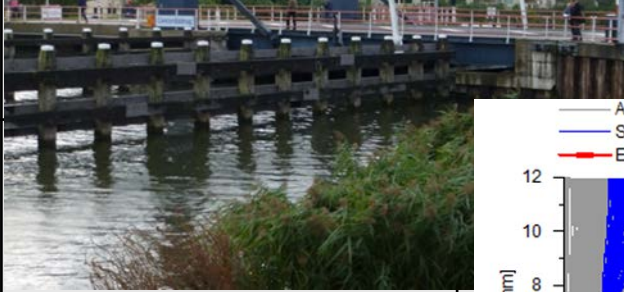
<p>the fail ns based on ata proves more an expected (b)</p>	<p>So far, the analysis did not result in conclusive answers. Added value of monitoring could not be established</p>
<p><b>Bridge joint, Martinus Nijhof bridge, Zaltbommel</b></p>

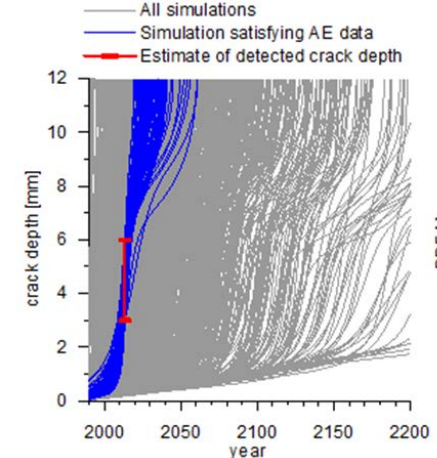
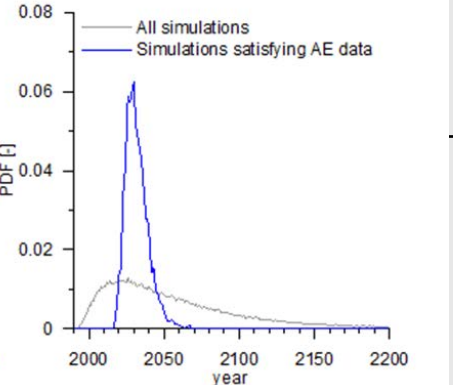
<p>d (g)</p>	<p>Yes, maintenance delayed for one year without safety warning</p>
<p><b>Steel deck, Van Brienoord bridge, Rotterdam</b></p>

<p><b>Alkali Silica reaction (ASR) deterioration, viaducts highway A59</b></p>	<p>Extend service life of affected concrete by assessing structural safety</p>
