# Monitoring of prestressed concrete slab with unbonded tendons during erection and in service

Rafal Szydowski, Maiusz Maslak, Michal Pazdanoski  
Cracow University of Technology

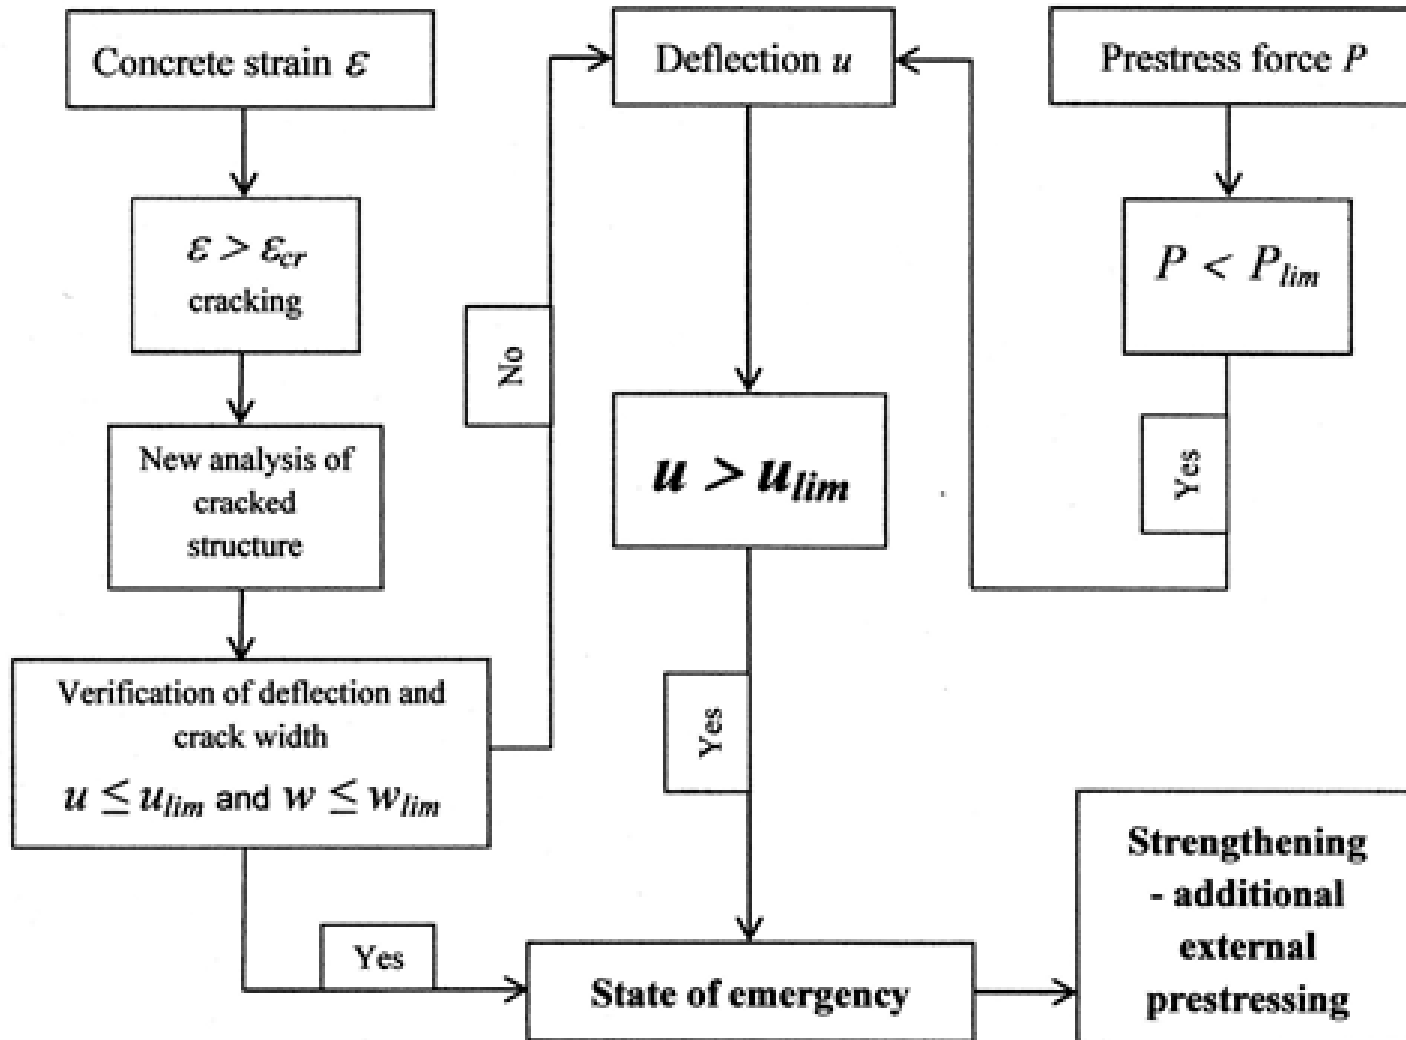
## Algorithm for action when the critical values are reached

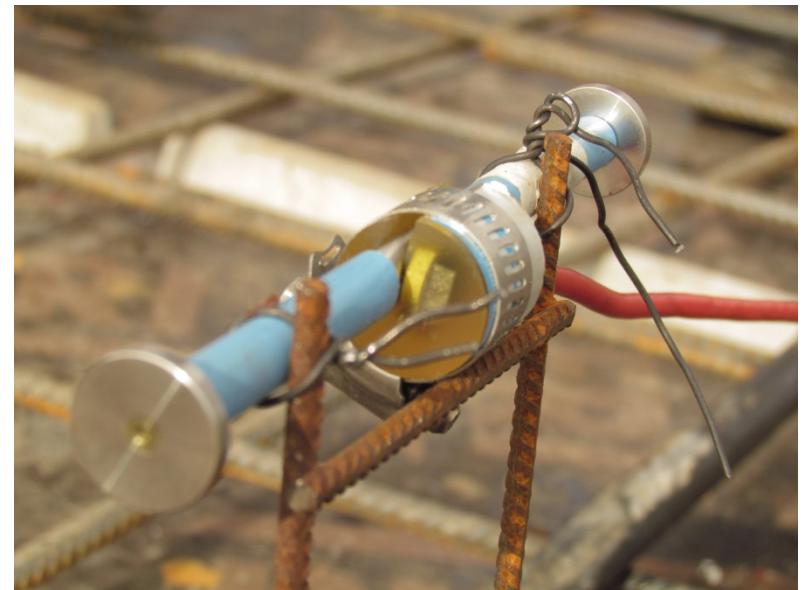
## Concrete strain transducers

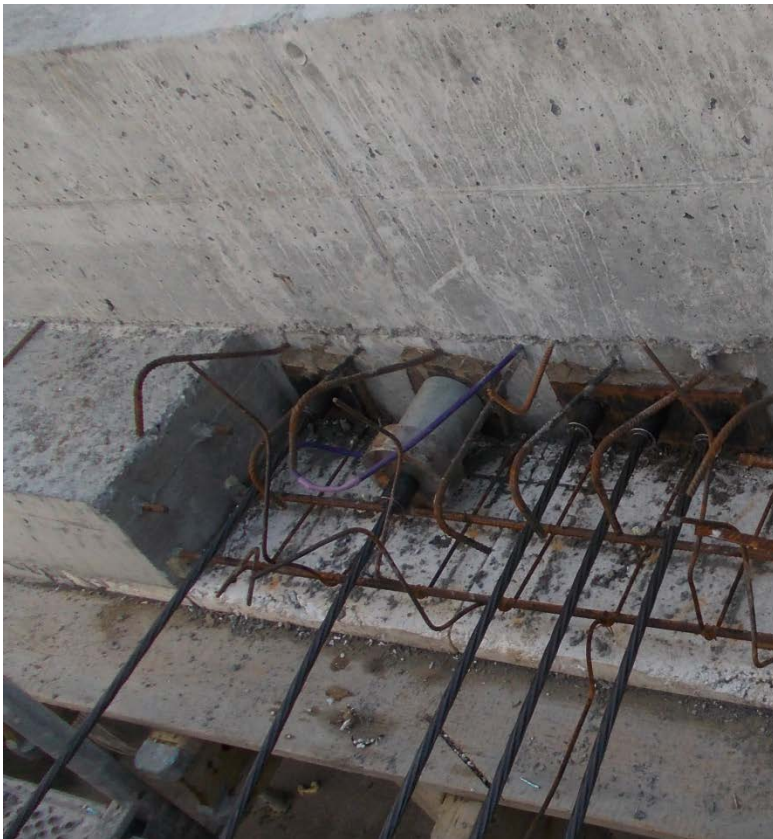
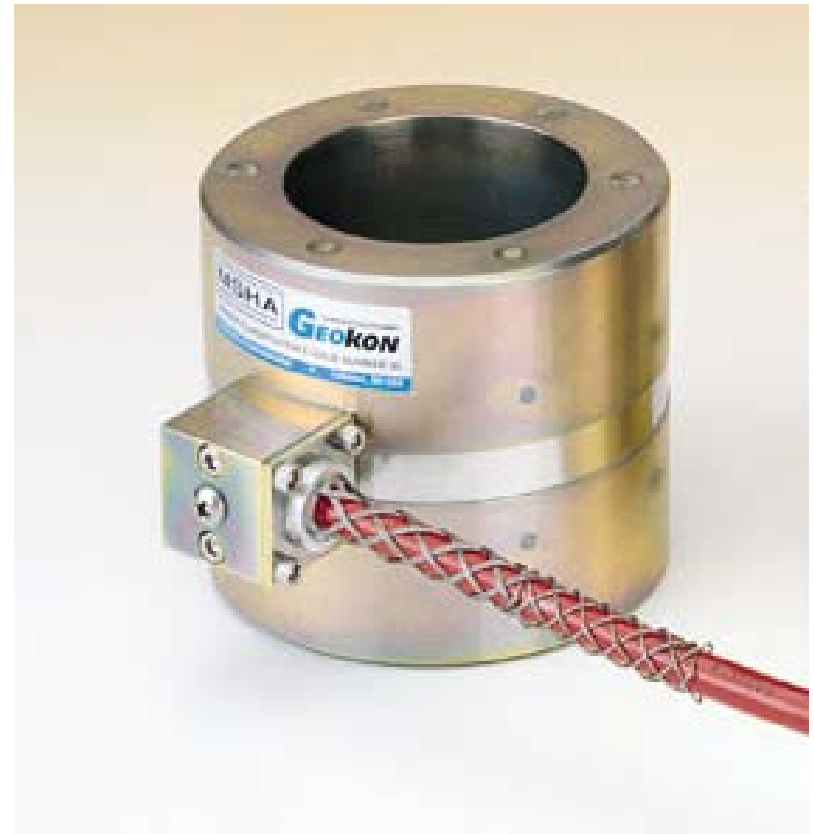
## Prestress force controlling

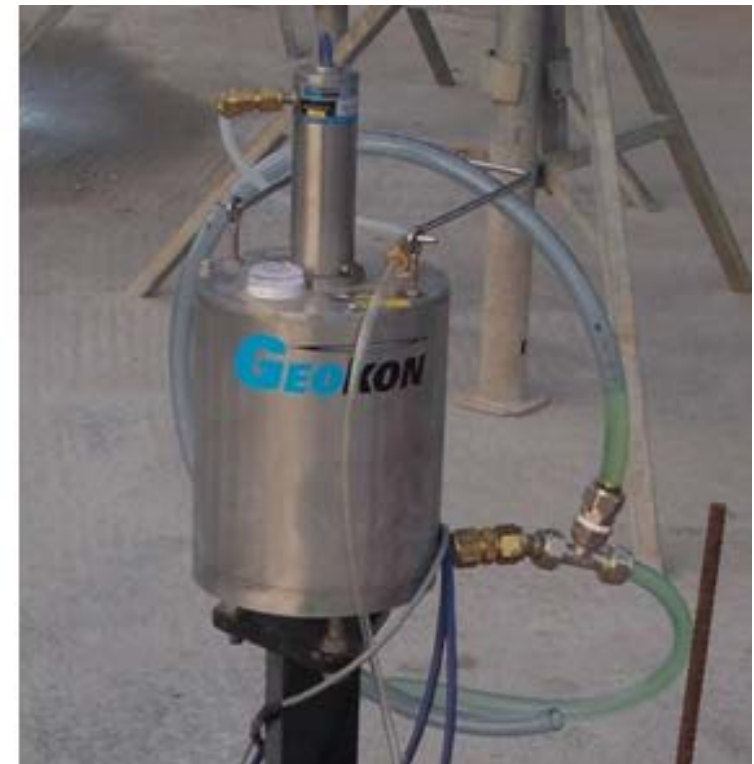
# Hydraulic system to control the deflection

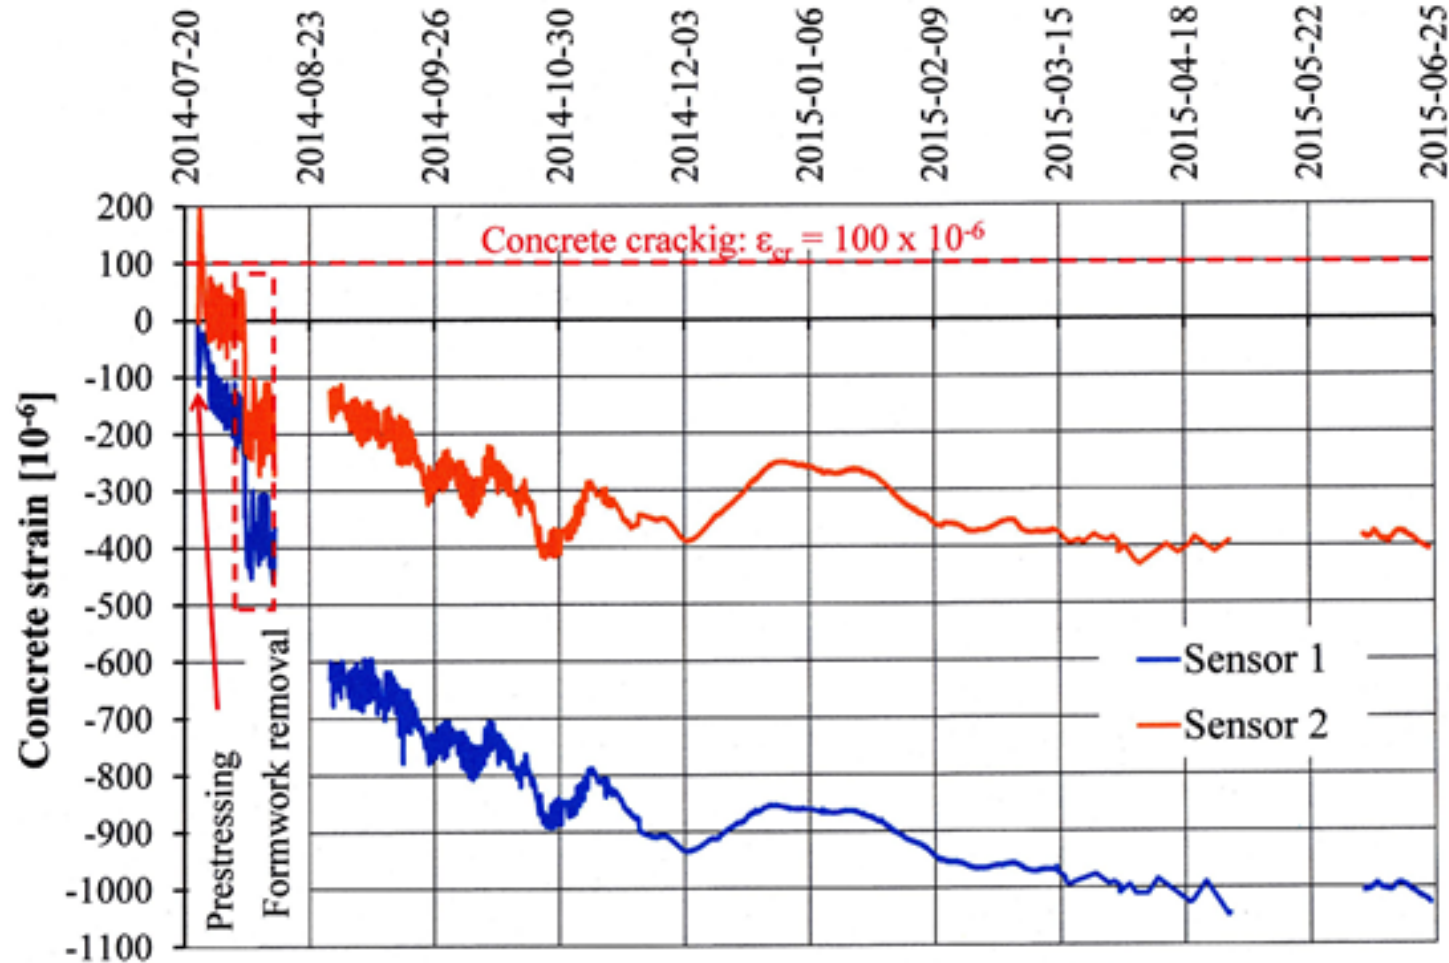
# Concrete strain development

- Application of monitoring during the erection and the initial phase of service of slabs prestressed with unbonded tendons allows to verify of computational methods and design assumptions applied.
- Positive behaviour of executed slabs, supported by the measured values, constitutes a contribution towards the construction of similar prestressed slabs in the future projects and their improvement.

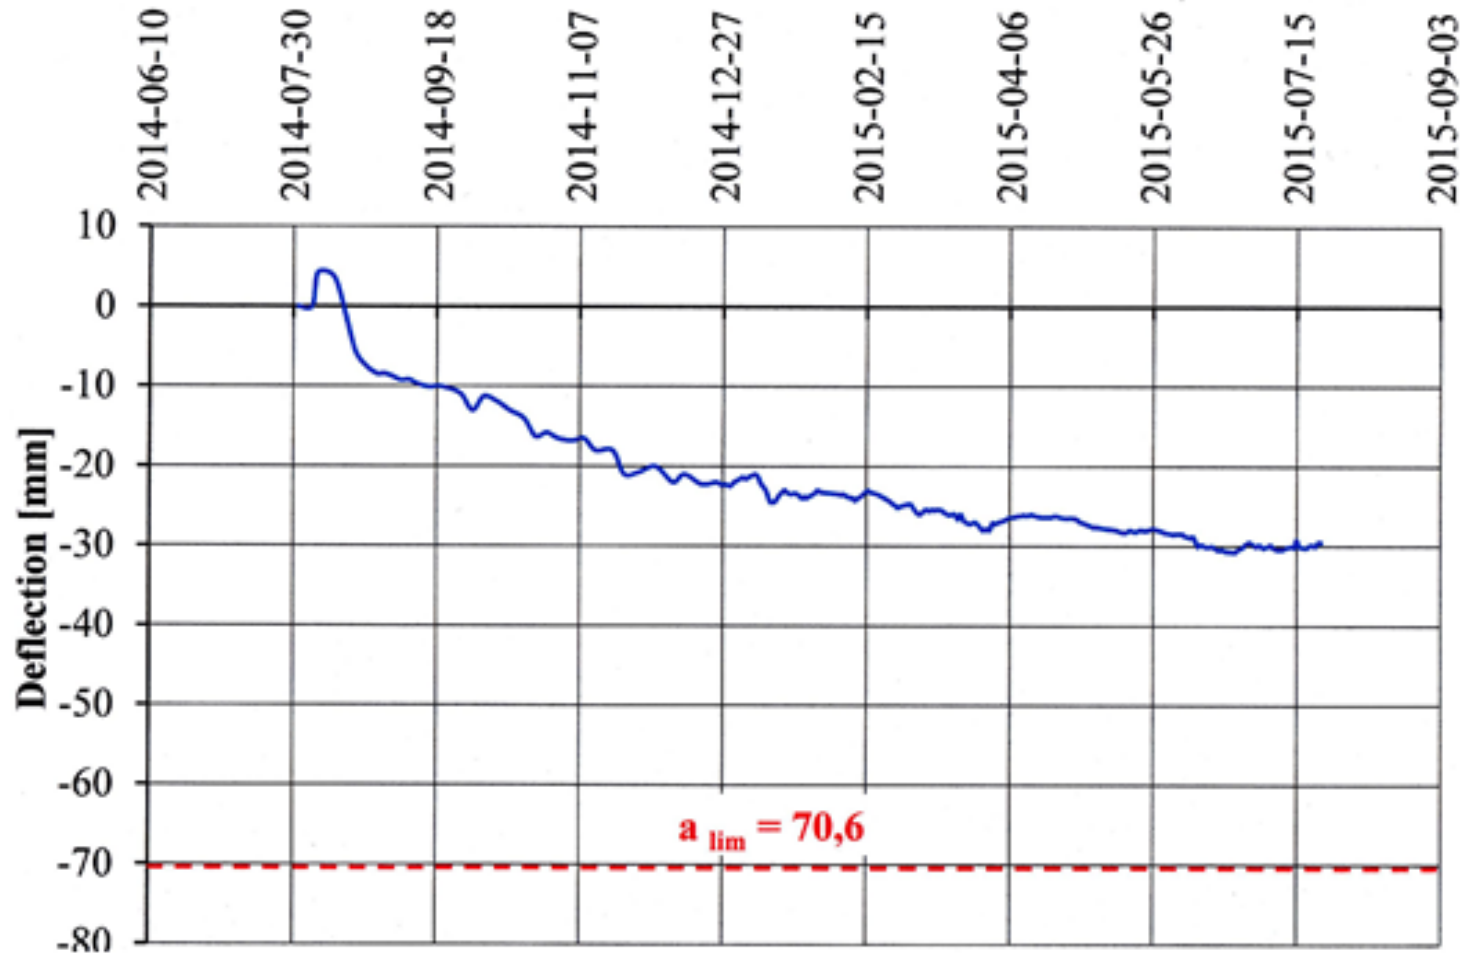
# Slab deflection
