COST TU1402:  
Quantifying the Value of  
Structural Health  
Monitoring

# CONCRETE STRUCTURES MONITORING WITH OBR BASED DISTRIBUTED OPTICAL FIBER SENSORS (DOFS)

## WG 2-2

Copenhagen, 24<sup>th</sup> August 2016

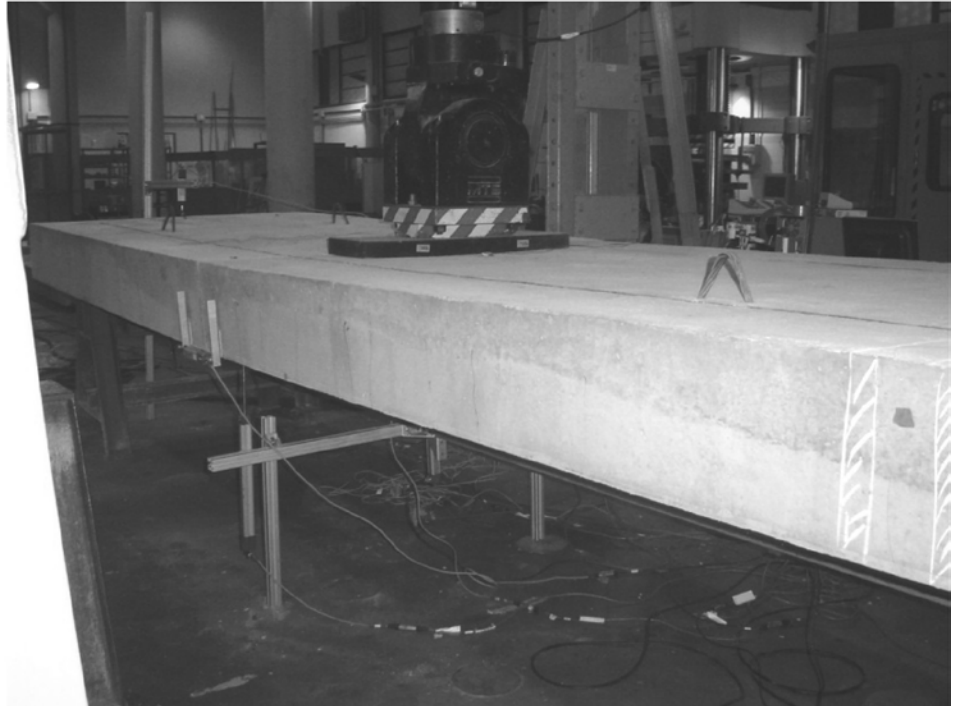
Dimensions: 5.60x1.60x0.285 [m]

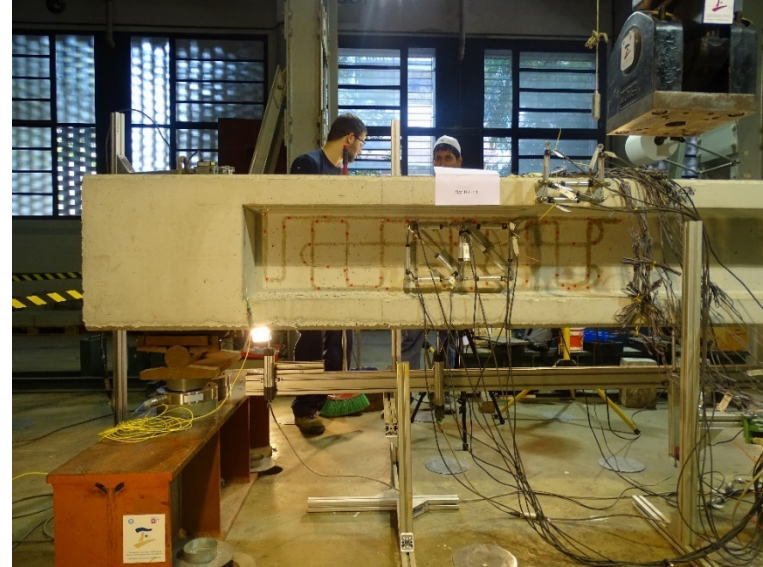
Use of conventional electrical sensors for comparison (potentiometers to conform a strain rosette)

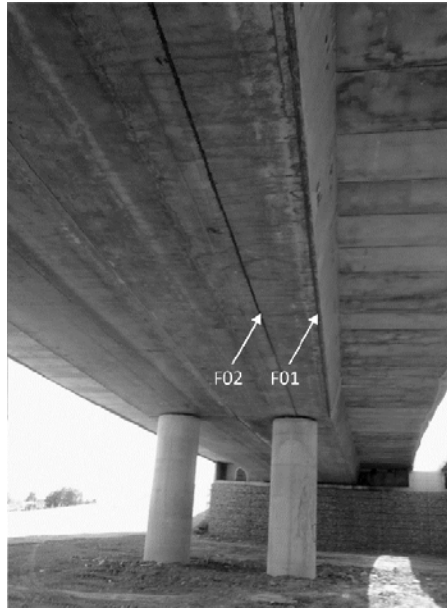
## Bridges – Can Fatjó Viaduct on the BP-1413

In this case, the experimental campaign had two main objectives:

- To check the feasibility and assess the system operation in concrete monitoring for a real bridge.
- To compare the resulting data with the theoretical and experimental values obtained by sensors installed during initial load tests.

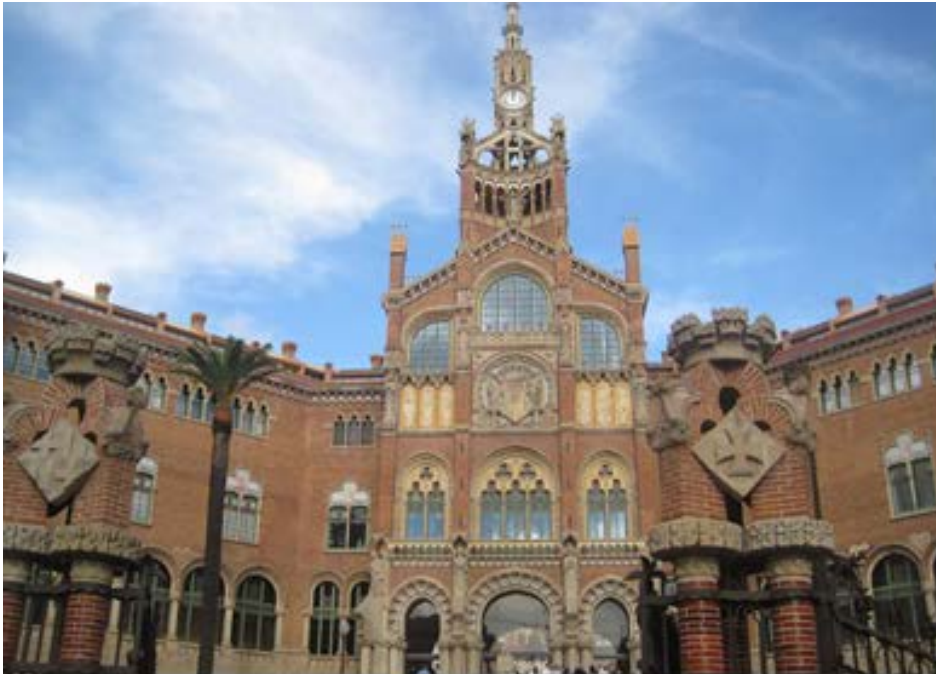
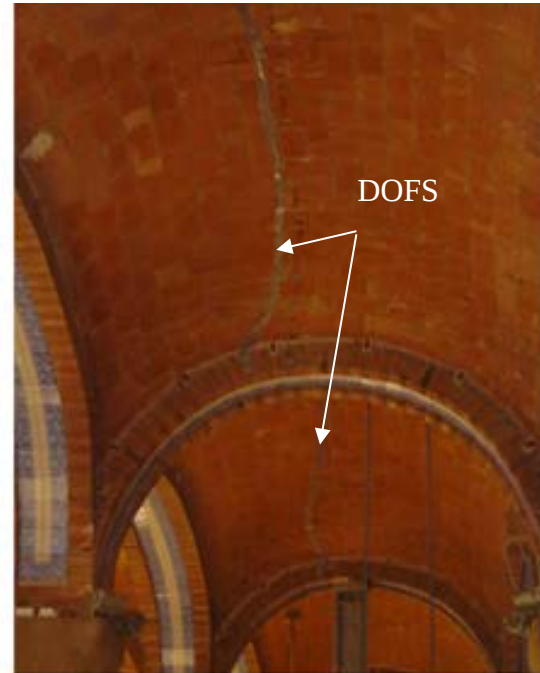
## Hospital de Sant Pau – Barcelona

UNESCO World heritage site instrumented with OBR sensors
