# **TERCENAS BRIDGE**

#### A chloride induced corrosion case

Luís Oliveira Santos

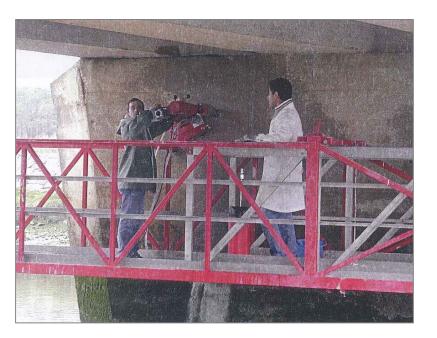
Taking cores for testing:

- Chloride content of concrete
- Carbonation of concrete
- Compressive strength of concrete
- Microscopic analysis

Bridge replacement was recommended.

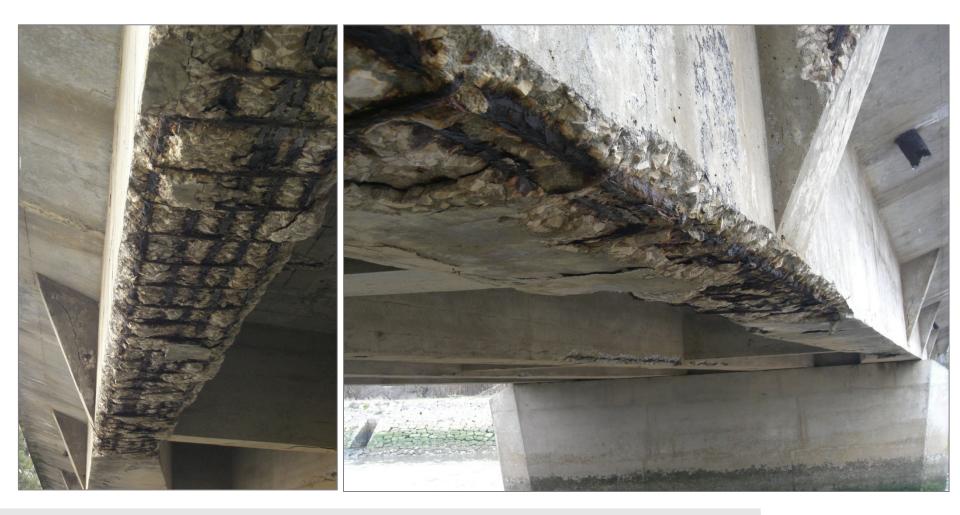
Jan. 2008

#### Bridge visual inspection Structural damages

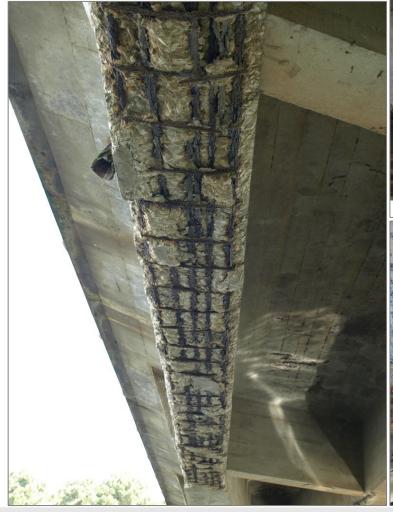
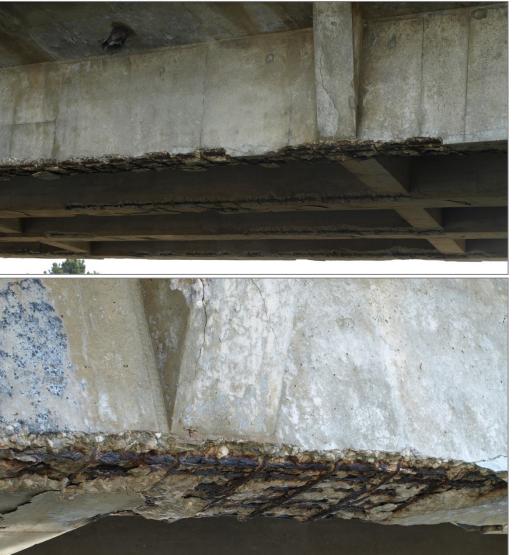
April 2009

#### Bridge visual inspection Structural damages

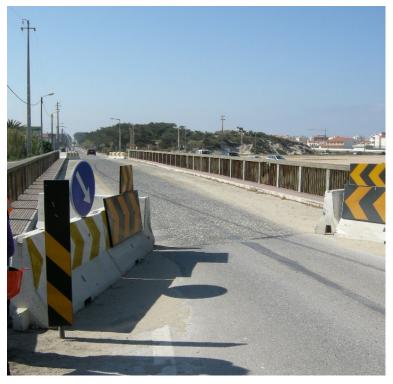
**Traffic restrictions**

- Traffic restrictions
  - Speed limit
  - Maximum weight
  - Avoid traffic over the left beam
- Frequent visual inspections
