TERCENAS BRIDGE

A chloride induced corrosion case

Luís Oliveira Santos

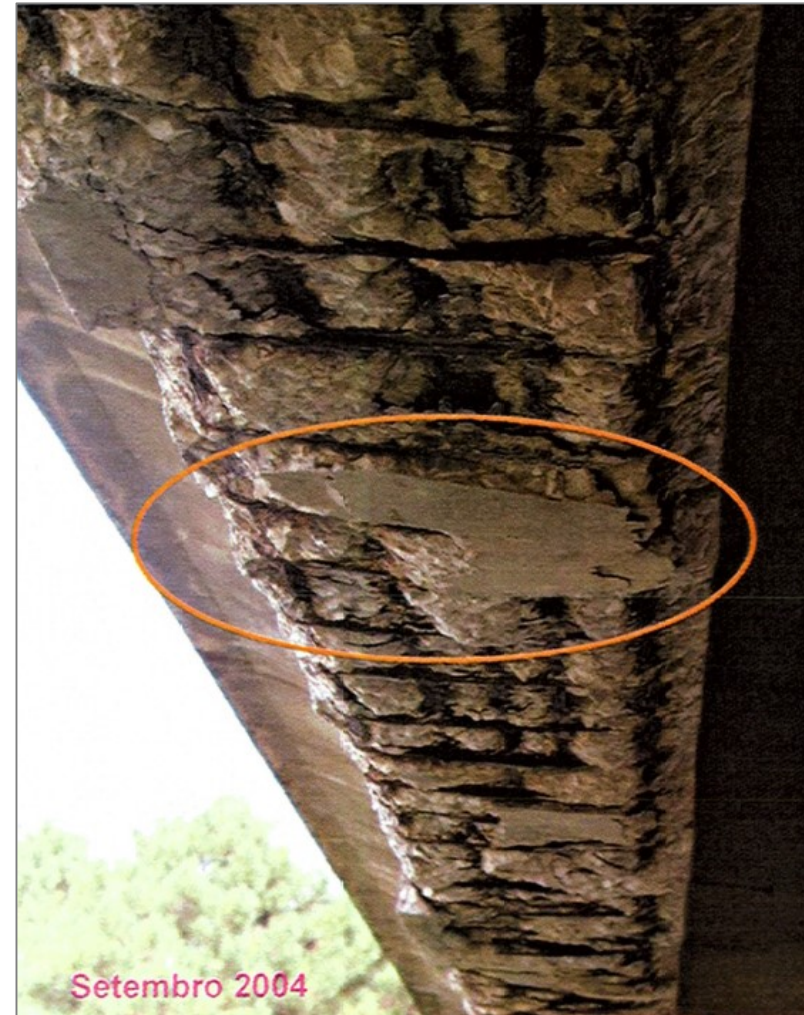
Visual inspection Structural damages

- Cracking
- Concrete delamination
- Corrosion of reinforcement bars

Beam on the sea side (left beam)

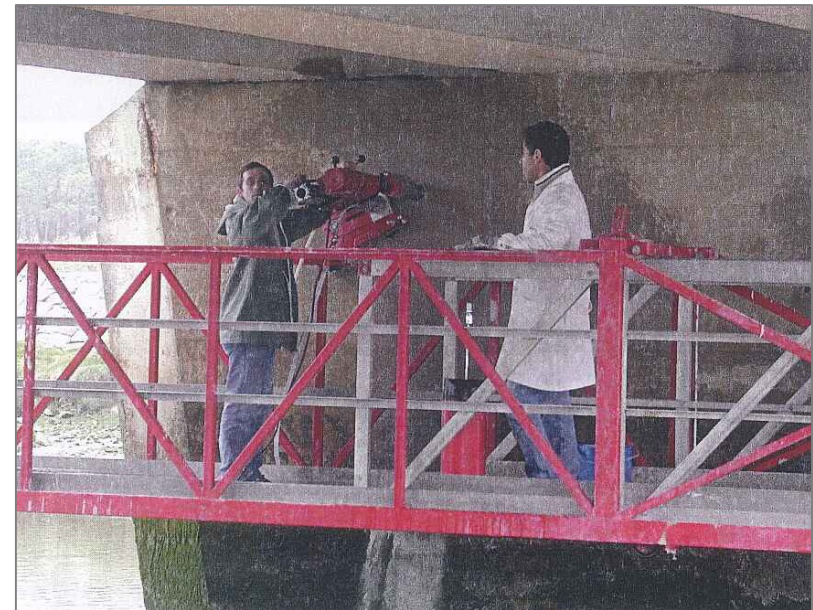
Laboratory tests

Taking cores for testing:

- Chloride content of concrete
- Carbonation of concrete
- Compressive strength of concrete
- Microscopic analysis

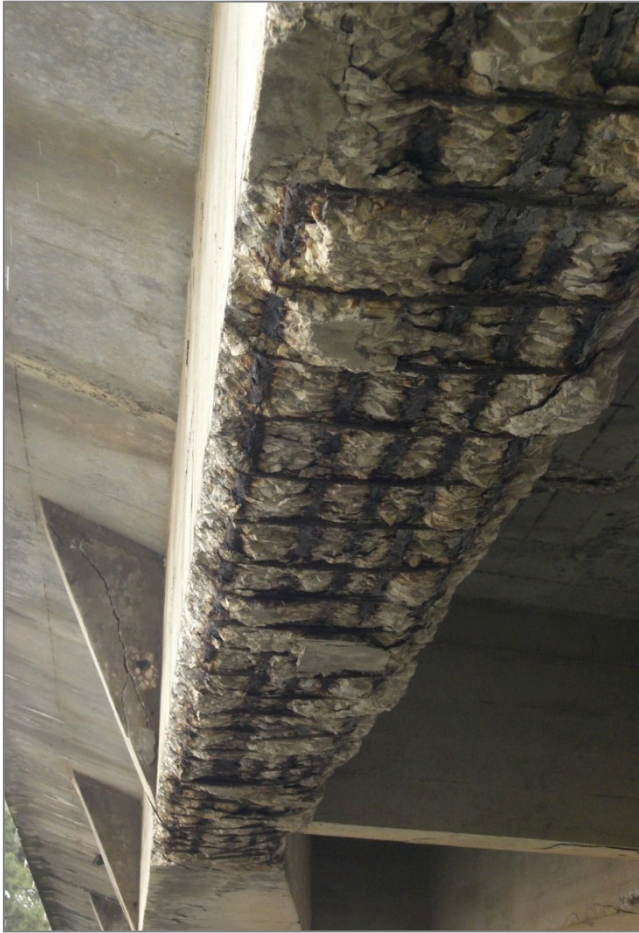
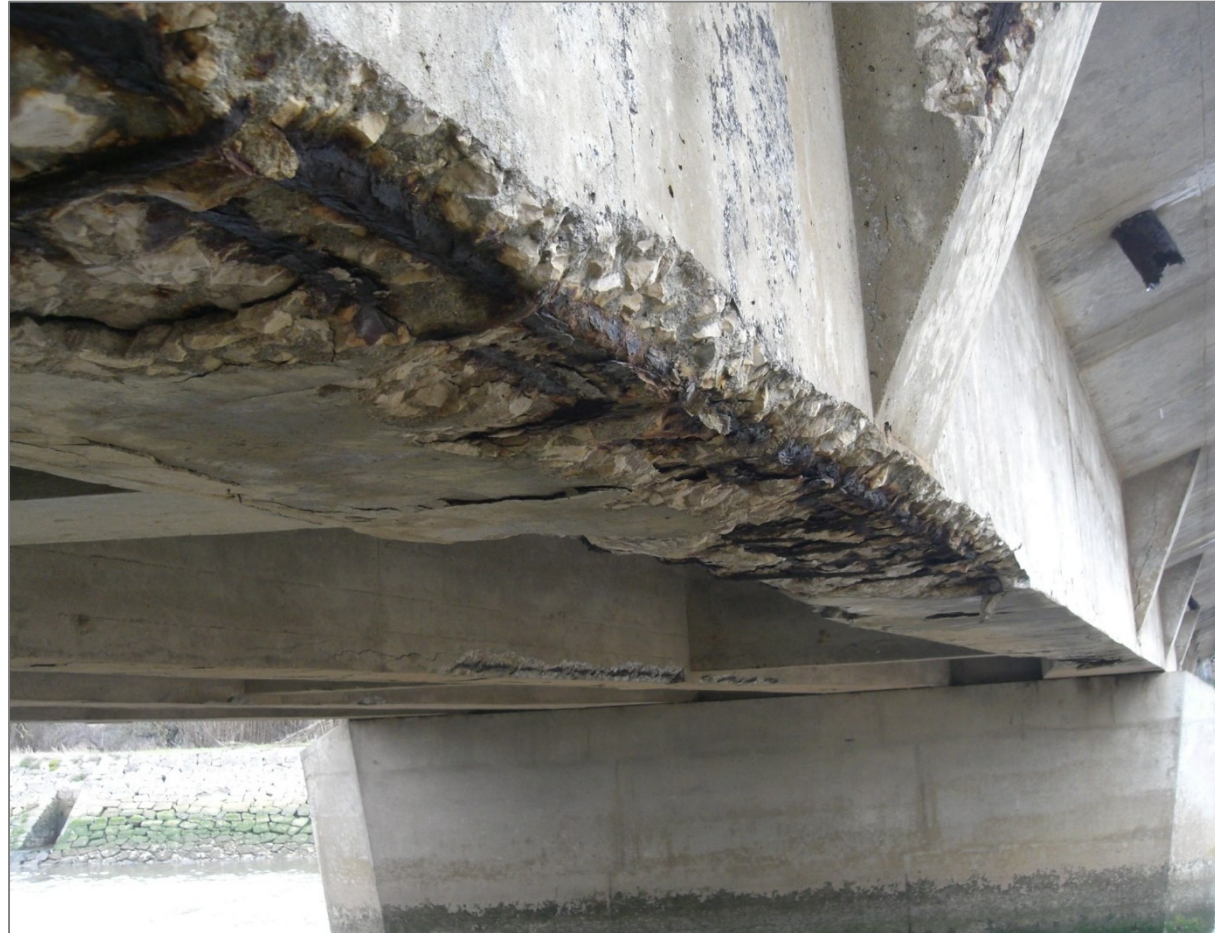
Jan. 2008

Bridge visual inspection

Structural damages

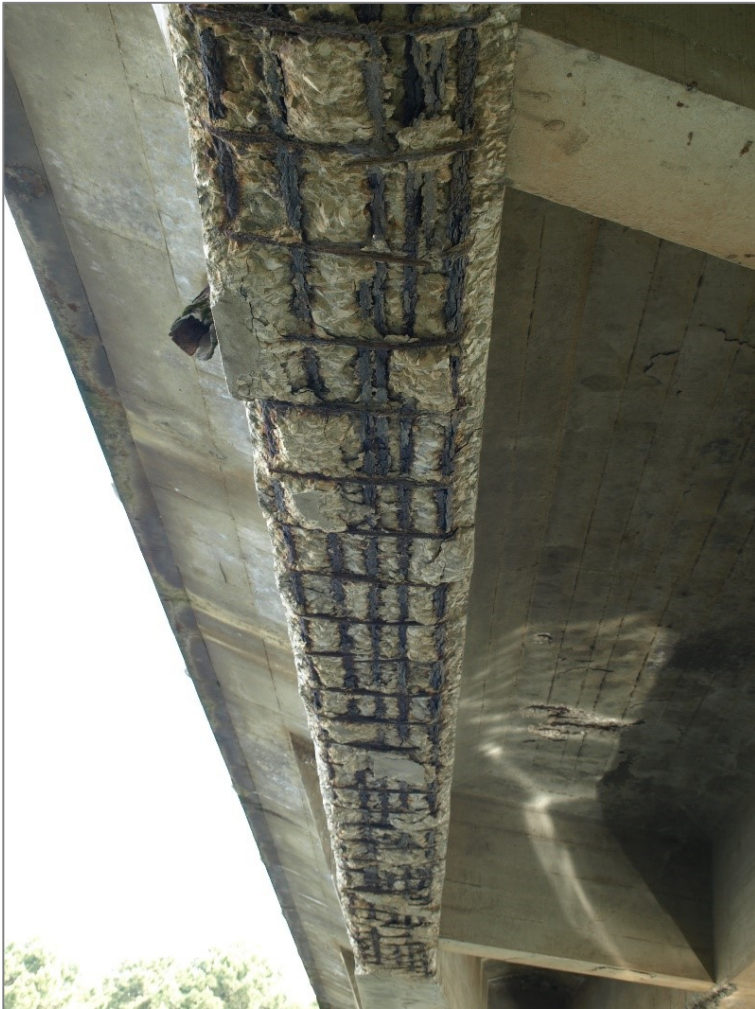
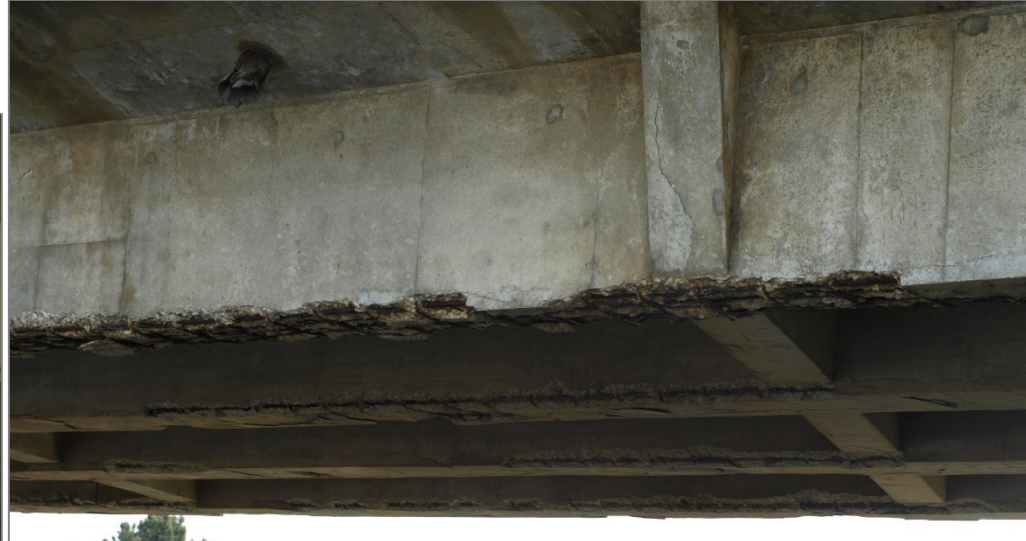
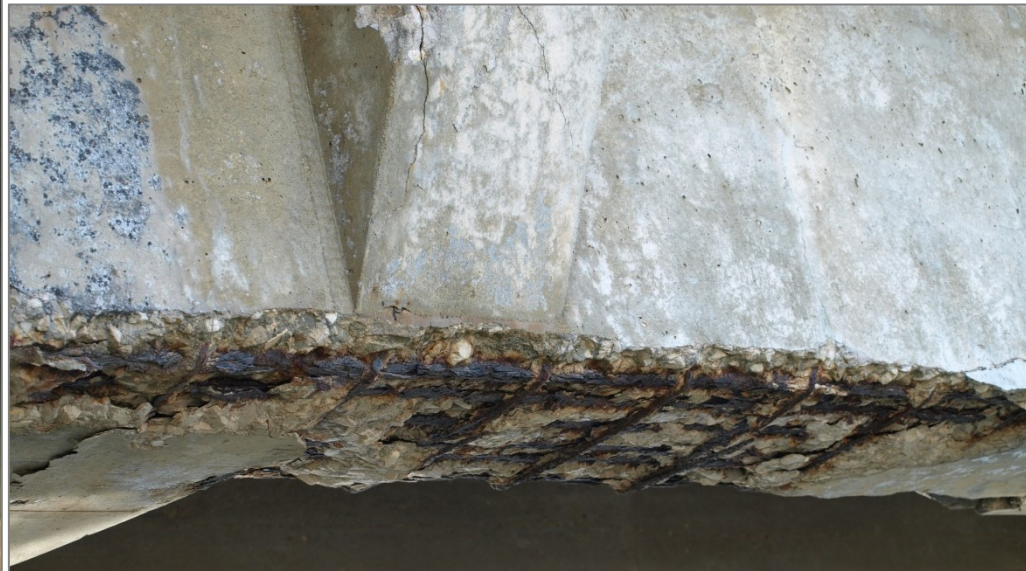
April 2009

Bridge visual inspection

Structural damages

- Traffic restrictions
 - Speed limit
 - Maximum weight
 - Avoid traffic over the left beam
- Frequent visual inspections

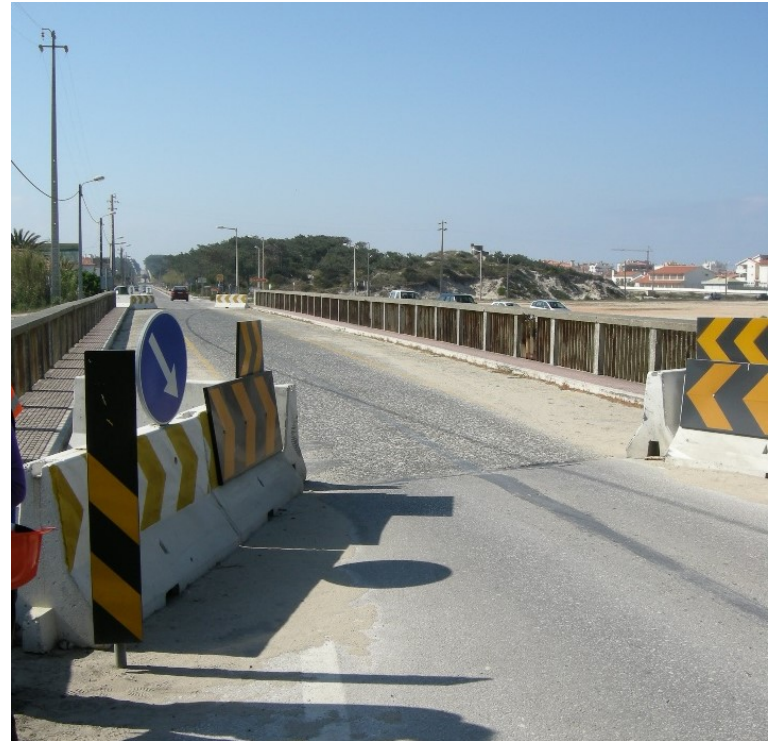
Safety until replacement ?

- Remedial actions**
- Immediate closing of the bridge
 - Traffic restrictions
 - Frequent visual inspections

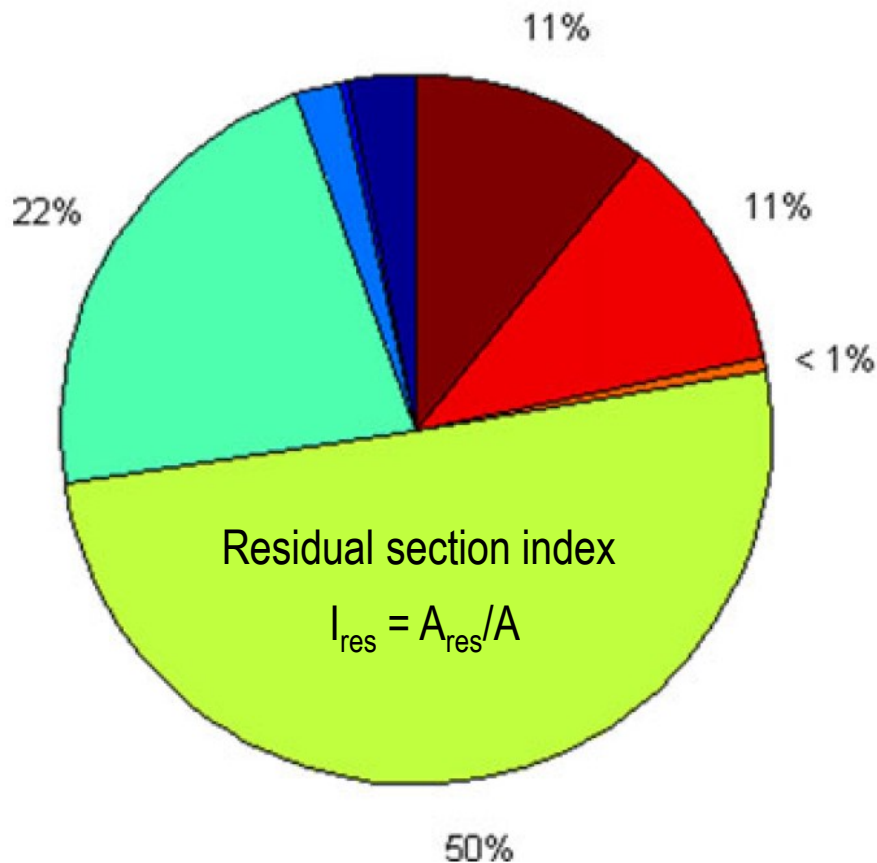
Sensitivity analysis

FORM Sensitivity coefficients

- Sensitivity analysis to identify the random variables more significant to structural safety → Residual section index ($i_{res} = A_{res} / A$)
- Collect information on key variable (i_{res})
- Updating the residual section index predictive model → **Bridge safe**

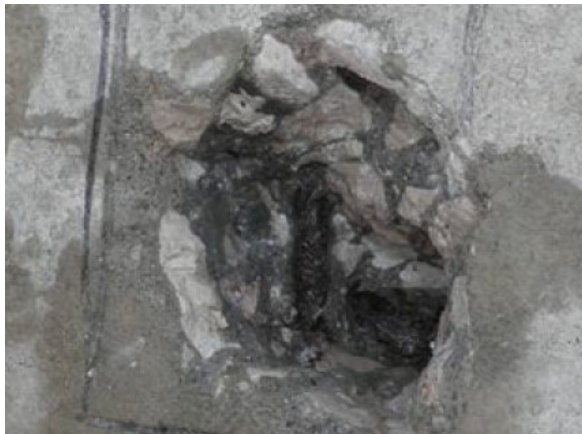
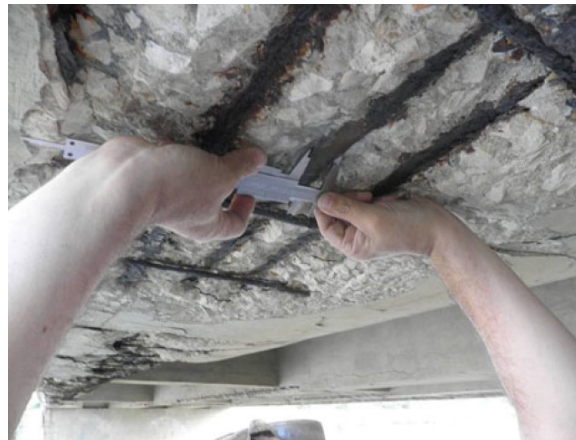
Bayesian updating of the residual section index

- Collection of information on residual areas of reinforcement

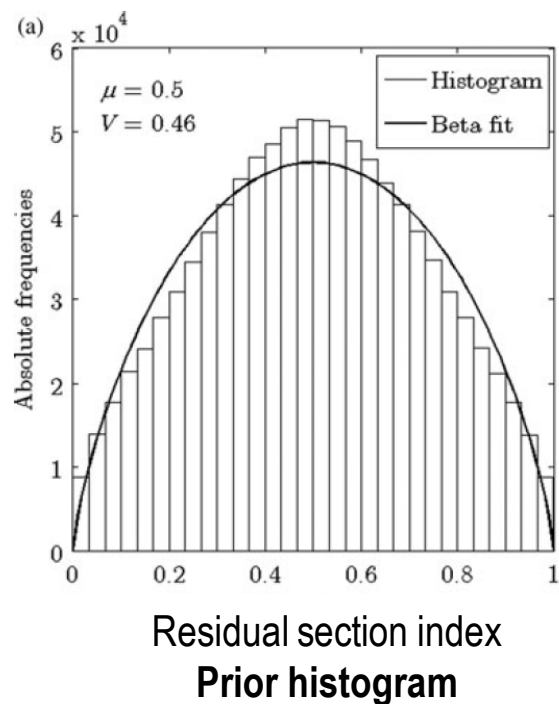
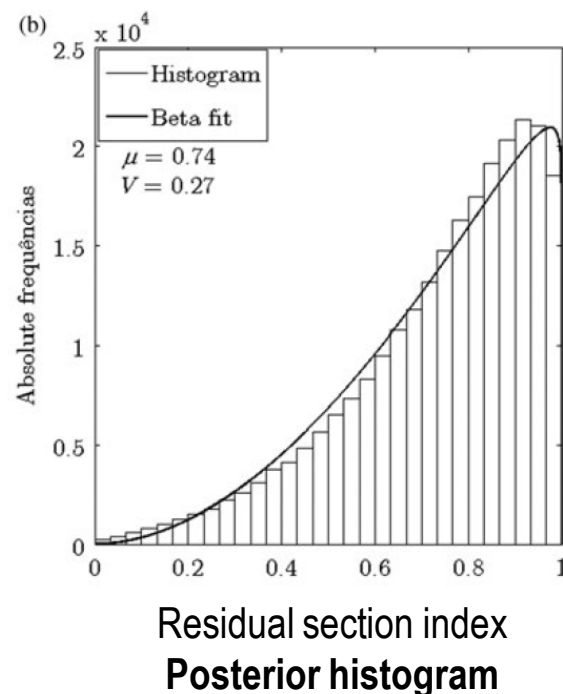
Bayesian updating of the residual section index

- Updating the residual section index predictive model

Reliability analysis using this updated probabilistic model : $\beta = 3,9 > \beta_T$

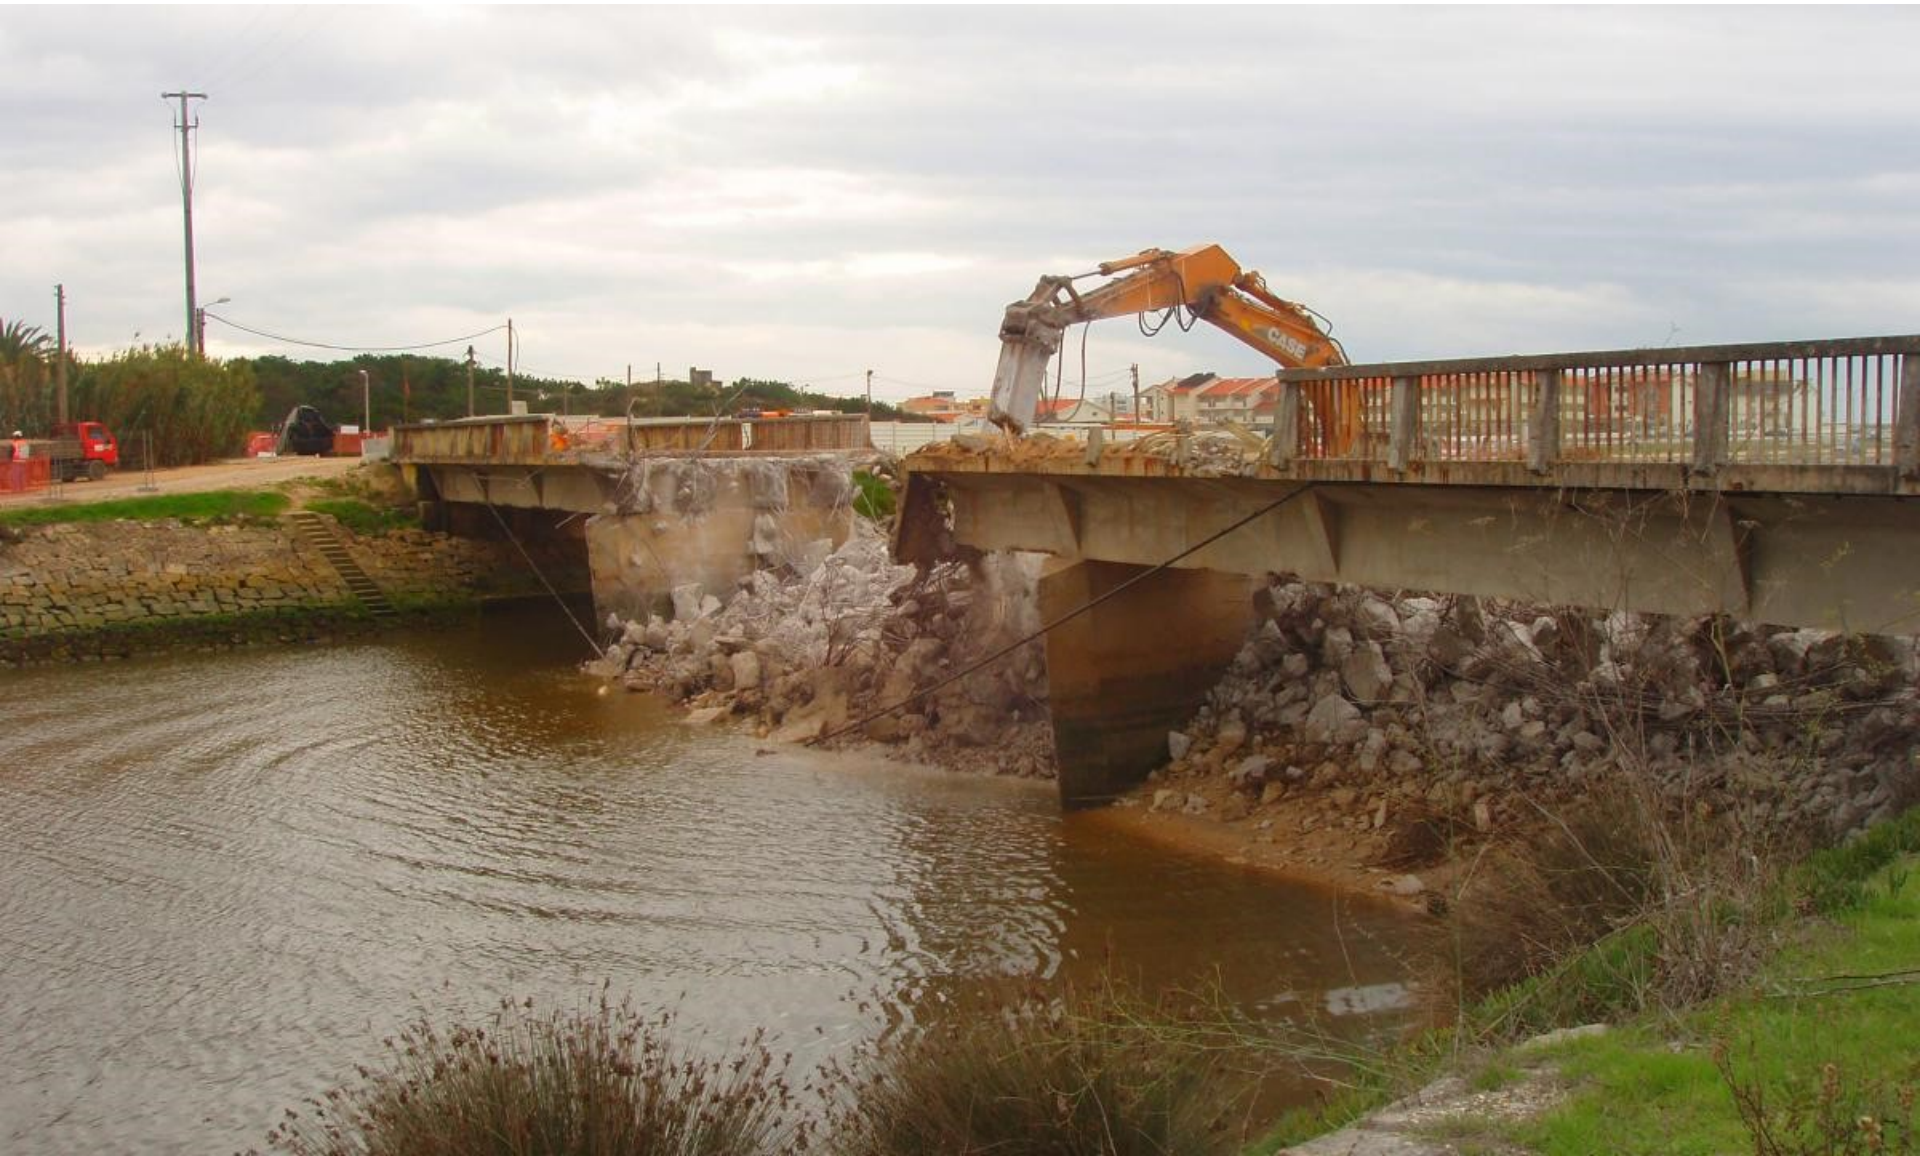
2012

Bridge demolition
