ViBest_SHM: A digital data repository for SHM

Álvaro Cunha, Elsa Caetano, Carlos Moutinho, Filipe Magalhães

10 Dynamic Monitoring Programs

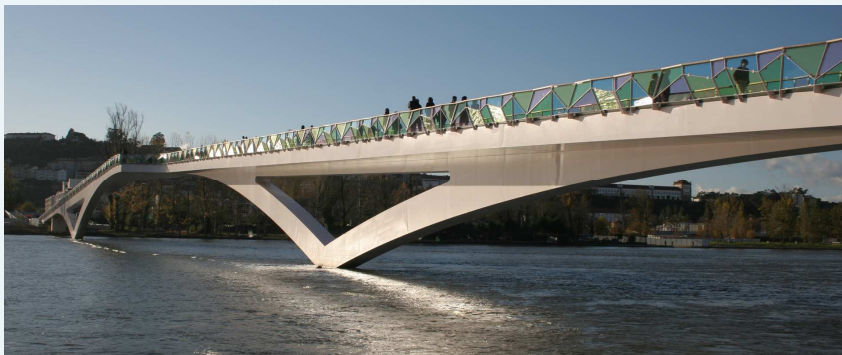
- Pedro e Inês footbridge (Coimbra)

L=275m

Parabolic arch 110m span, 9m rise

2 half-arches 64m long, asymmetric box section

Composite deck, 4m width

Arch foundation: massifs of 35m deep vertical piles

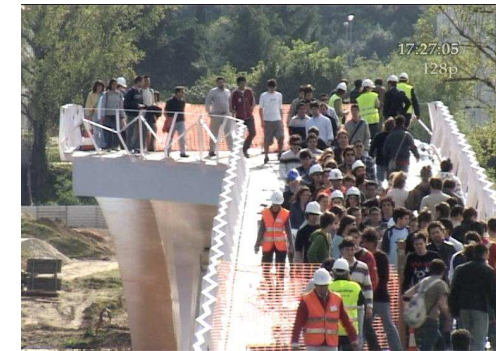
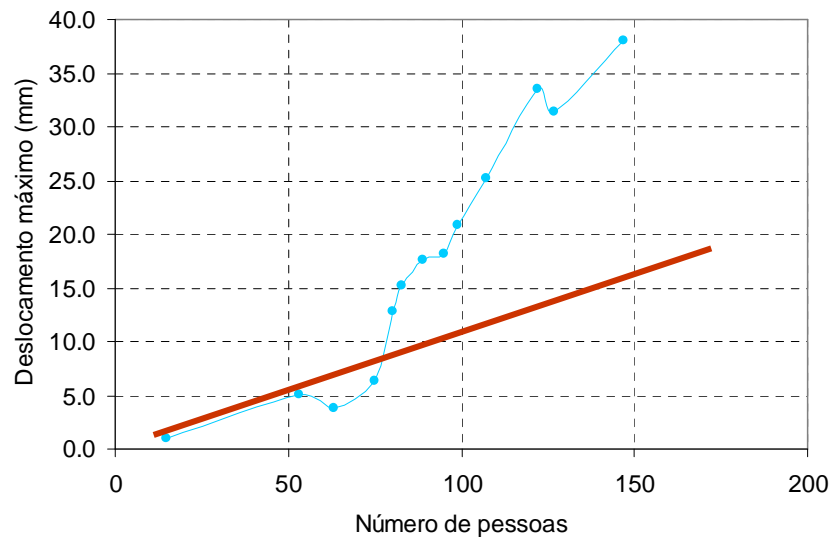
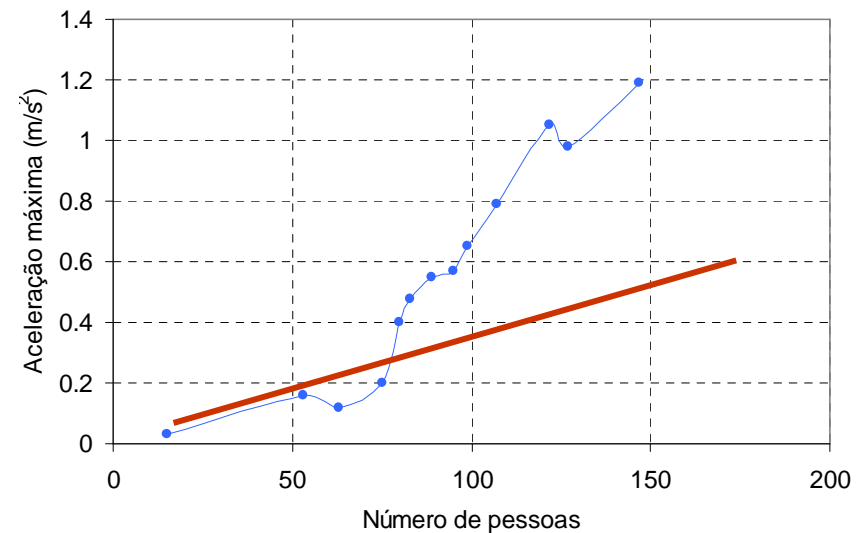
Dynamic tests at the end of construction

Crowd tests (excessive lateral vibrations)

- Variation of response with number of persons on the bridge

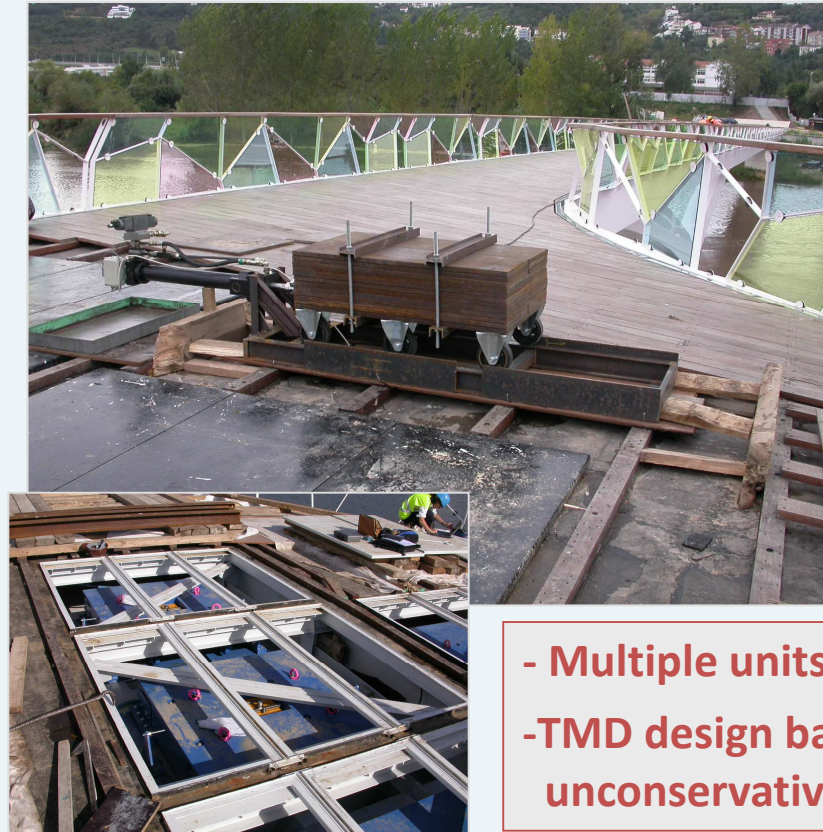
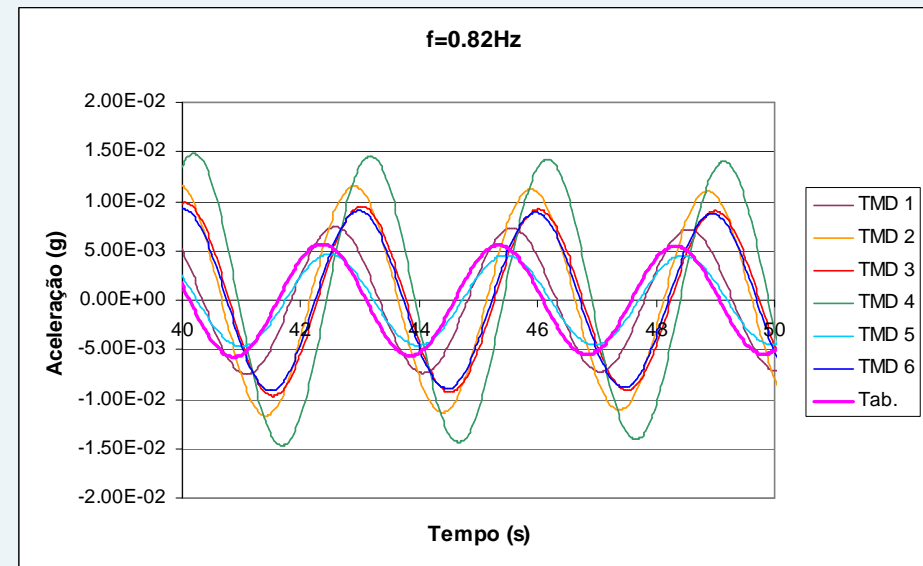
Forced vibration tests

- Evaluation of the efficiency of the TMDs

- Multiple units of the same TMD reduce global efficiency
- TMD design based on linear viscous damper is unconservative in this application

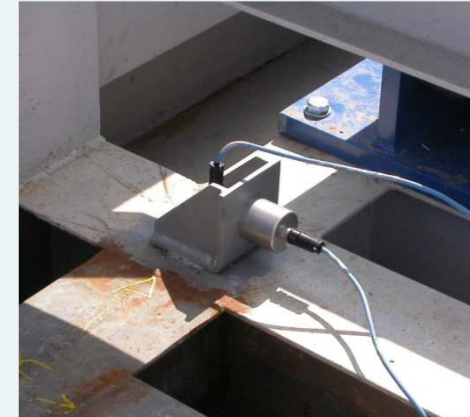
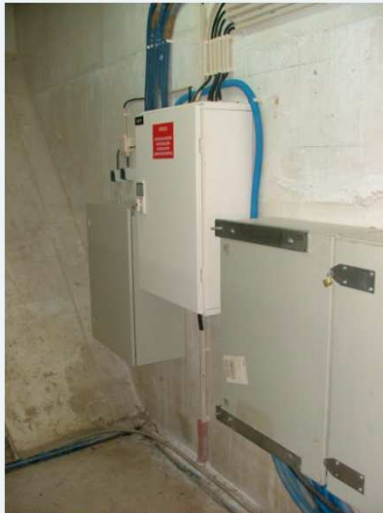
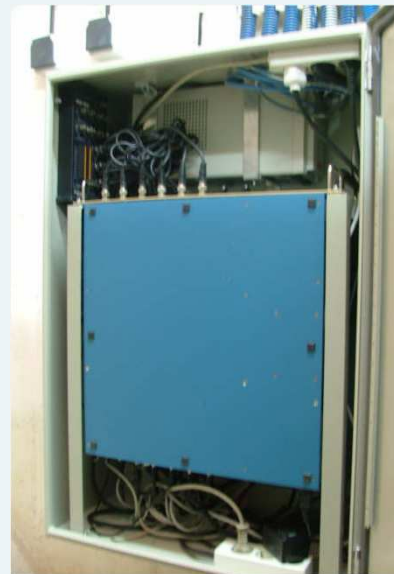
5-years Continuous Dynamic Monitoring

6 uniaxial piezoelectric accelerometers

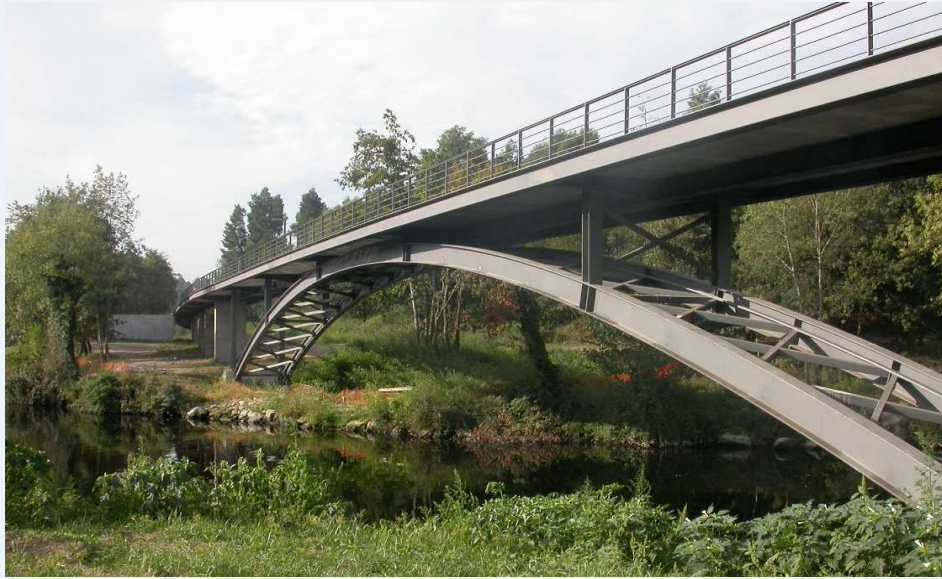
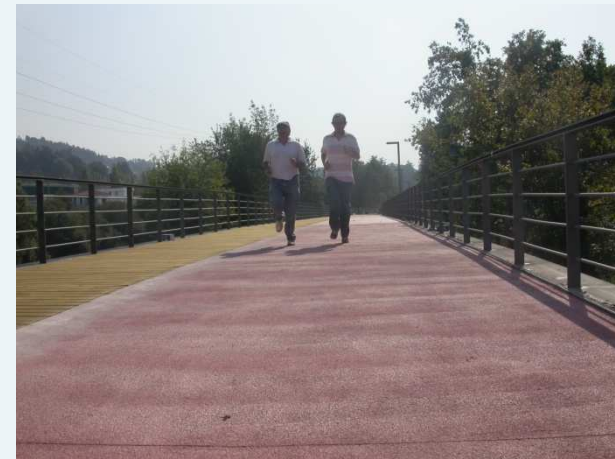
Santo Tirso footbridge

Excessive vertical vibrations

Designer: SOPSEC, Portugal

Steel arch, 60m chord, 6 m rise
Length= 84 m; Width: 5 m
Deck: 0.15 m thick light weight
concrete slab supported by steel
girders

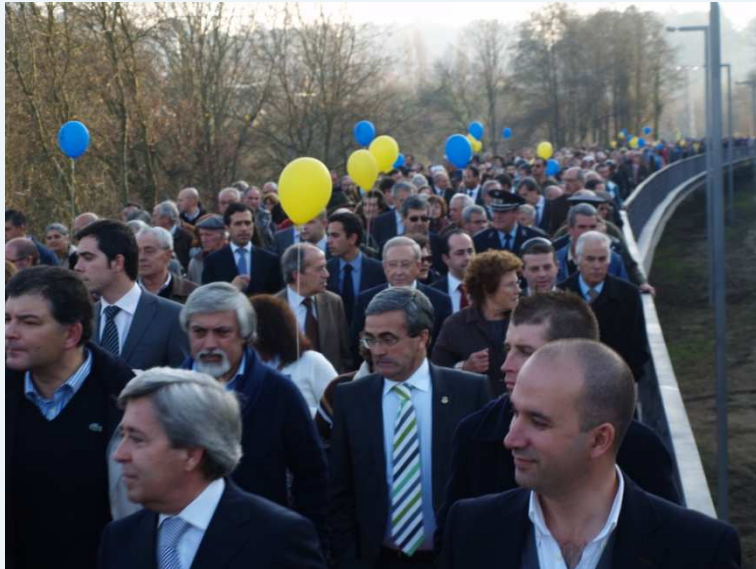
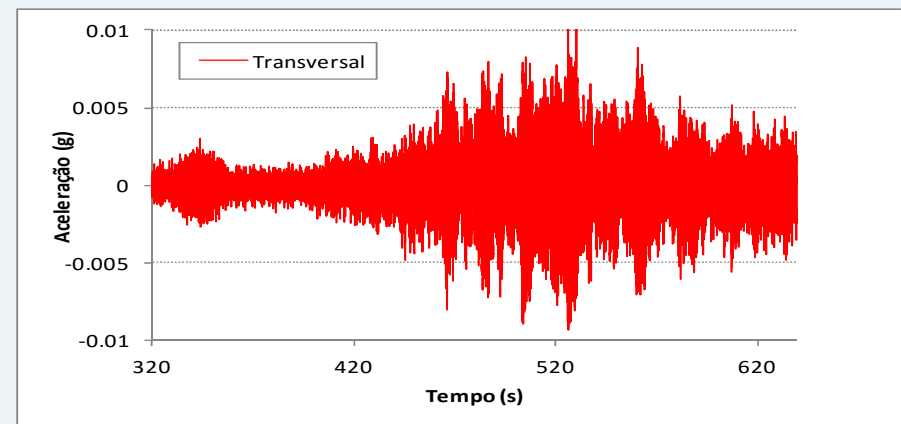
Verification of efficiency of installed TMDs

Maximum acceleration:

Vertical: 0.35 m/s^2

Lateral: 0.1 m/s^2

Maximum comfort

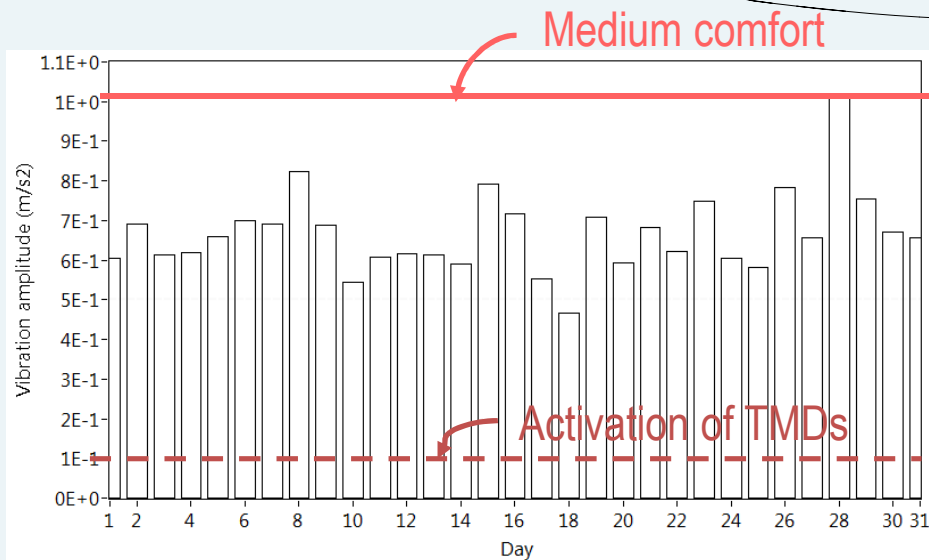
Continuous Dynamic Monitoring

Maximum vertical daily acceleration

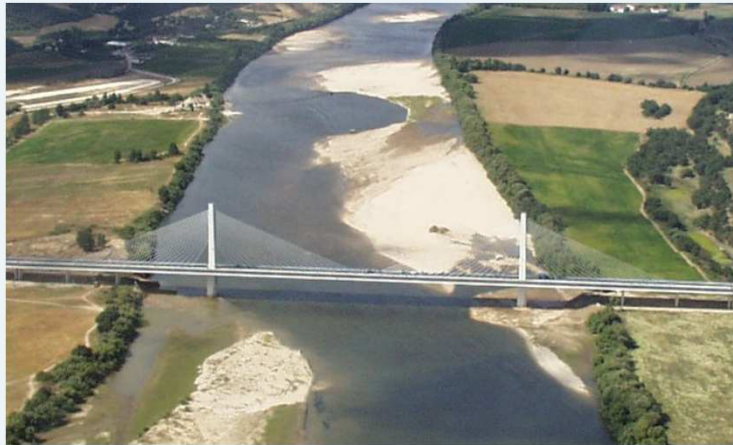
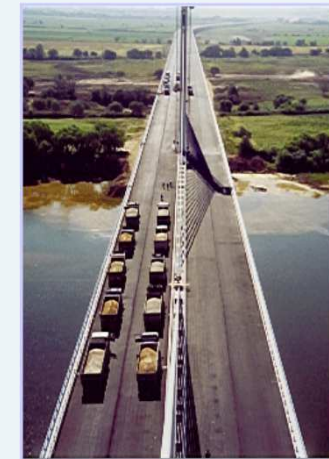
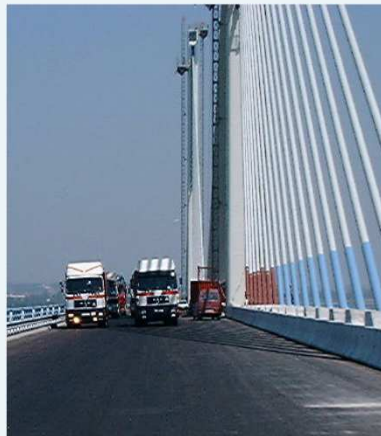
- Salgueiro Maia cable-stayed bridge

Temporary Monitoring Traffic induced vibrations in Roadway Bridges

Load cells in stay cables

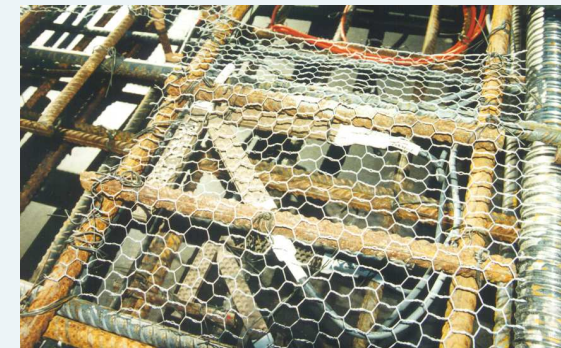
Embedded strain gages

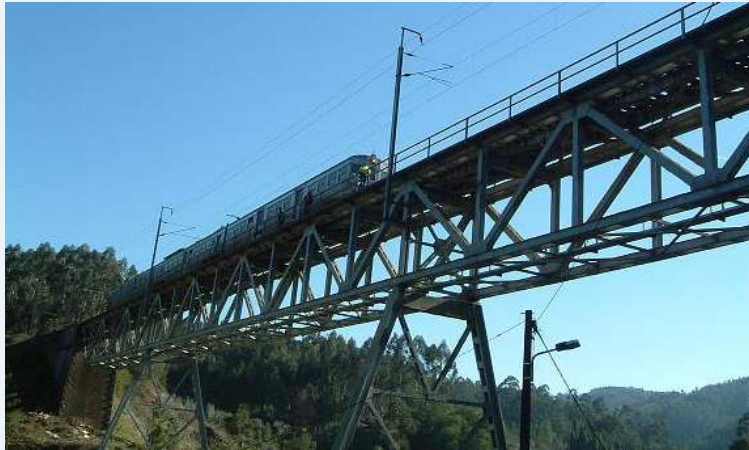
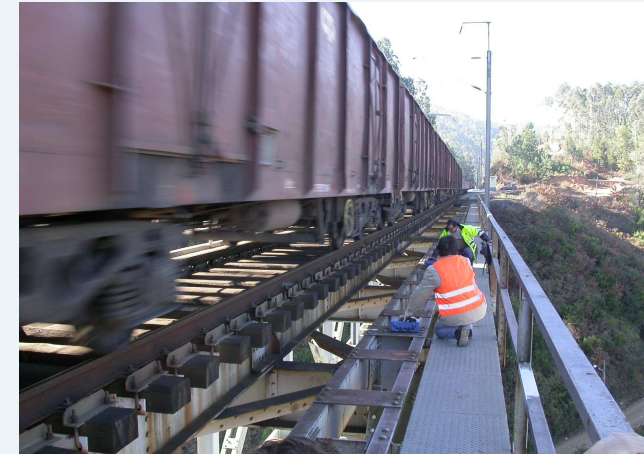
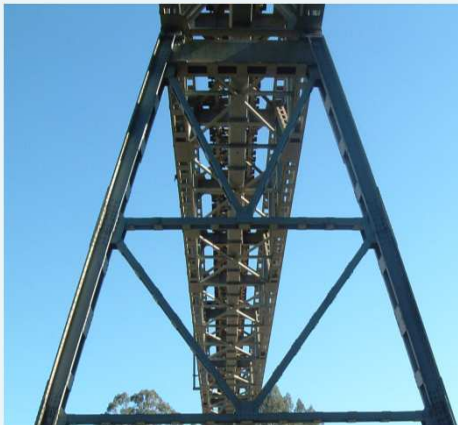
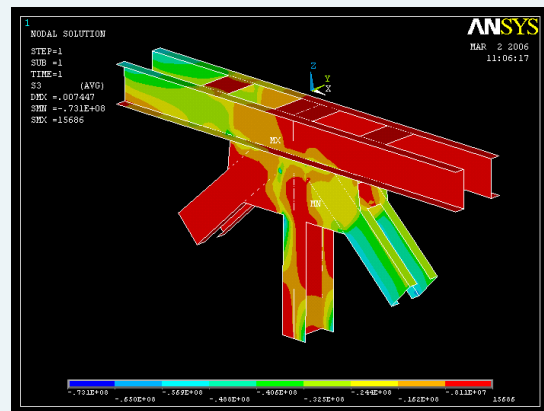
- Dynamic effects and fatigue assessment of Trezói Bridge

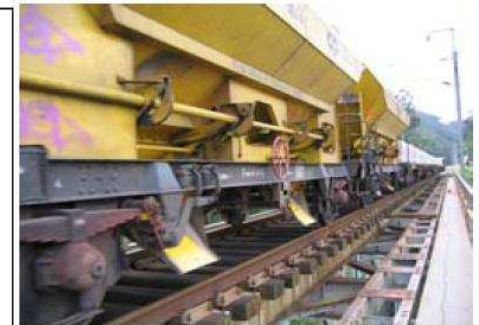
Strain measurements under traffic loads

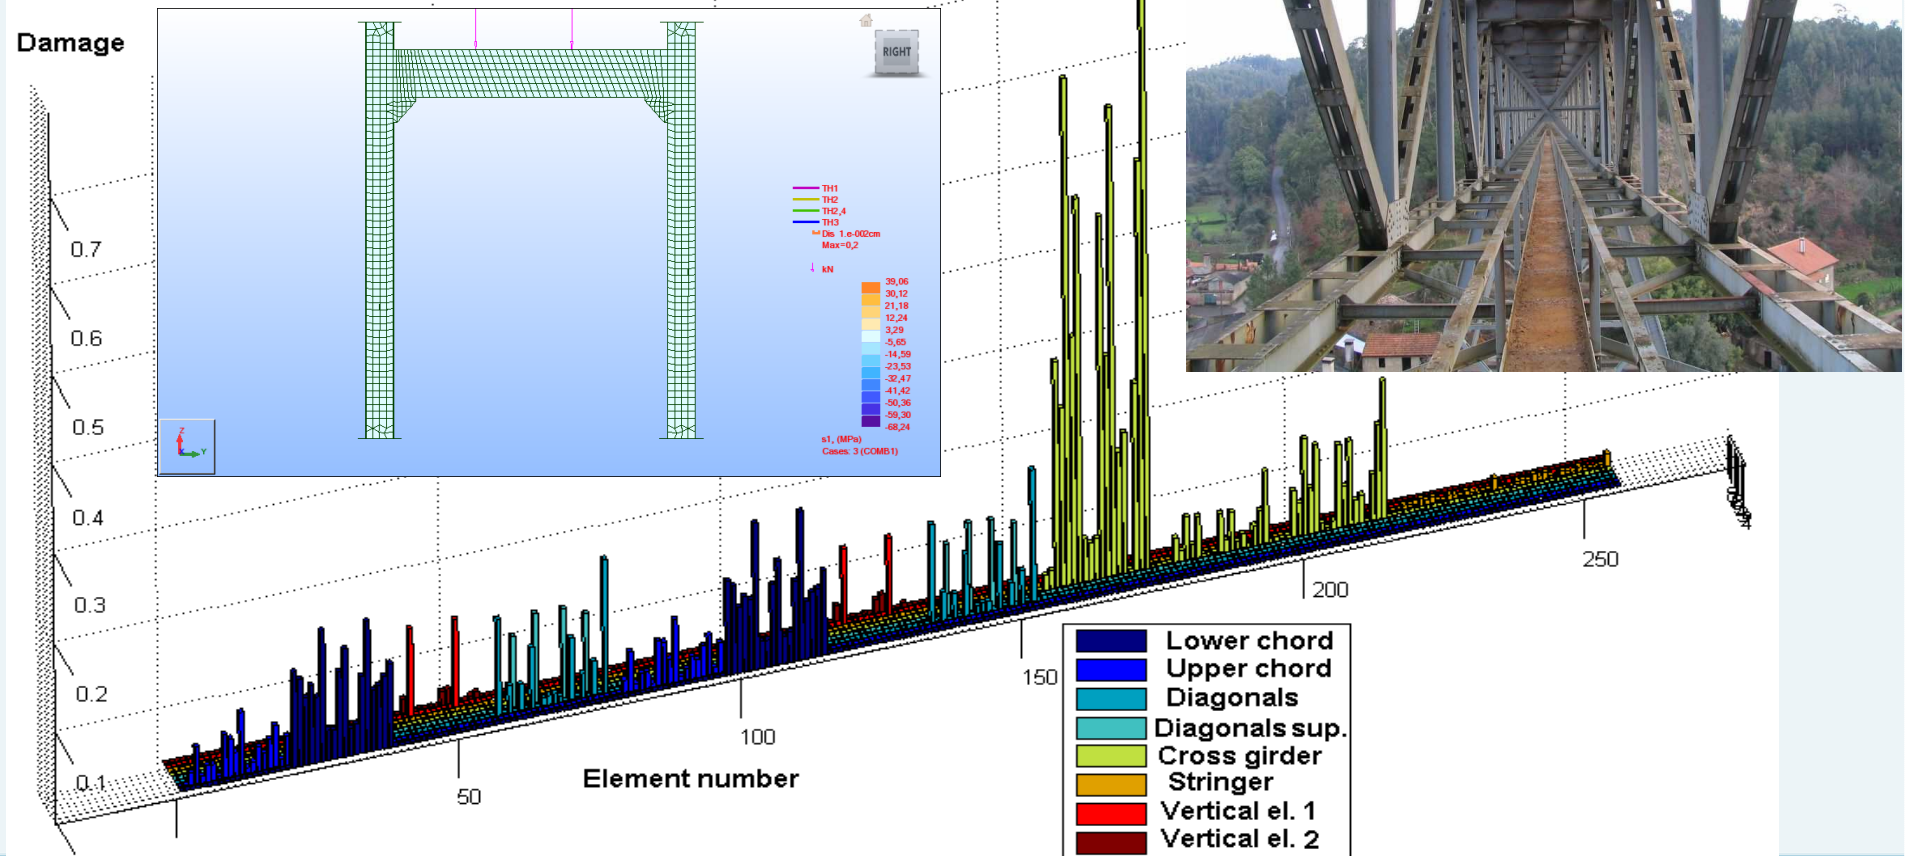
Fatigue damage (Miner rule) – Real trains

Damage in 54 years

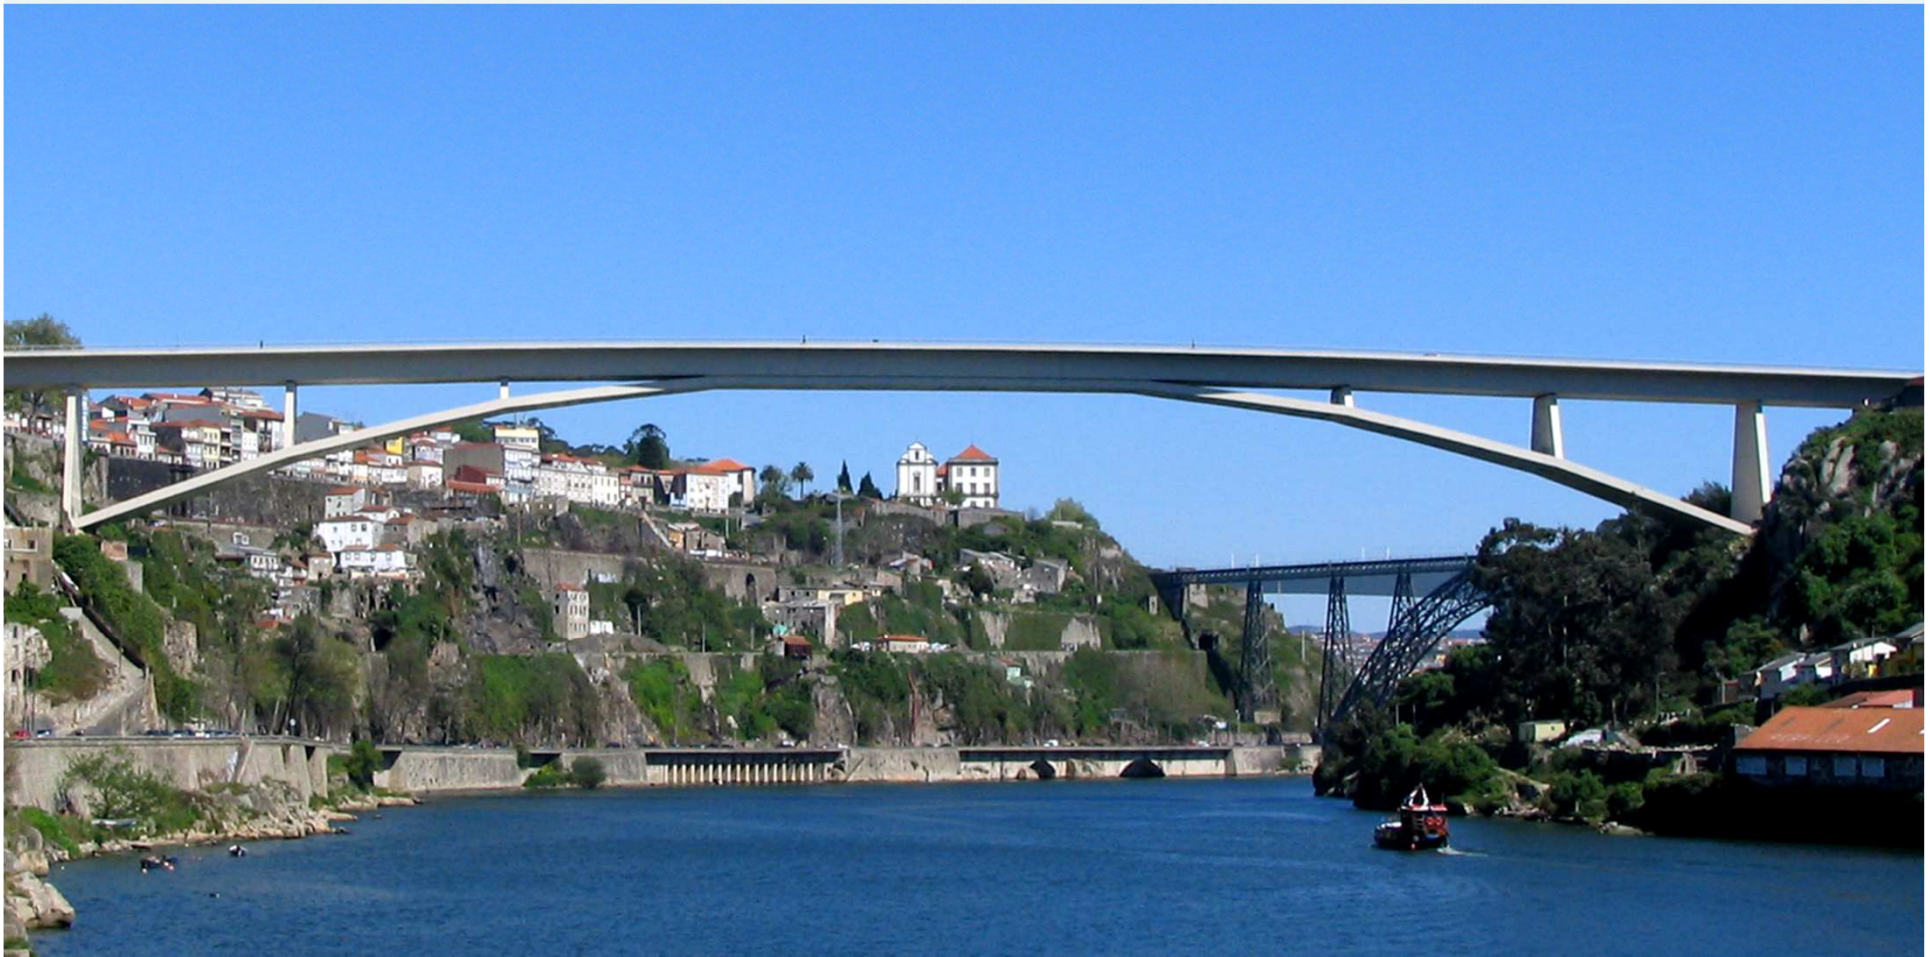
Continuous Dynamic Monitoring for Damage Detection

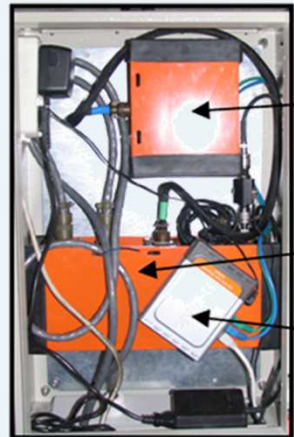
Local Backup Disk

Digitizer

Ethernet Switch

Router

Internet

FEUP (Real Time Data)

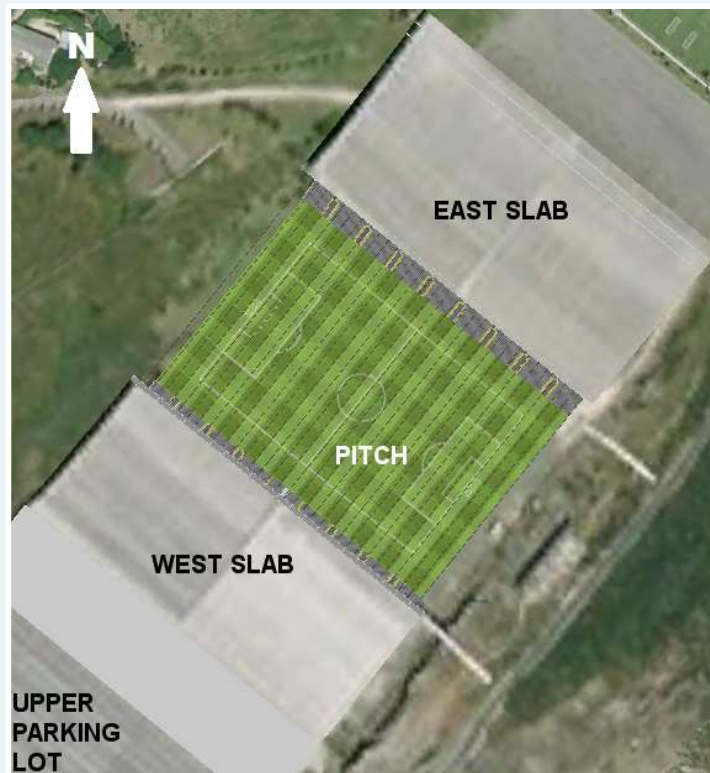
Top view of the stadium

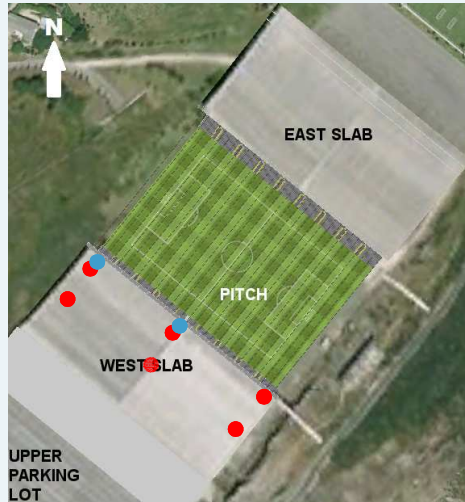
Continuous wind and dynamic monitoring systems

- 6 force balance accelerometers**
- 2 sonic anemometers**
- 8 temperature sensors**
- Continuous sampling at 20 Hz/10Hz**
- Records with 30 minutes duration**
- Data transfer to a server at FEUP**

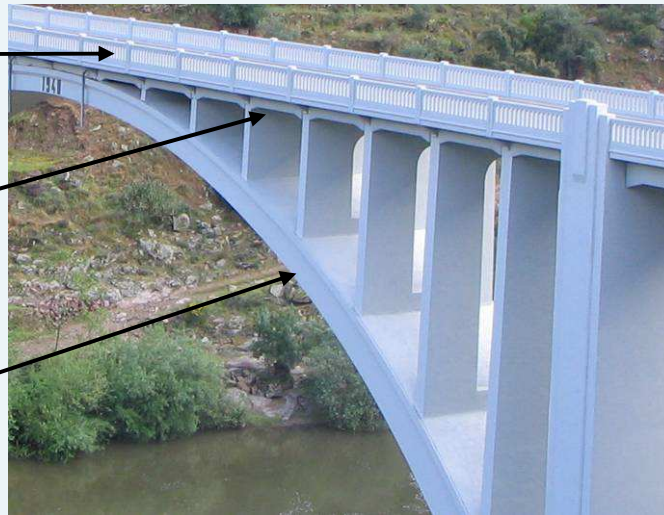
Built in 1940

Rehabilitated in 2007

- stiffing of the deck
- replacement of the handrails
- replacement of the supports and dilation joints
- surface repair and painting

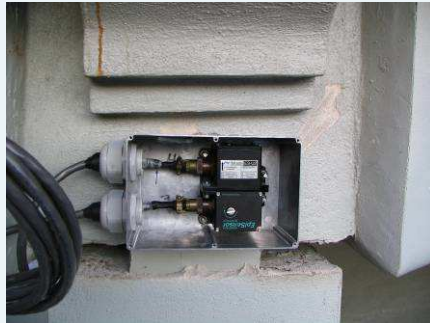
2 tri-axial Geophones

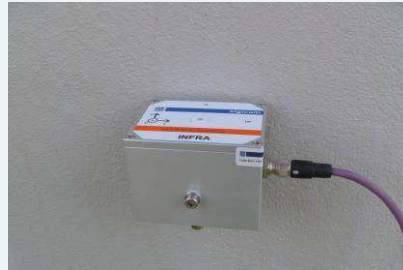
24 bit digitizer

Field processor

Blast monitoring system

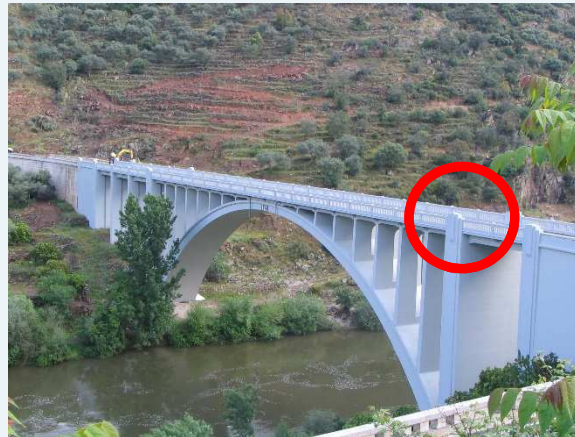
Mode shape in plan view

Lower temperatures

The support of the deck in the main piers allows free relative lateral displacements

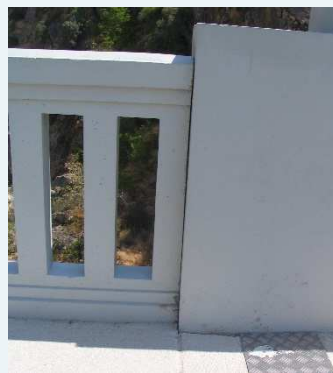
Mode shape in plan view

Higher temperatures

The expansion of the deck leads to a contact between deck and main piers that constrains relative lateral displacements

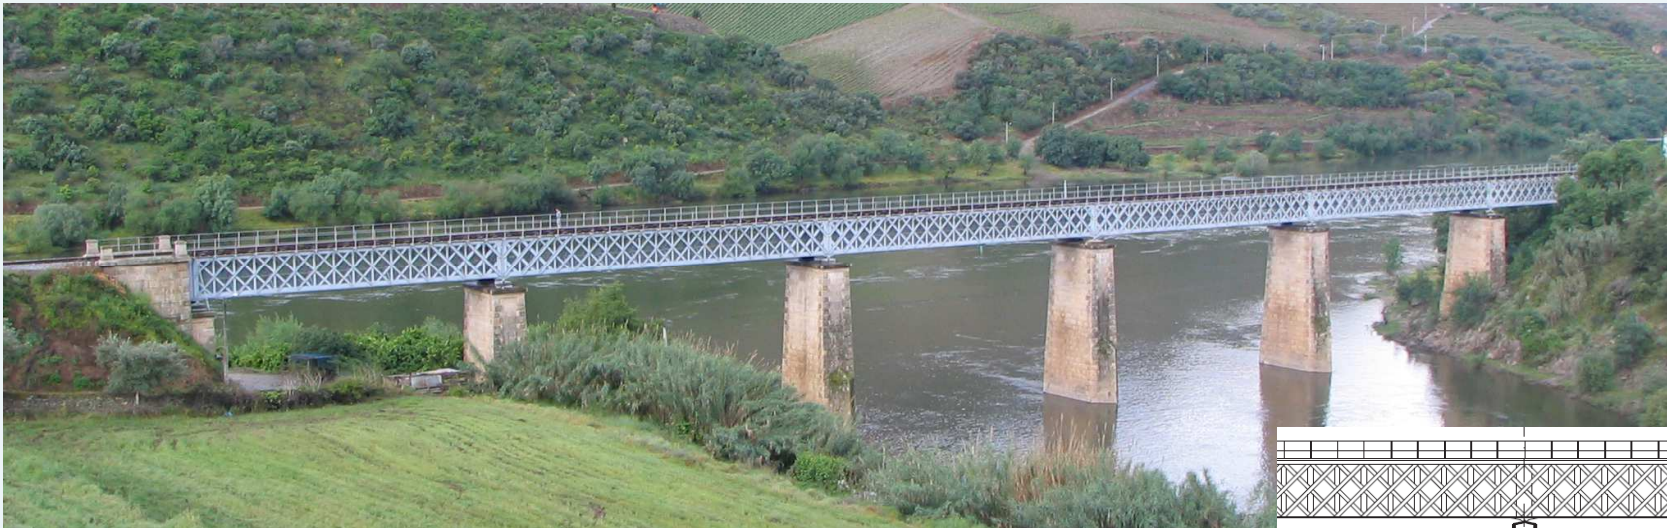
Railway Bridge

Built in 1882

Steel riveted truss deck with a height of 3 meters and a total length of 169 meters

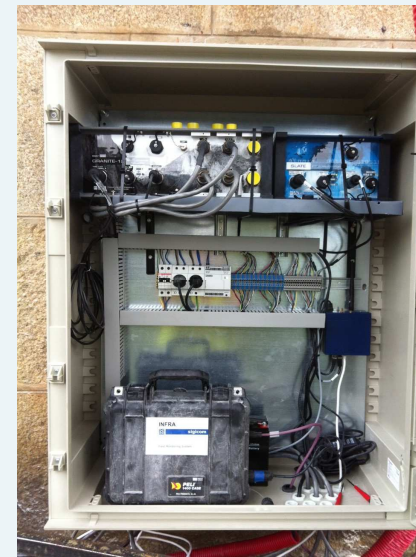
Railway Bridge - Monitoring System

13 force balance accelerometers

2 24-bit digitizers

4 temperature sensors

7 geophones

3 bi-axial clinometers

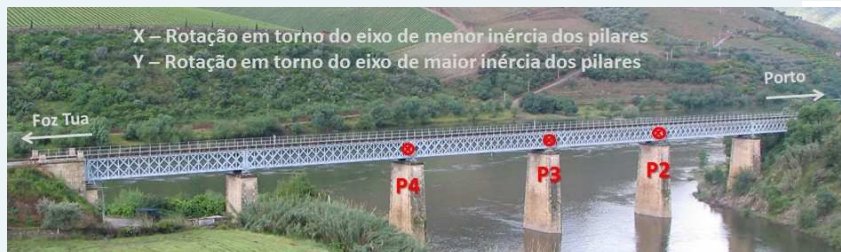
Results - Railway Bridge

Clinometers

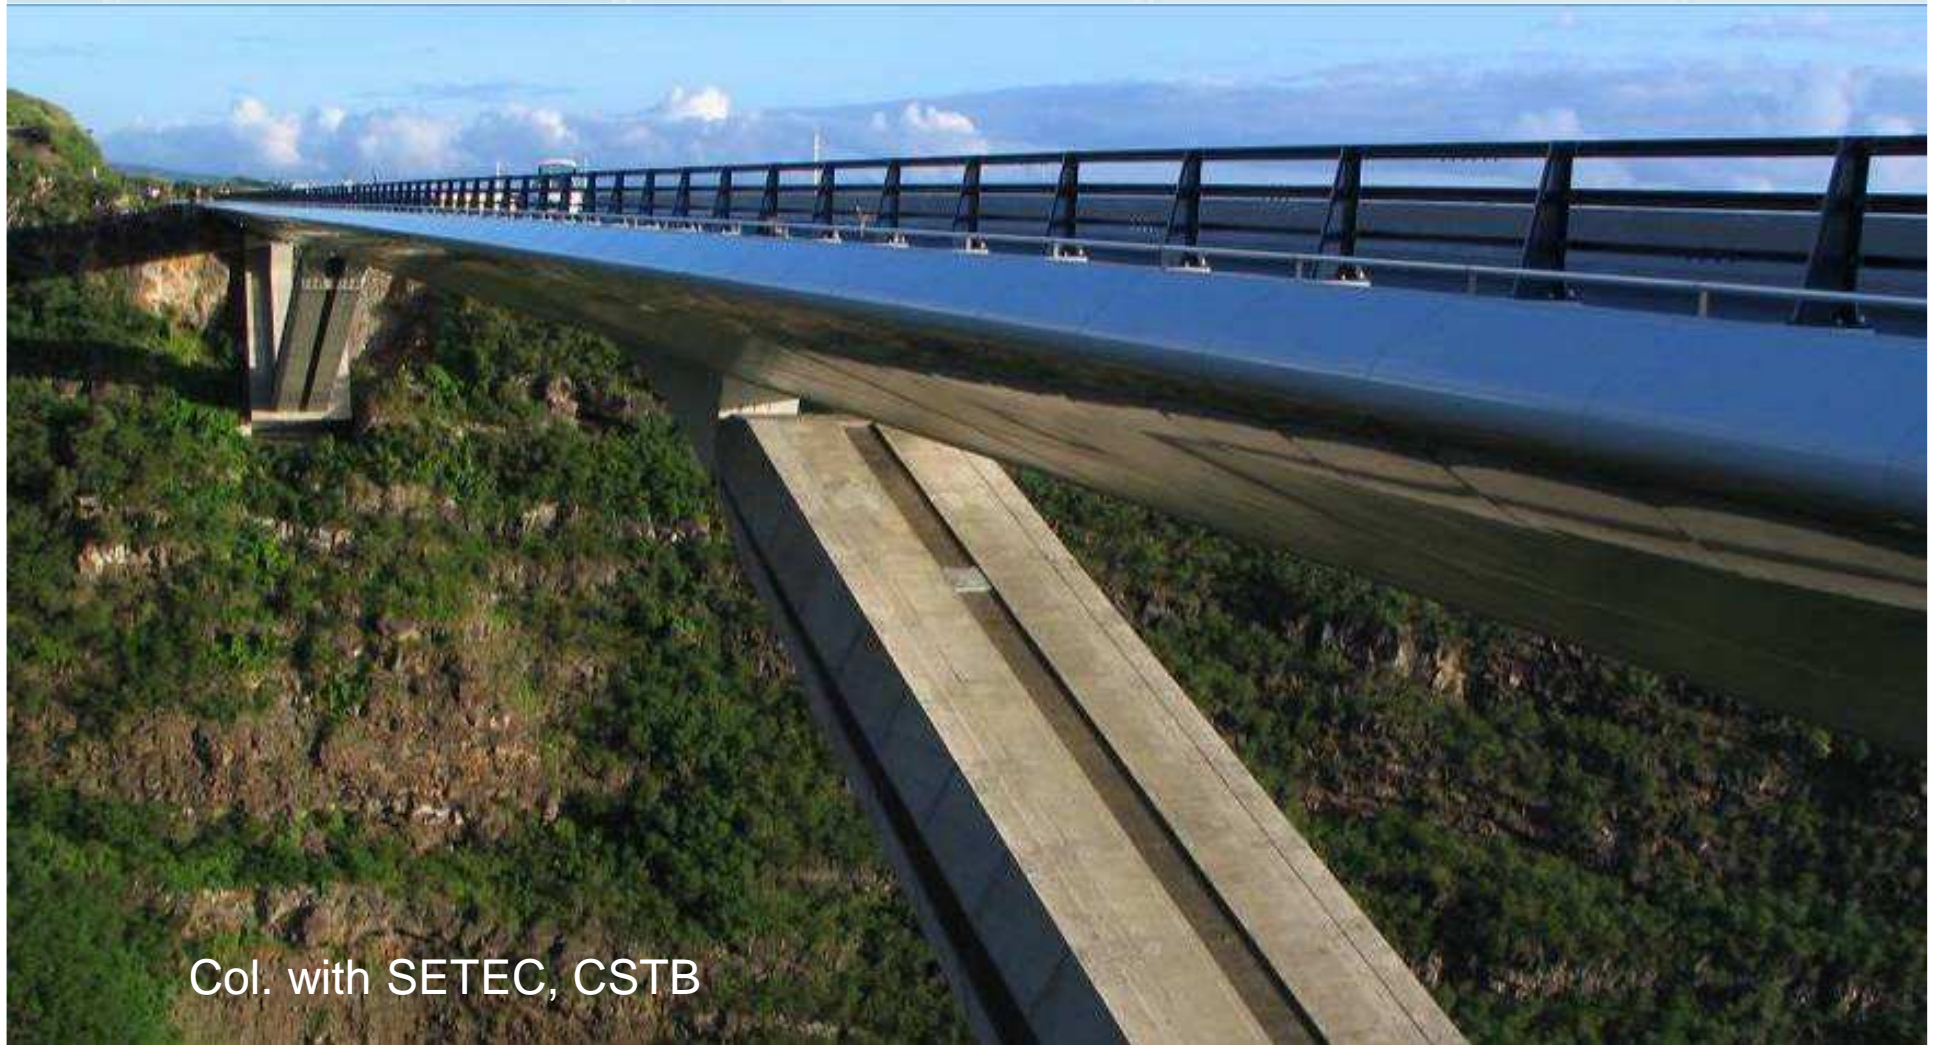
Continuous Aerodynamic Monitoring of “Viaduc de La Grande Ravine”

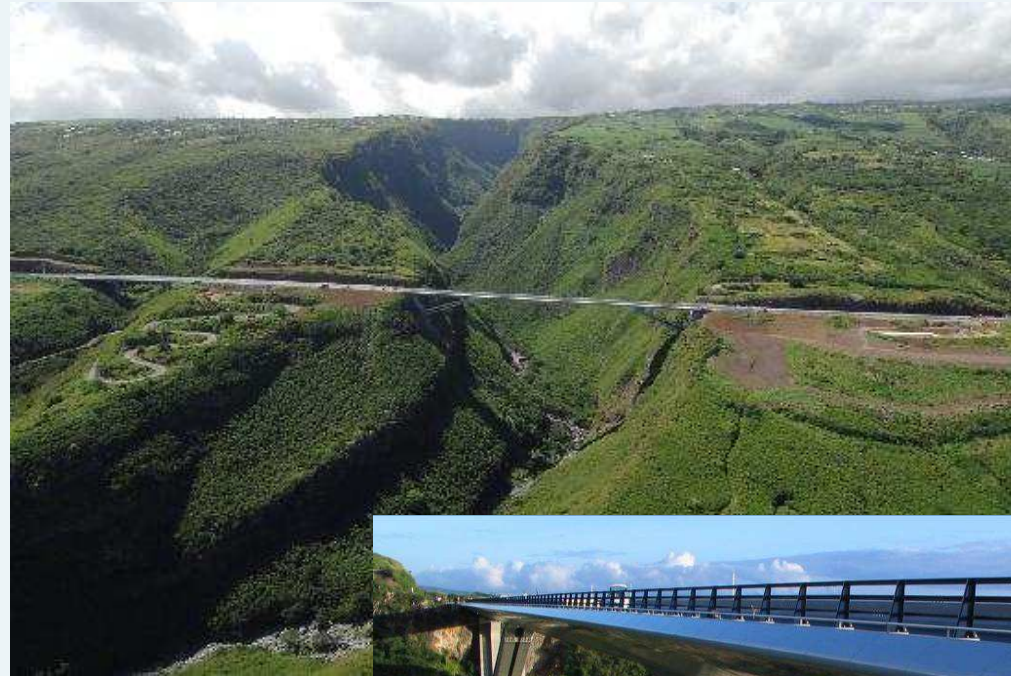
Continuous Aerodynamic Monitoring of “Viaduc de La Grande Ravine”

- 5 anemometers
- 14 pressure cells
- 6 termometers
- 6 accelerometers

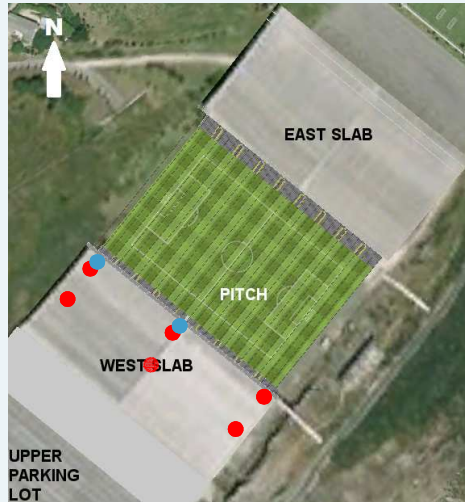
Continuous wind and dynamic monitoring systems

- 6 force balance accelerometers**
- 2 sonic anemometers**
- 8 temperature sensors**
- Continuous sampling at 20 Hz/10Hz**
- Records with 30 minutes duration**
- Data transfer to a server at FEUP**

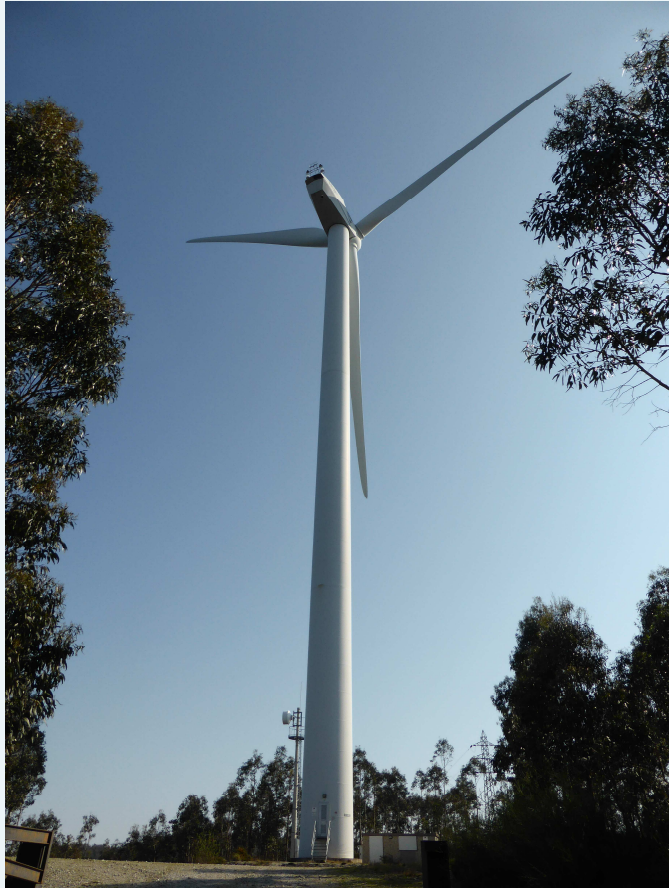
Wind Turbine

- Located in the North of Portugal (Torrão Wind Farm)
- 2.0 MW – variable speed generator
- Hub height: 80 m
- Rotor diameter: 80 m
- Tubular steel tower
- Bolted flanged connection between tower segments
- Slab foundation

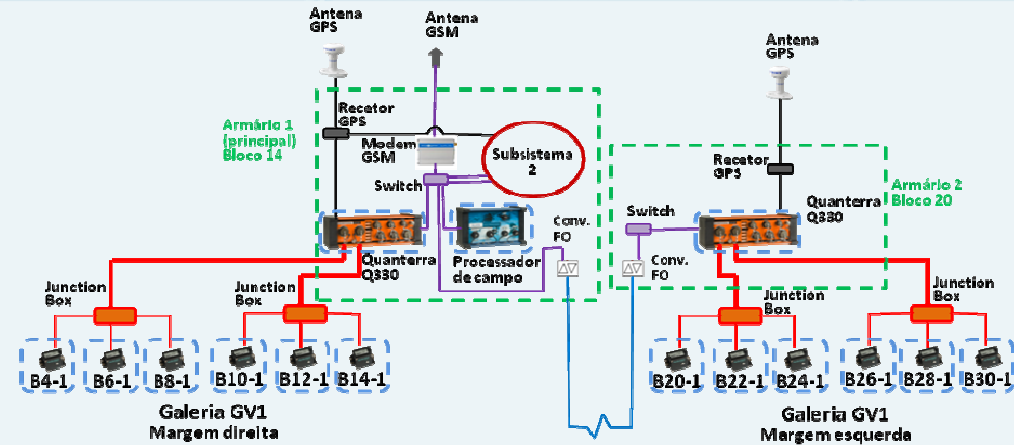
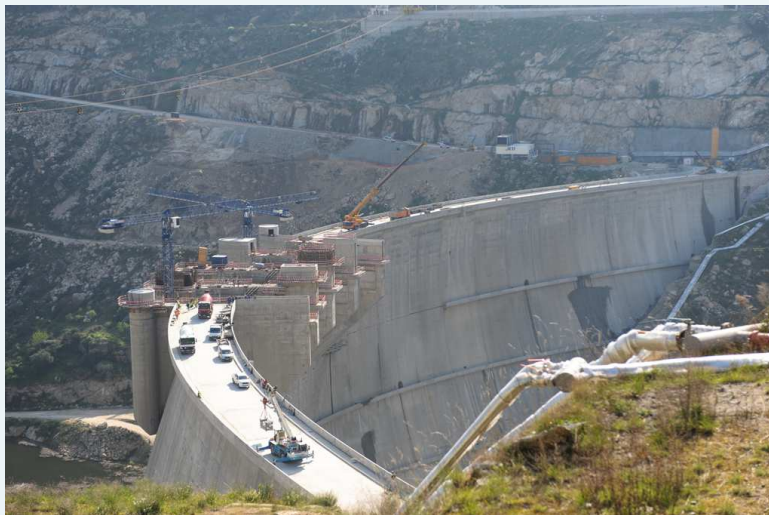
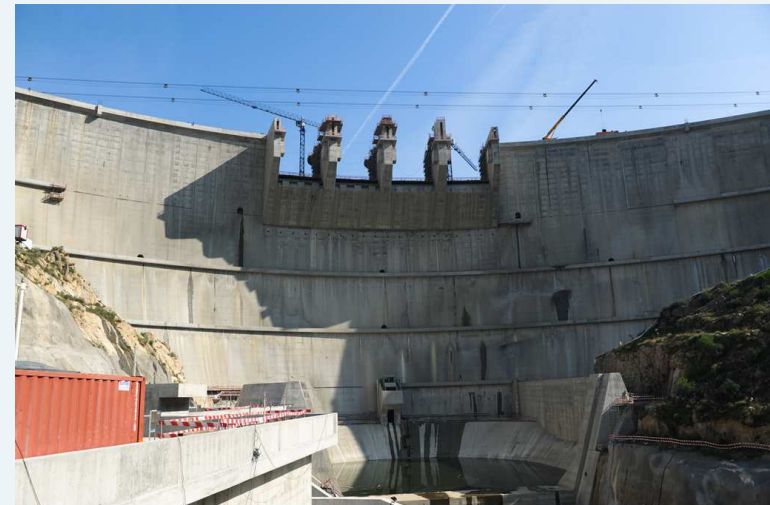
Dynamic Monitoring of Baixo Sabor Dam

- Baixo Sabor Dam
(Client: EDP)

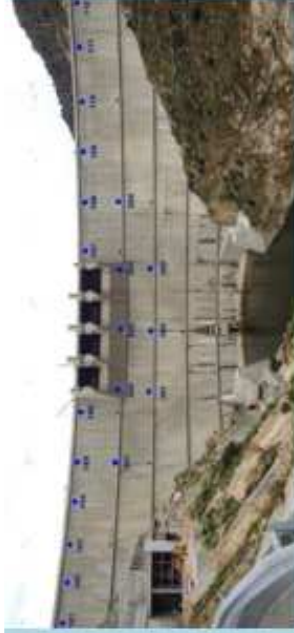
Sistema de Monitorização Dinâmica da Barragem do Sabor Escalão de Montante
