Vienna Consulting  
Engineers ZT GmbH

# TU1402 Monitoring Case Studies

Relevant cases for the proof of concept

Helmut **WENZEL**

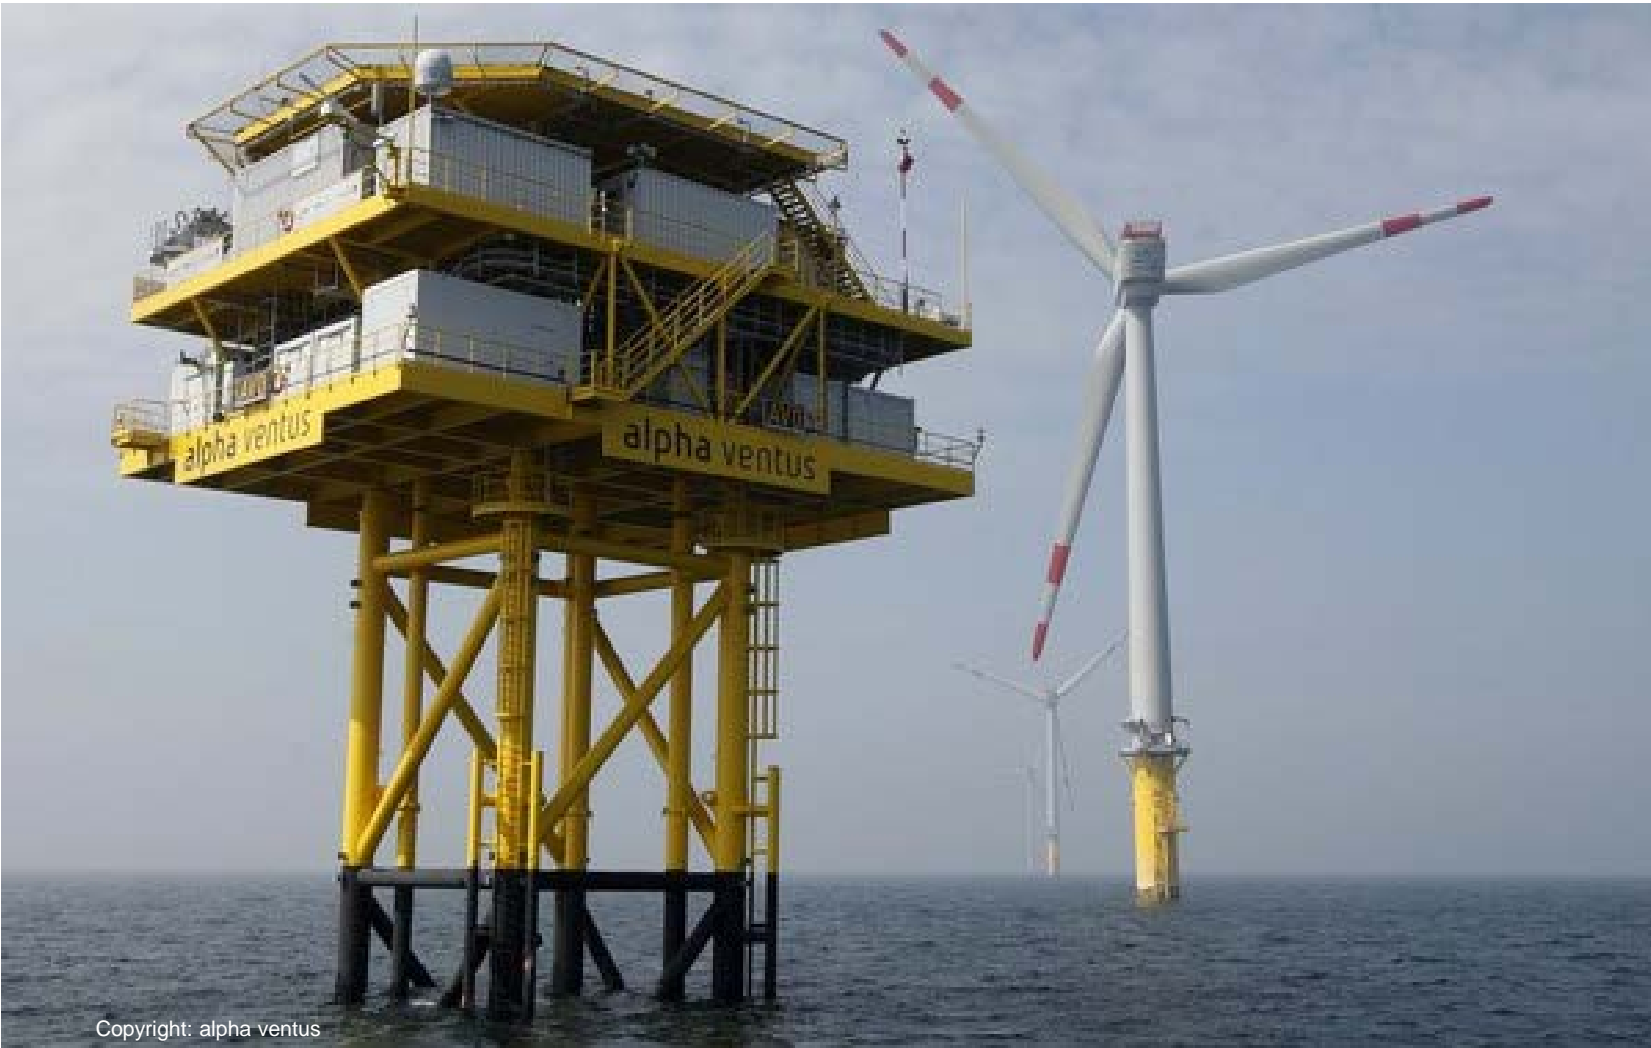
# Offshore Issue: Grouted Joints?

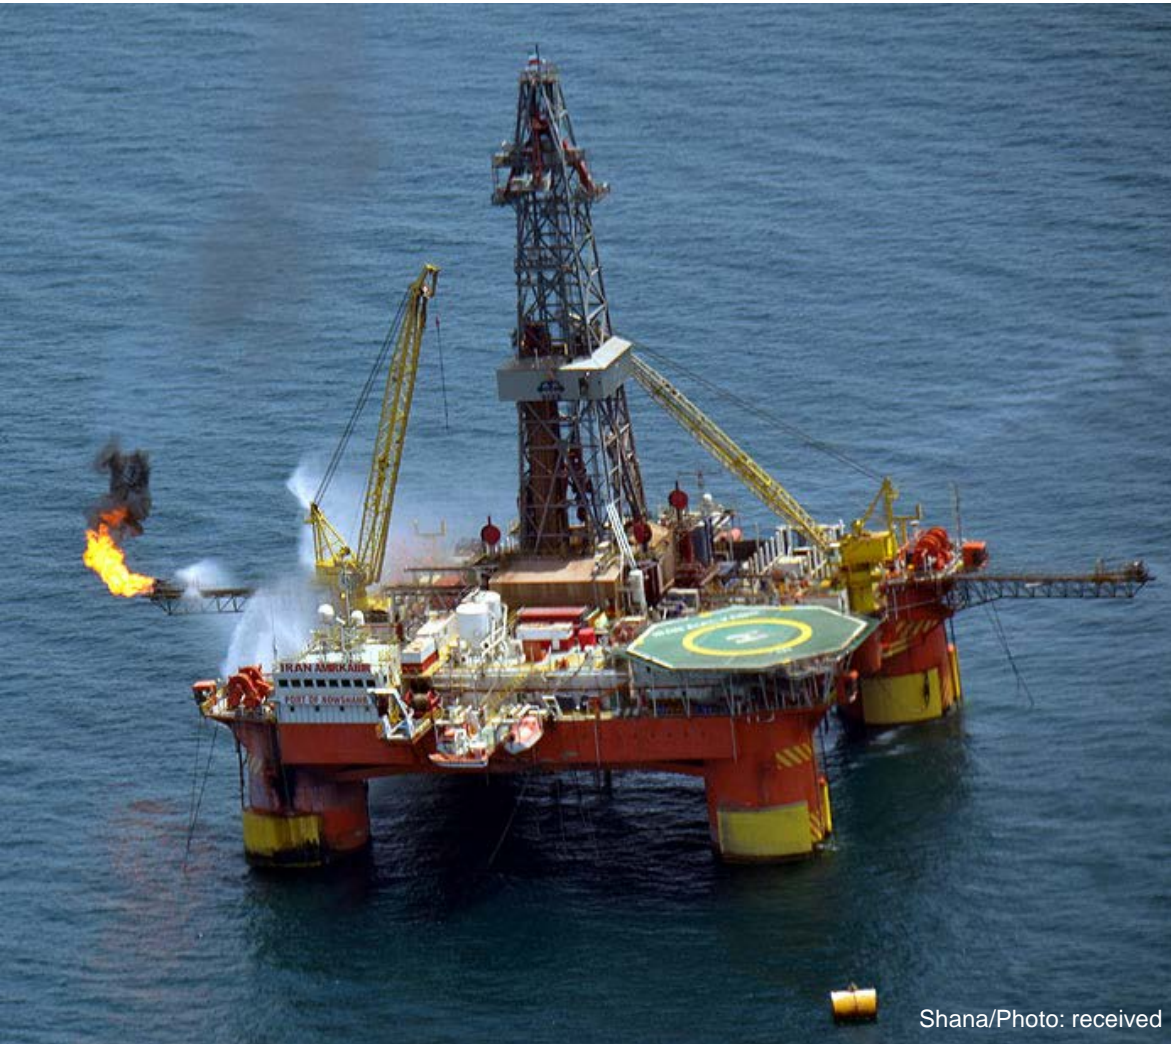
# Amir Kabir Semi-Submersible Drilling Unit, Caspian Sea

## On-board Calibration and Adjustment of Mooring System

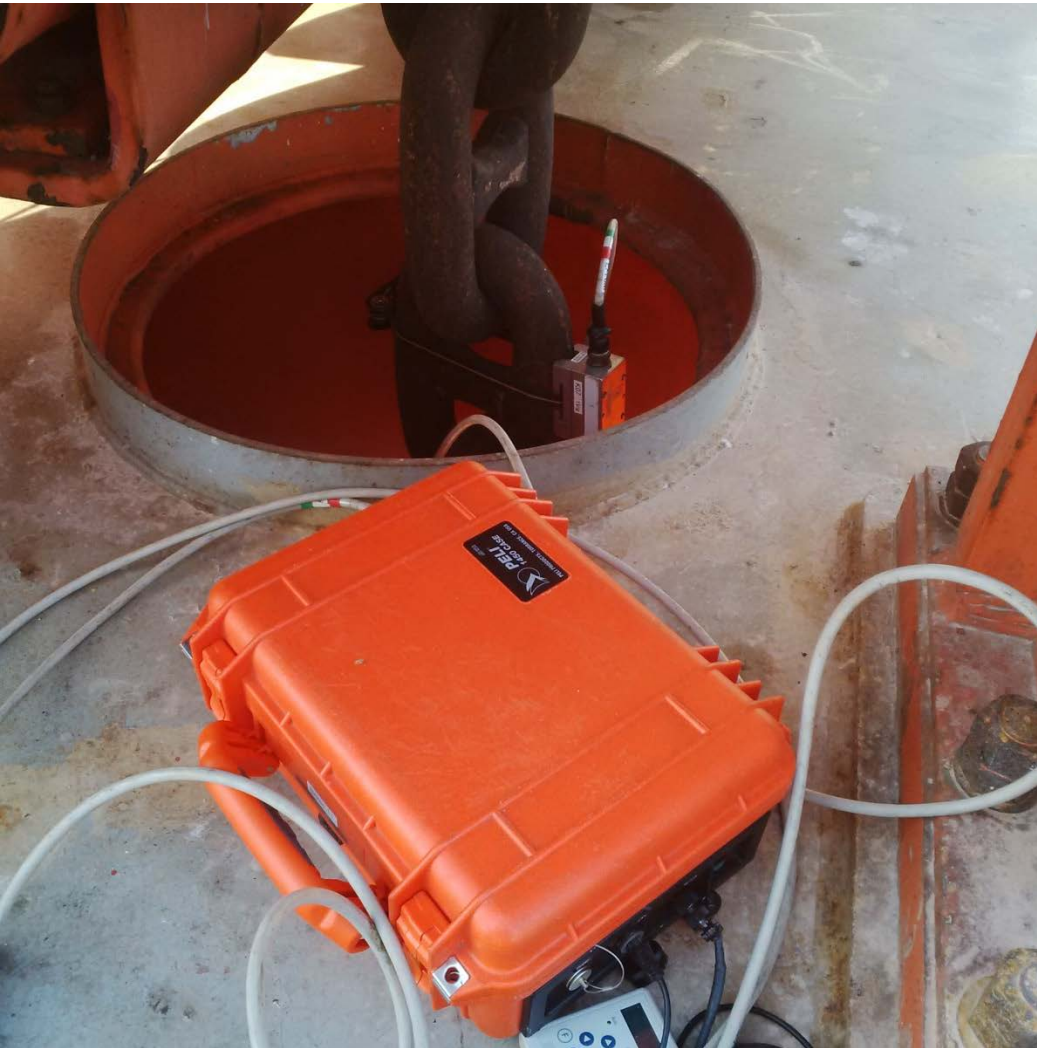
# Amir Kabir Semi-Submersible Drilling Unit, Caspian Sea

## On-board Calibration and Adjustment of Mooring System

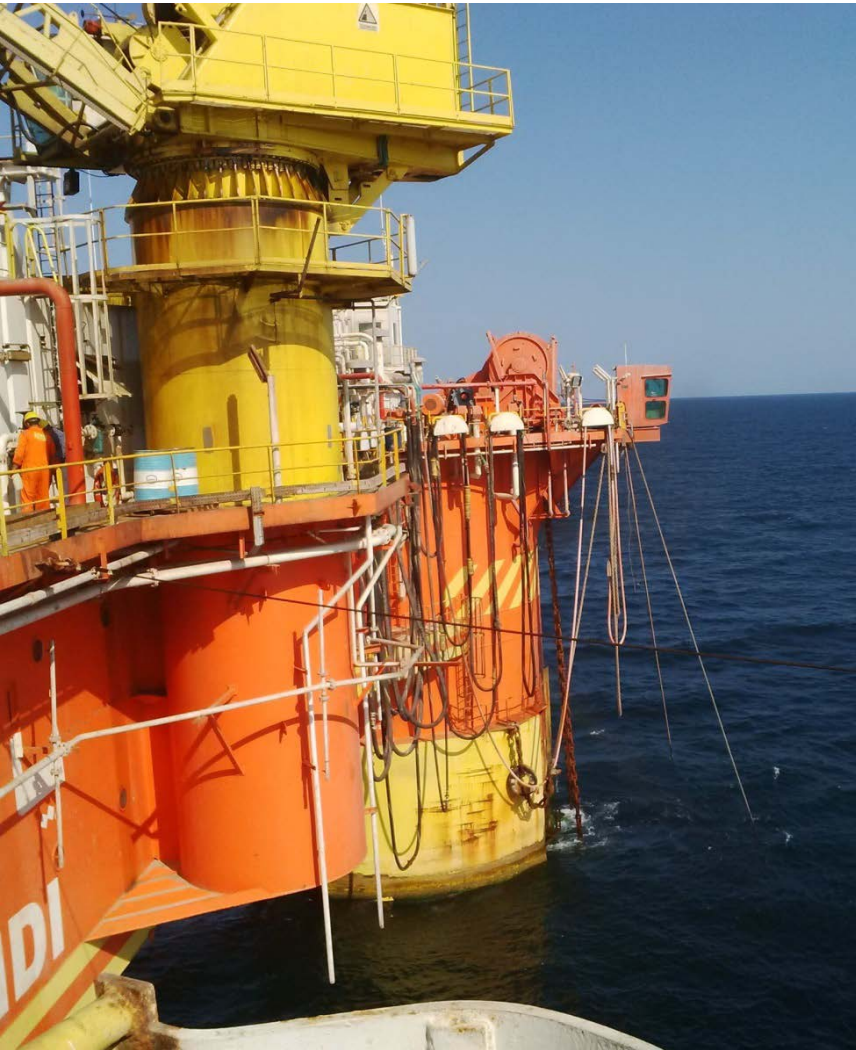
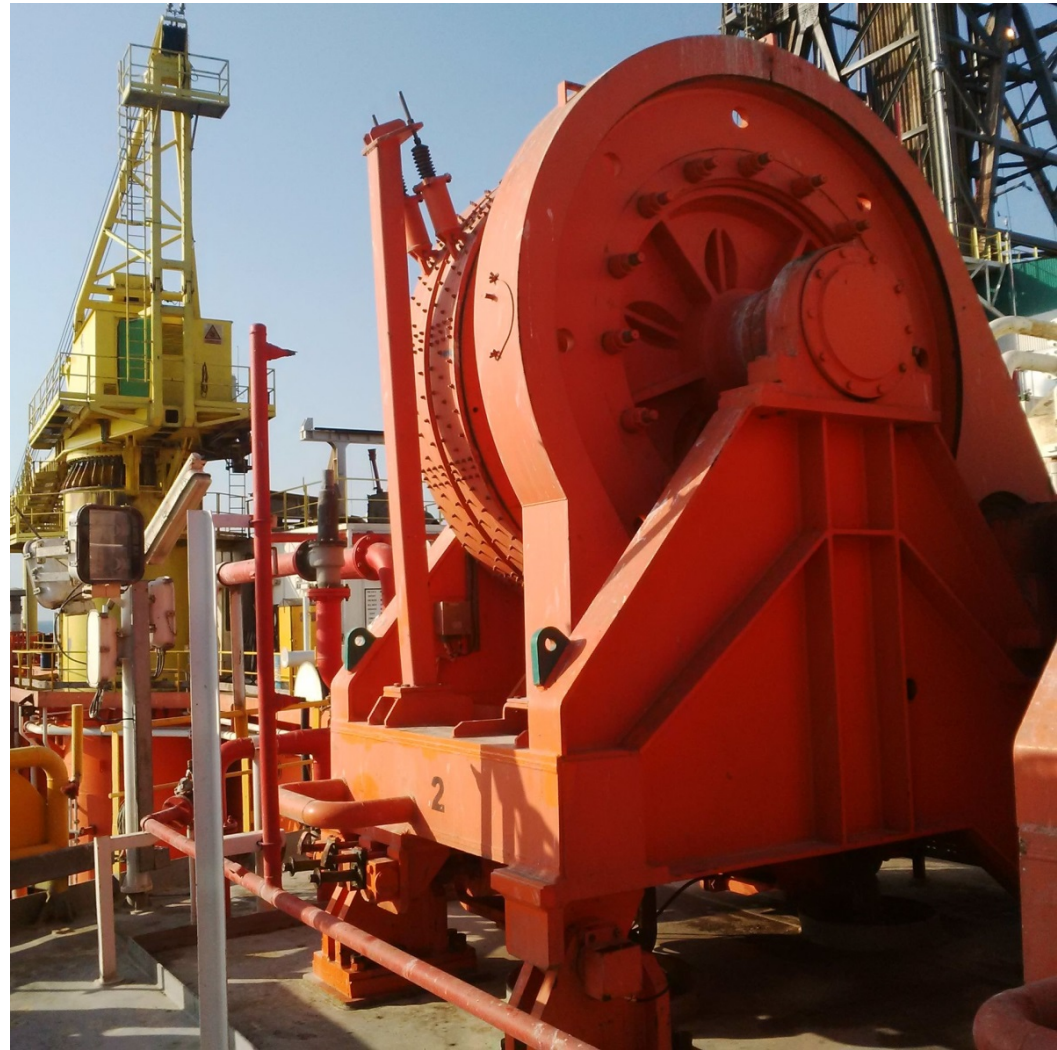
# Amir Kabir Semi-Submersible Drilling Unit, Caspian Sea

## On-board Calibration and Adjustment of Mooring System

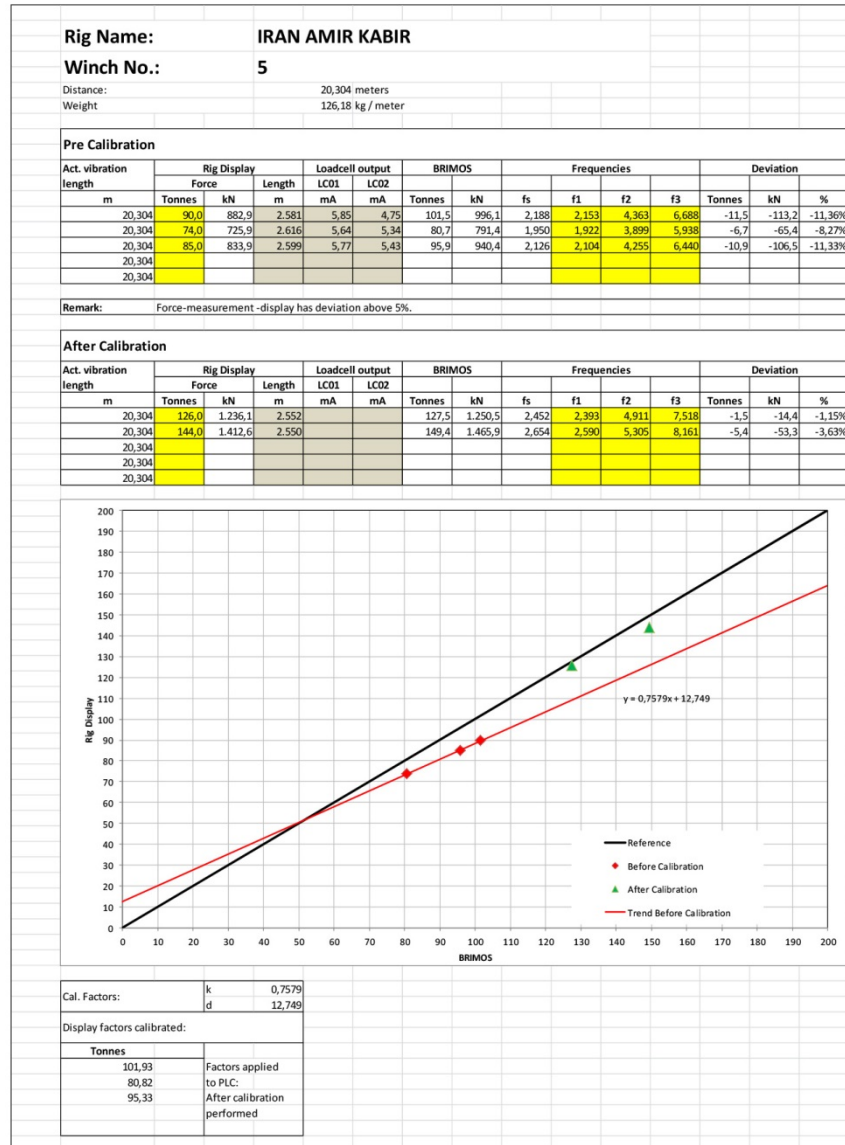
# Amir Kabir Semi-Submersible Drilling Unit, Caspian Sea On-board Calibration and Adjustment of Mooring System

## Results of Winch 5

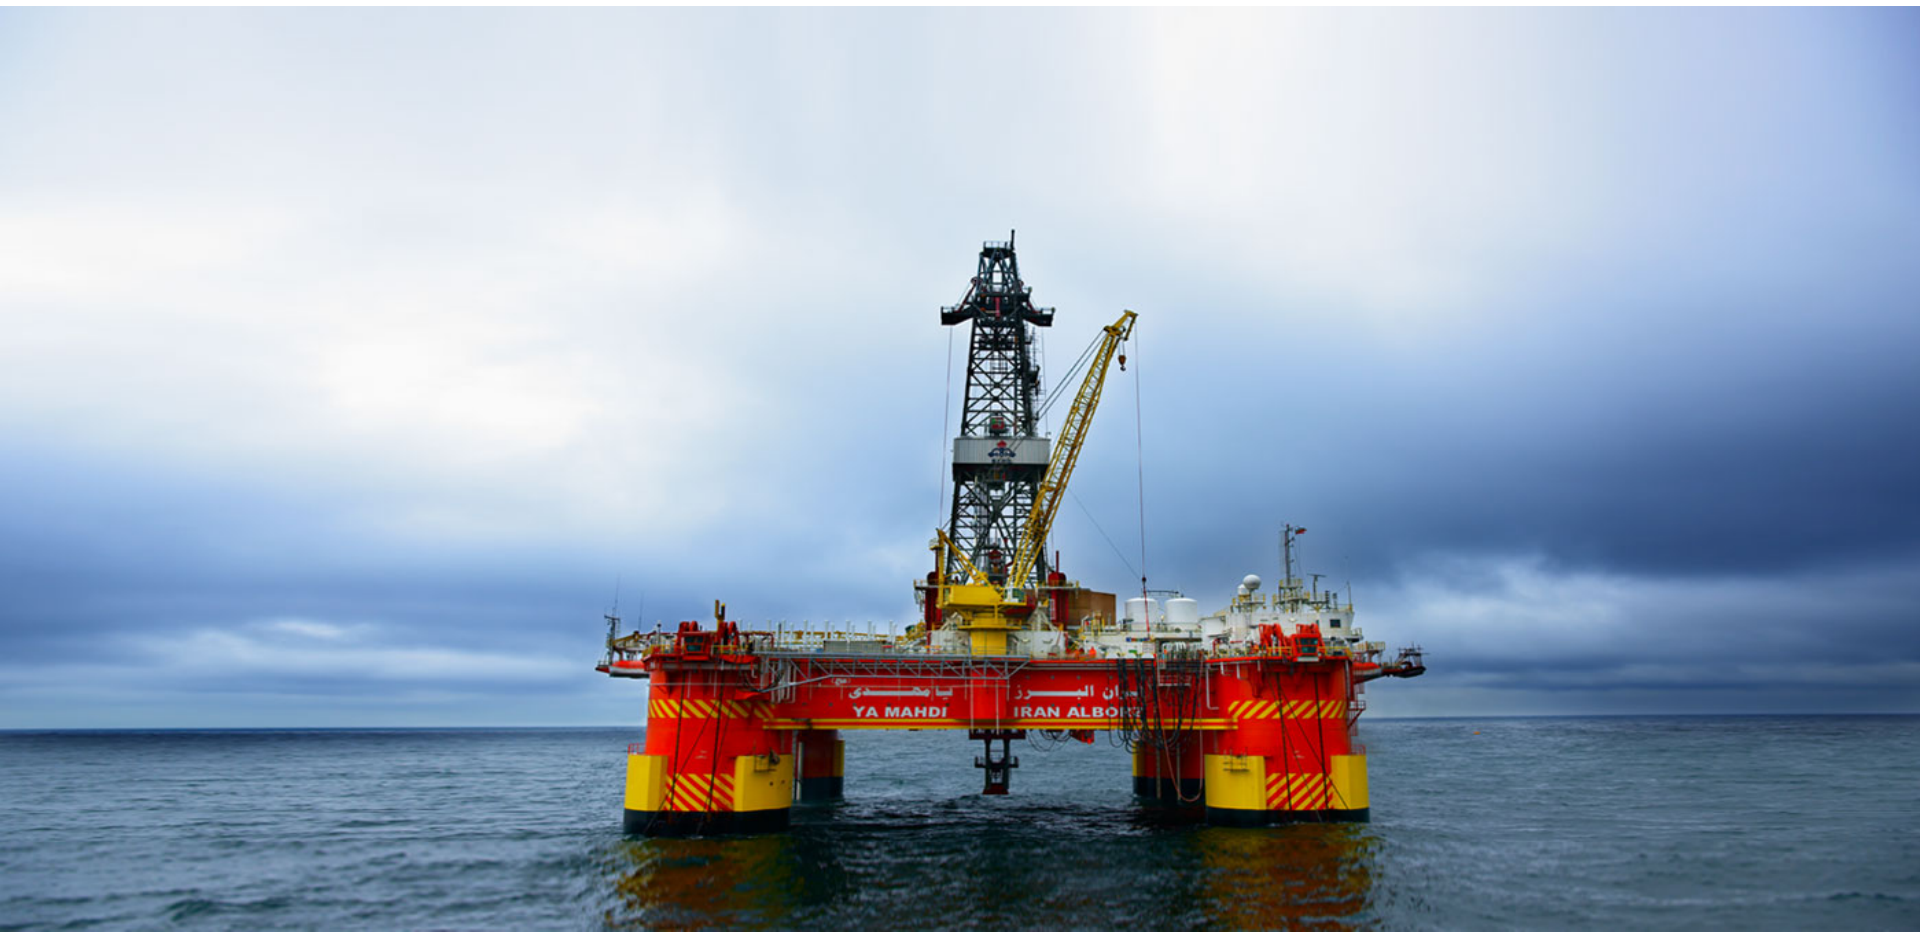
# Amir Kabir Semi-Submersible Drilling Unit, Caspian Sea

## On-board Calibration and Adjustment of Mooring System

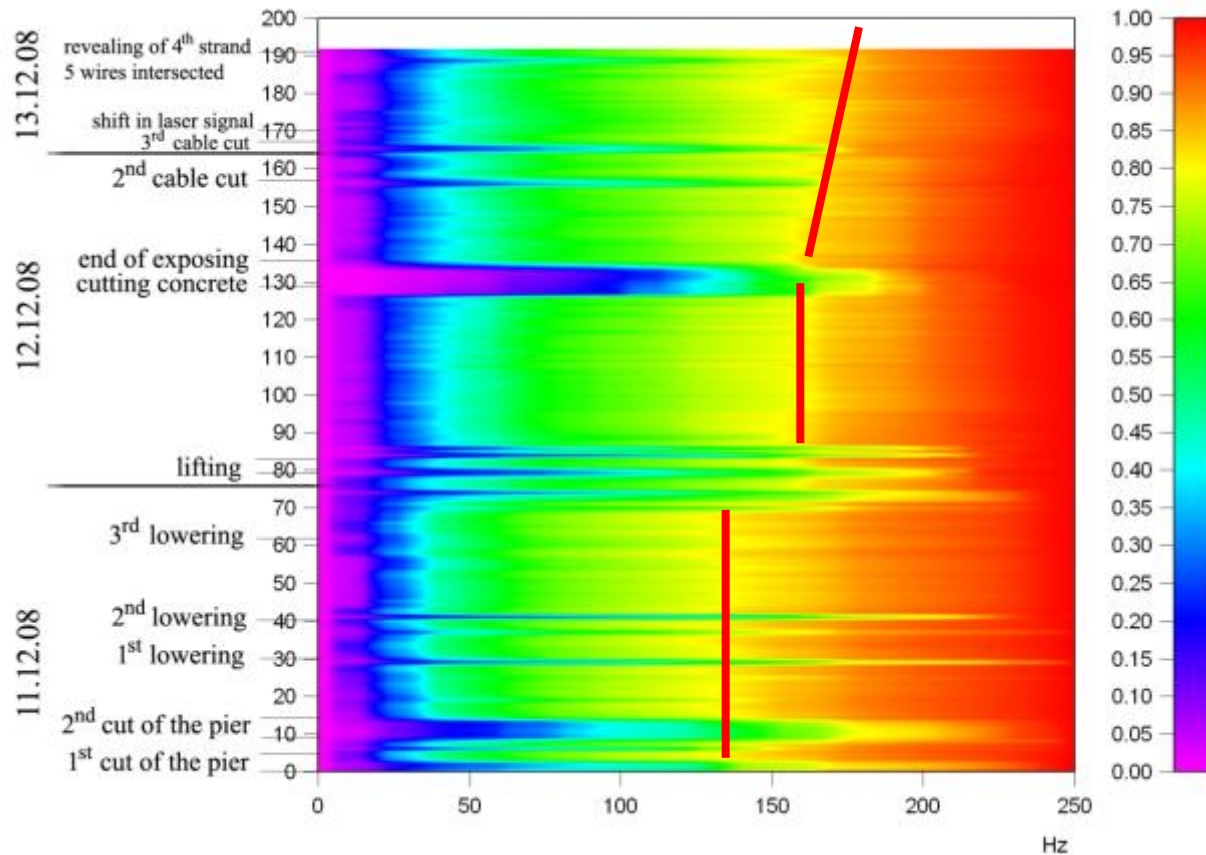
# ACCUMULATED ENERGY FUNCTION

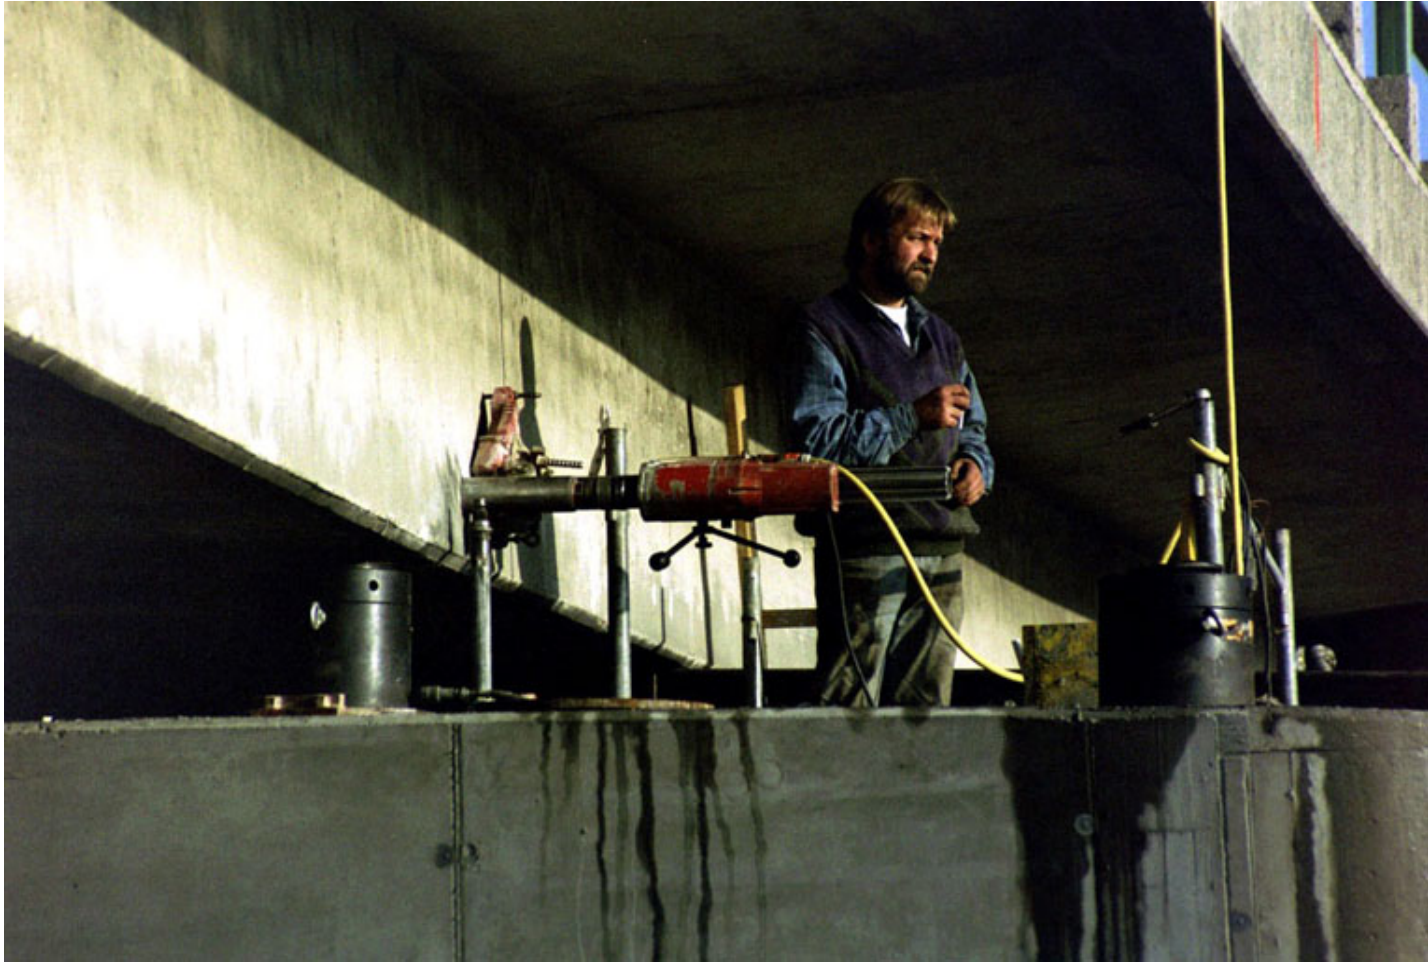
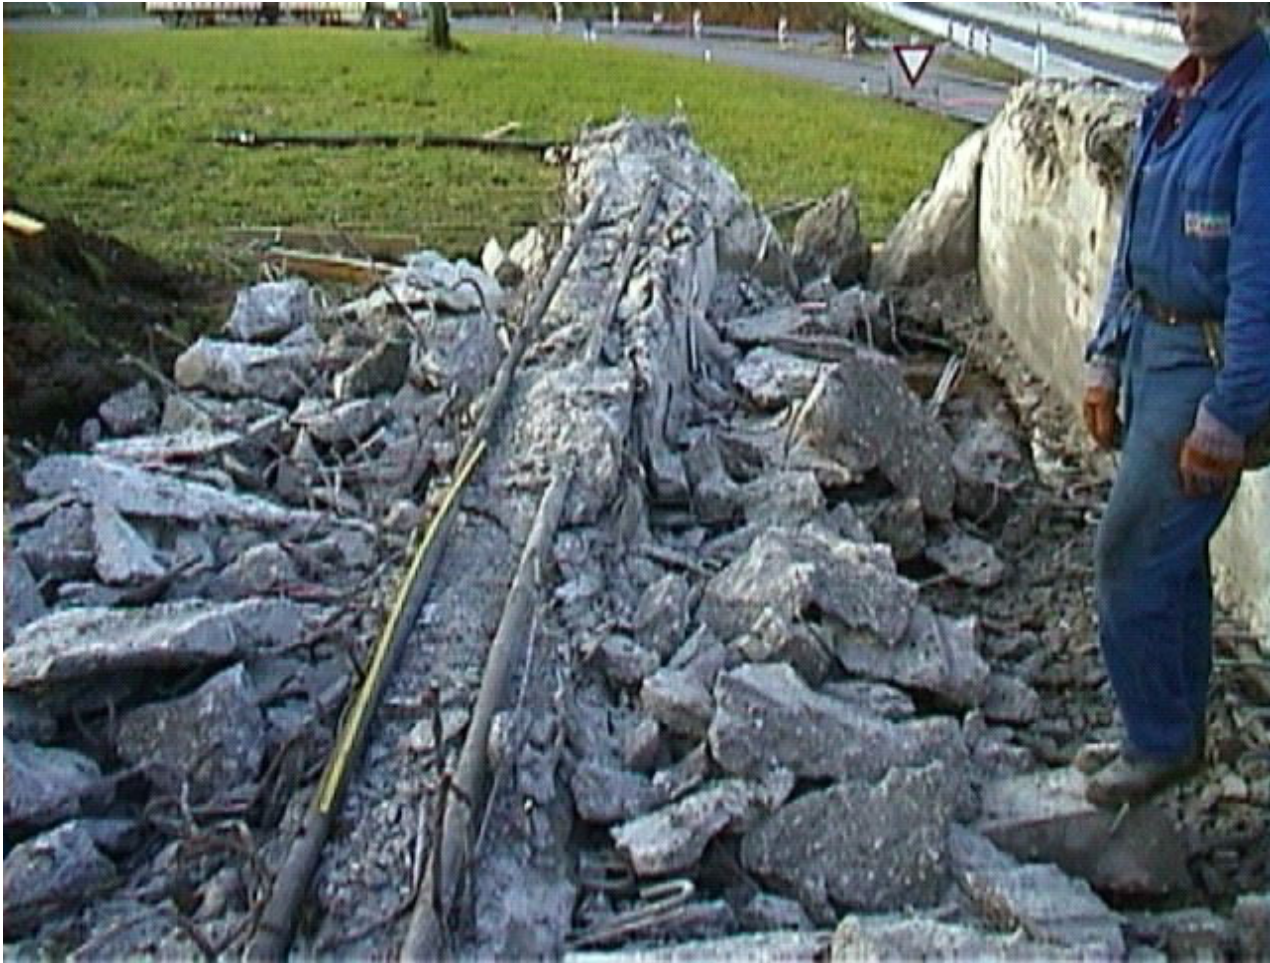
# INDUCED DAMAGE TEST REGAU

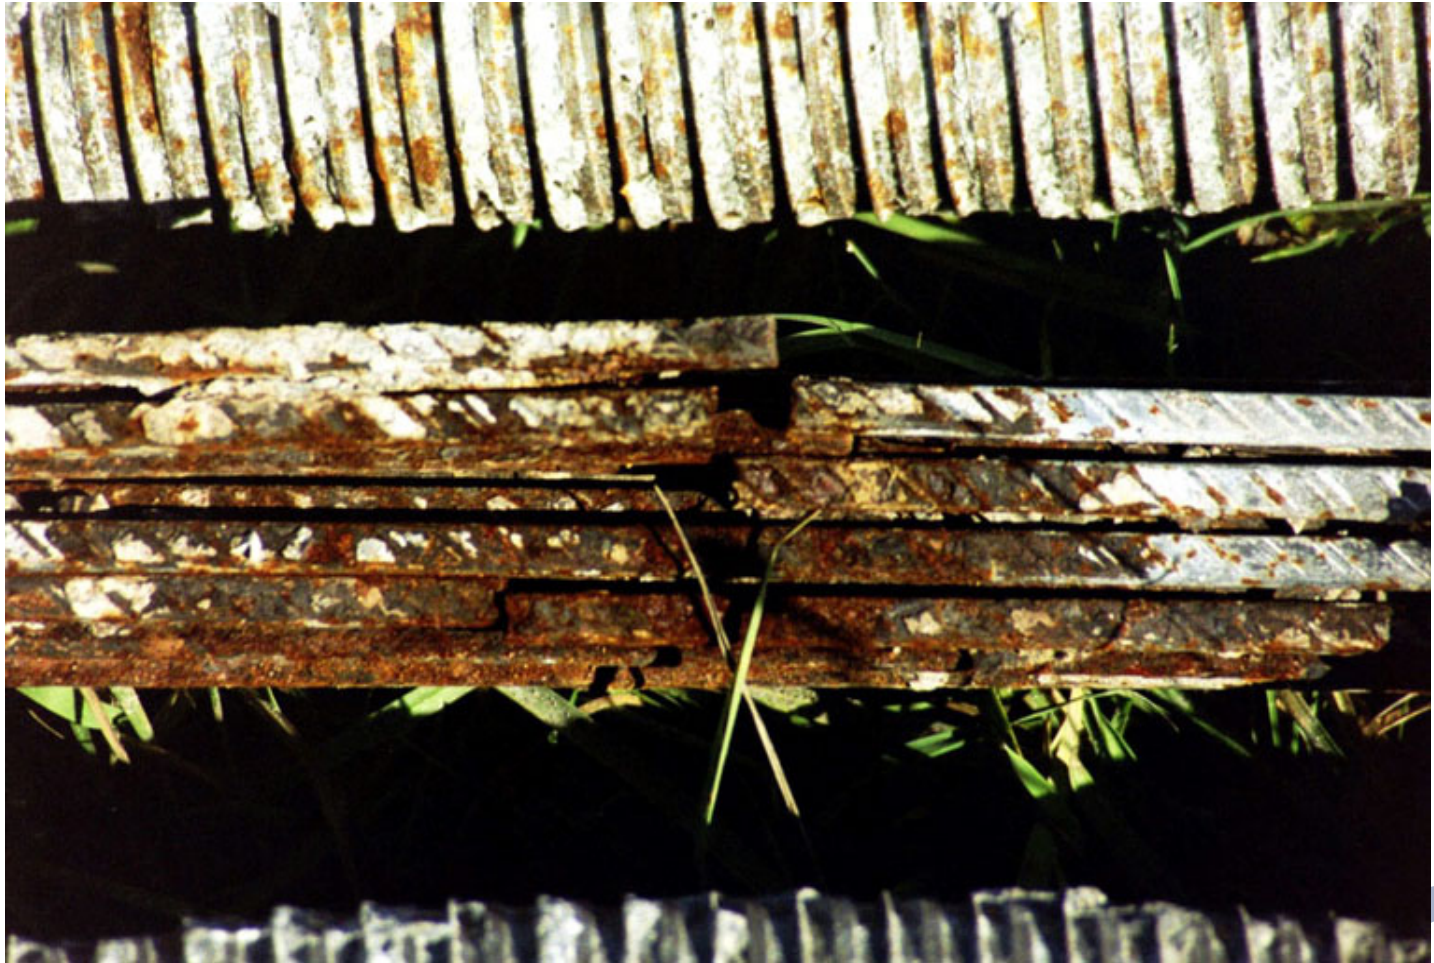
# CLORITE CONTENT 0,8%

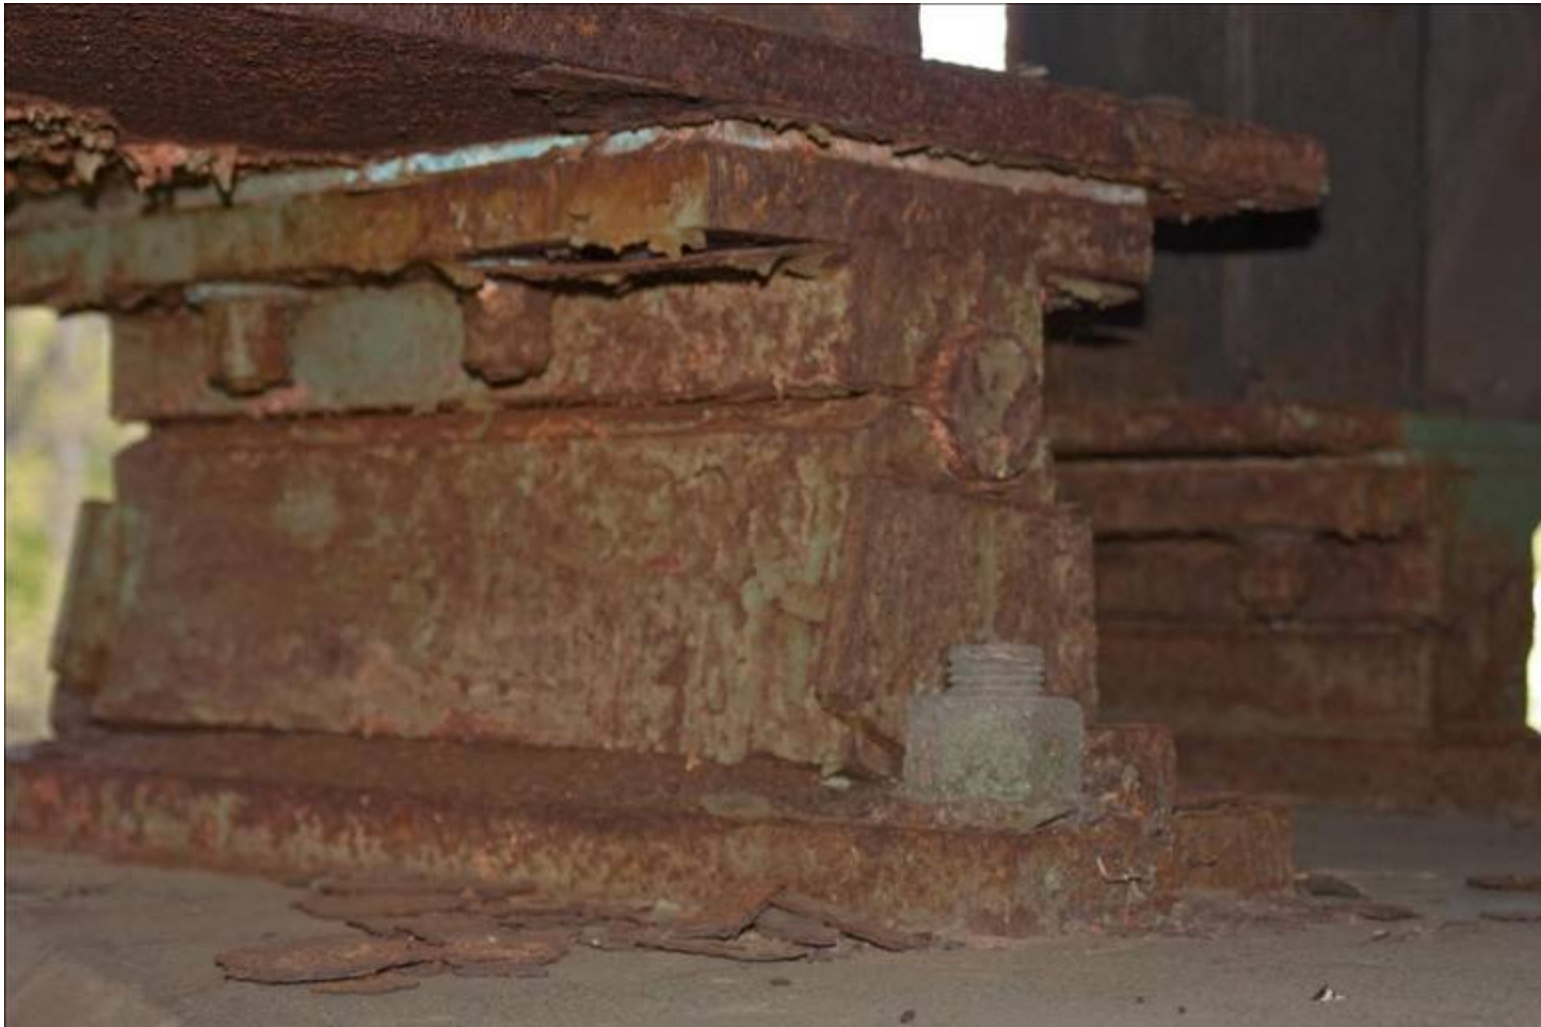
# Visual Condition, Corrosion

## Structural Condition – Fascia Bearing Deterioration

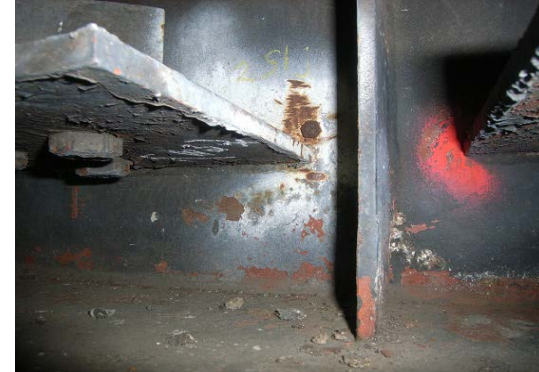
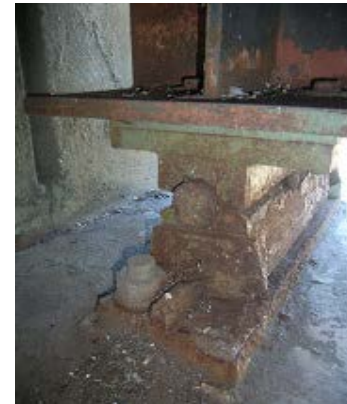
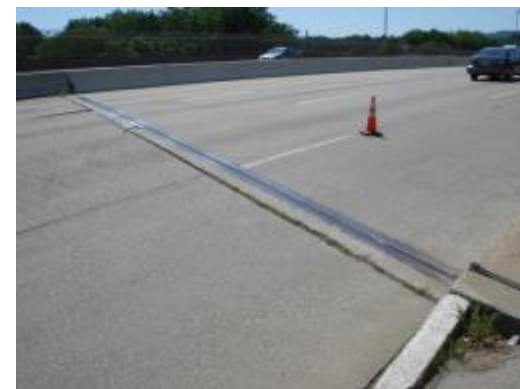
## RECOMMENDED RETROFIT INTERVENTIONS

Renewal of corrosion protection,  
Repair of spallings, holes and concrete pockets,  
removal of contamination of the concrete surface,  
Deep injection of cracks

Establishing of an effective drainage concept

Proper detailing & design  
⇒ Full replacement (abutment area)  
⇒ Partial replacement (at least seals above the piers)

Renewal of corrosion protection,  
Repair of the concrete surface,  
fatigue cracks, Repair of corroded stringers,  
Replacement of wind bracings,  
proper replacement of the bearings

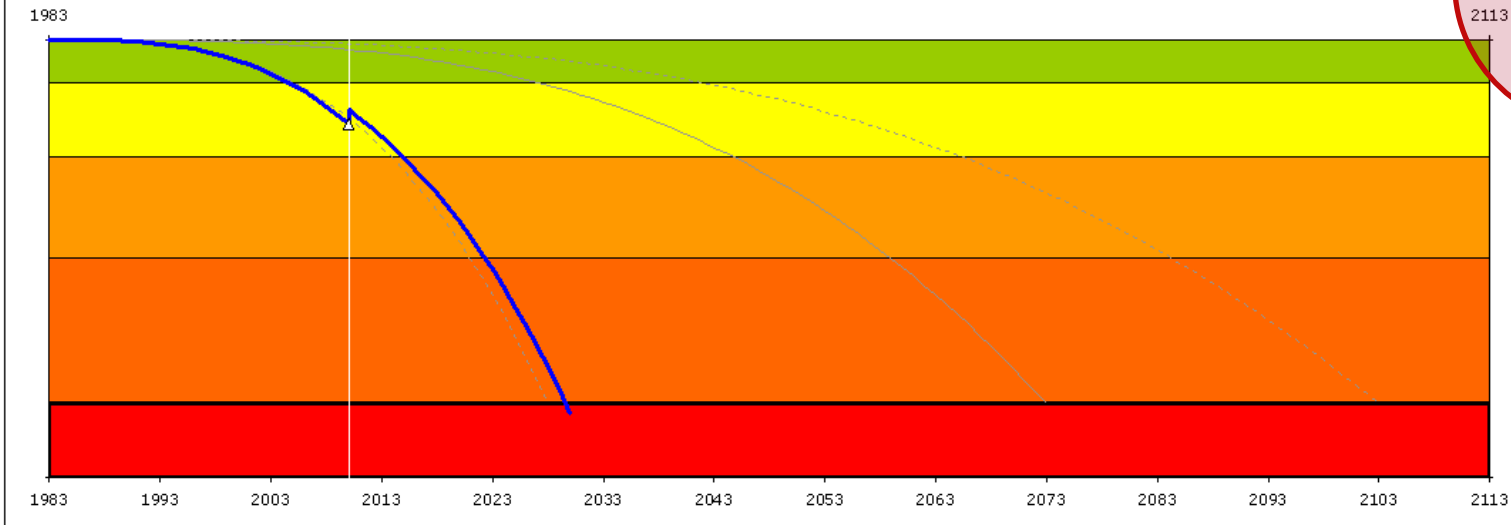
Bridge Object 1618-150 - Global Lifeline (Safety Level regarding ULS)

REMAINING LIFE  
**19**

COSTS [€]  
Retrofit 922.328  
Replacement 11.901.000

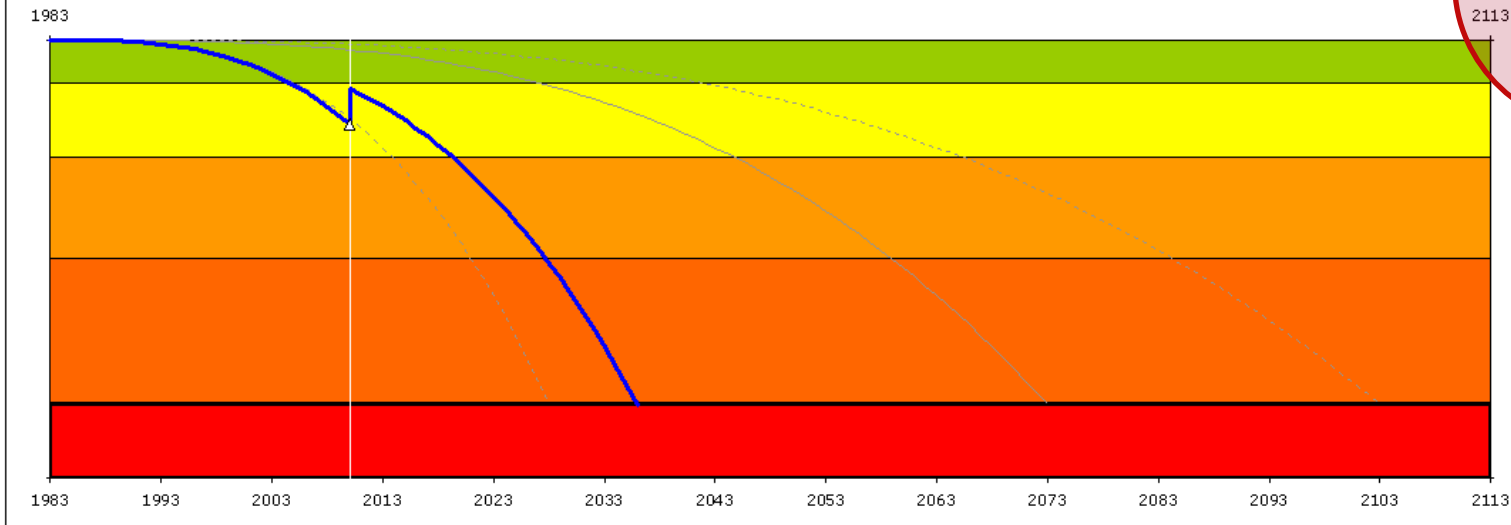
Bridge Object 1618-150 - Global Lifeline (Safety Level regarding ULS)

REMAINING LIFE  
**25**

COSTS [€]  
Retrofit 1.160.348  
Replacement 11.901.000

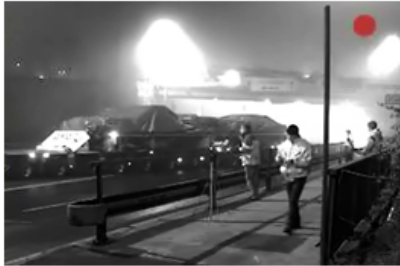
1.Überfahrtsserie

1. Überfahrtsserie 16.12.2013	
	Überfahrt 1	Überfahrt 2
Tonnage	305	305
Achszahl Tieflader	20	20
Gewichtverteilung	Achse 7-15	Achse 7-15

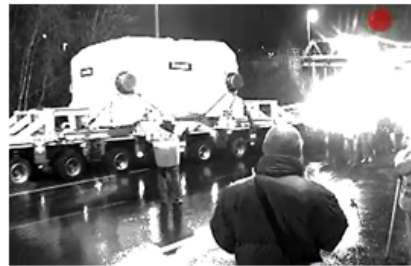
2.Überfahrtsserie

2. Überfahrtsserie 21.01.2014	
	Überfahrt 1	Überfahrt 2
Tonnage	260	286
Achszahl Tieflader	20	20
Gewichtverteilung	Achse 9-11	Achse 9-11

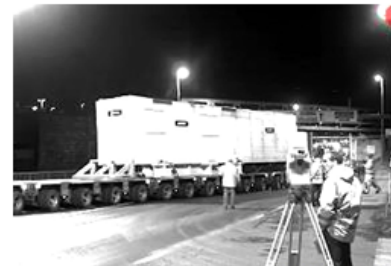
3.Überfahrtsserie

3. Überfahrtsserie 17.02.2014	
	Überfahrt 1	Überfahrt 2
Tonnage	295	295
Achszahl Tieflader	20	20
Gewichtverteilung	Achse 8-17	Achse 8-17

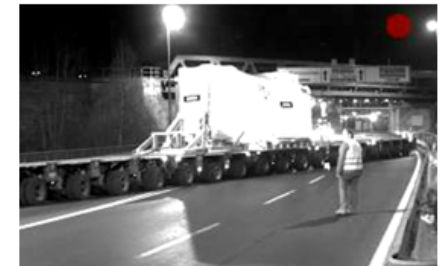
4.Überfahrtsserie

4. Überfahrtsserie 20.03.2014	
	Überfahrt 1	Überfahrt 2
Tonnage	295	280
Achszahl Tieflader	20	20
Gewichtverteilung	Achse 9-13	Achse 8-13

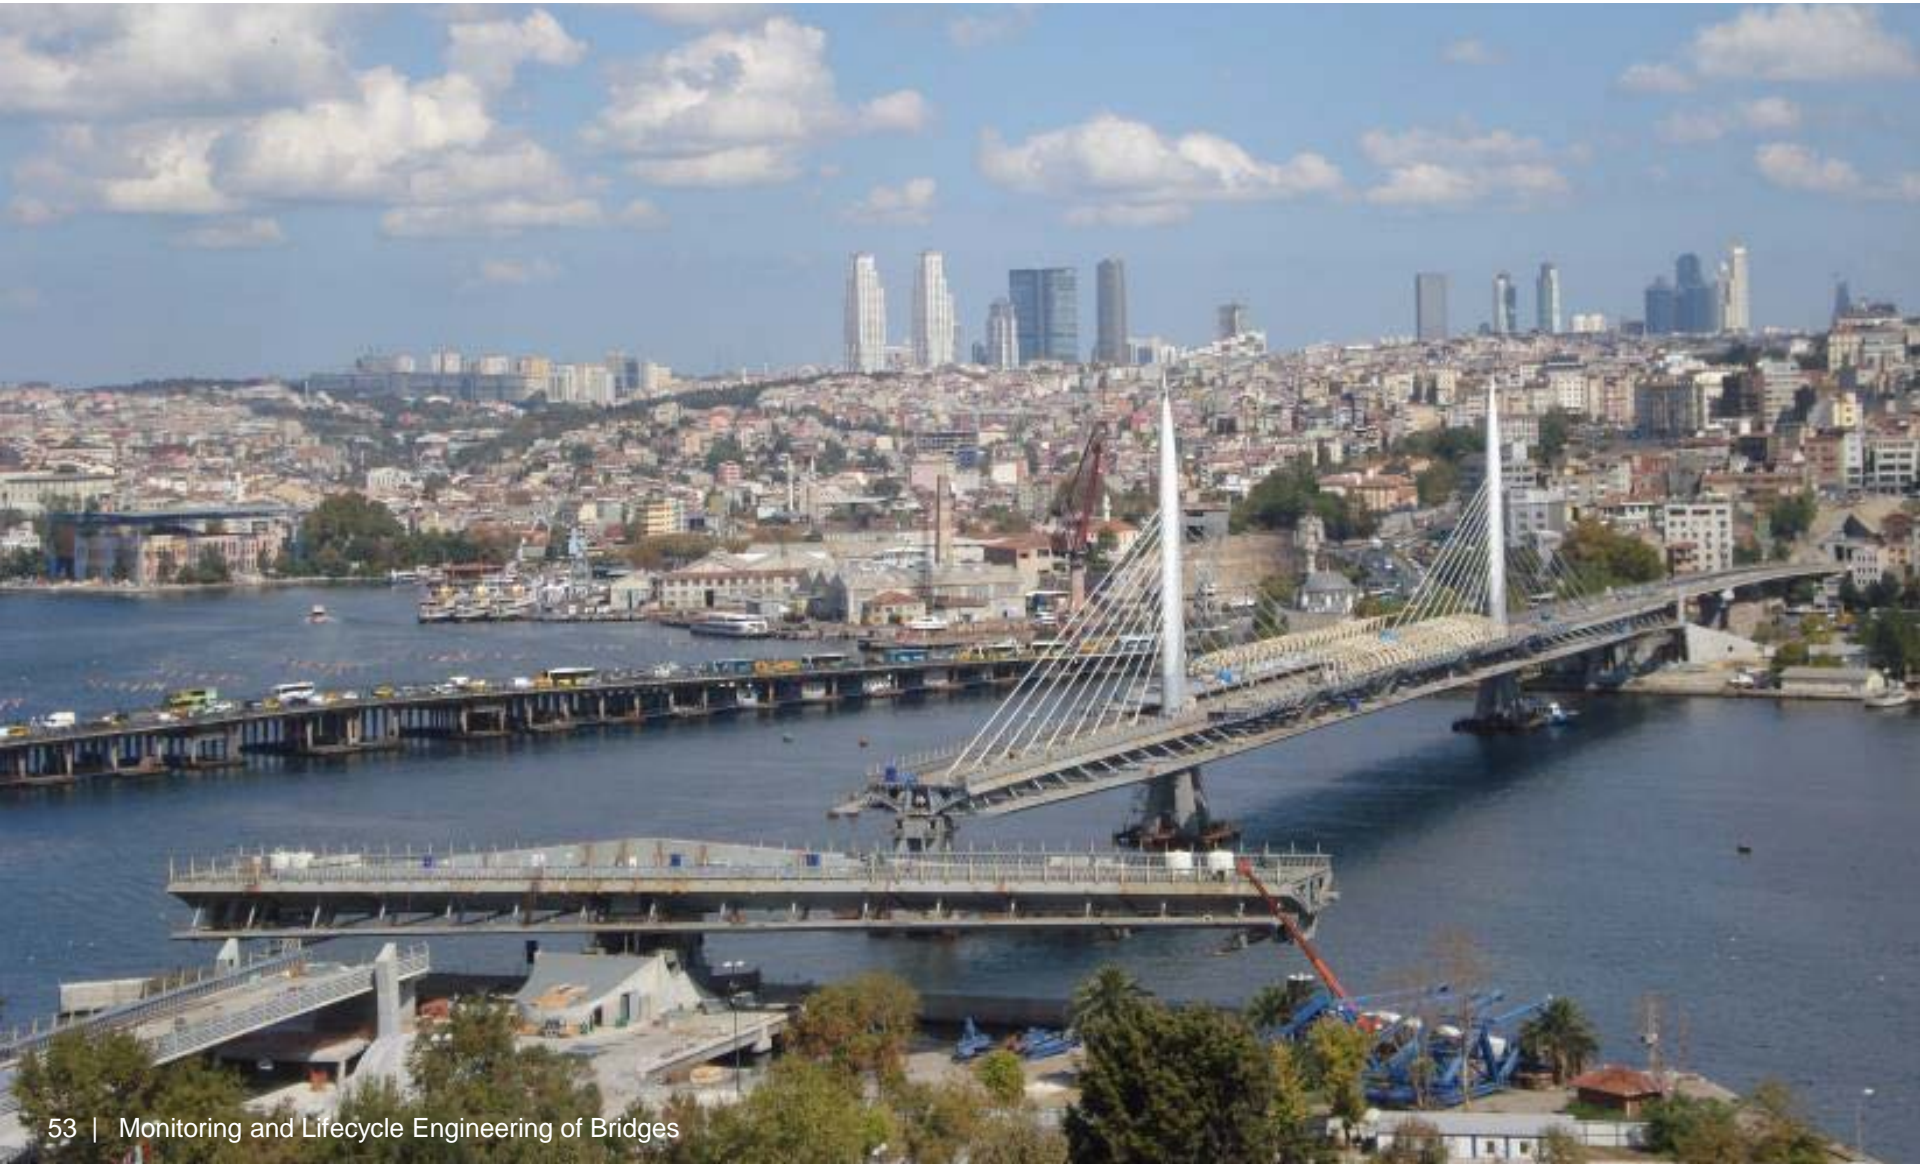
# Halic Metro Bridge

## Operation and Rotation Tests

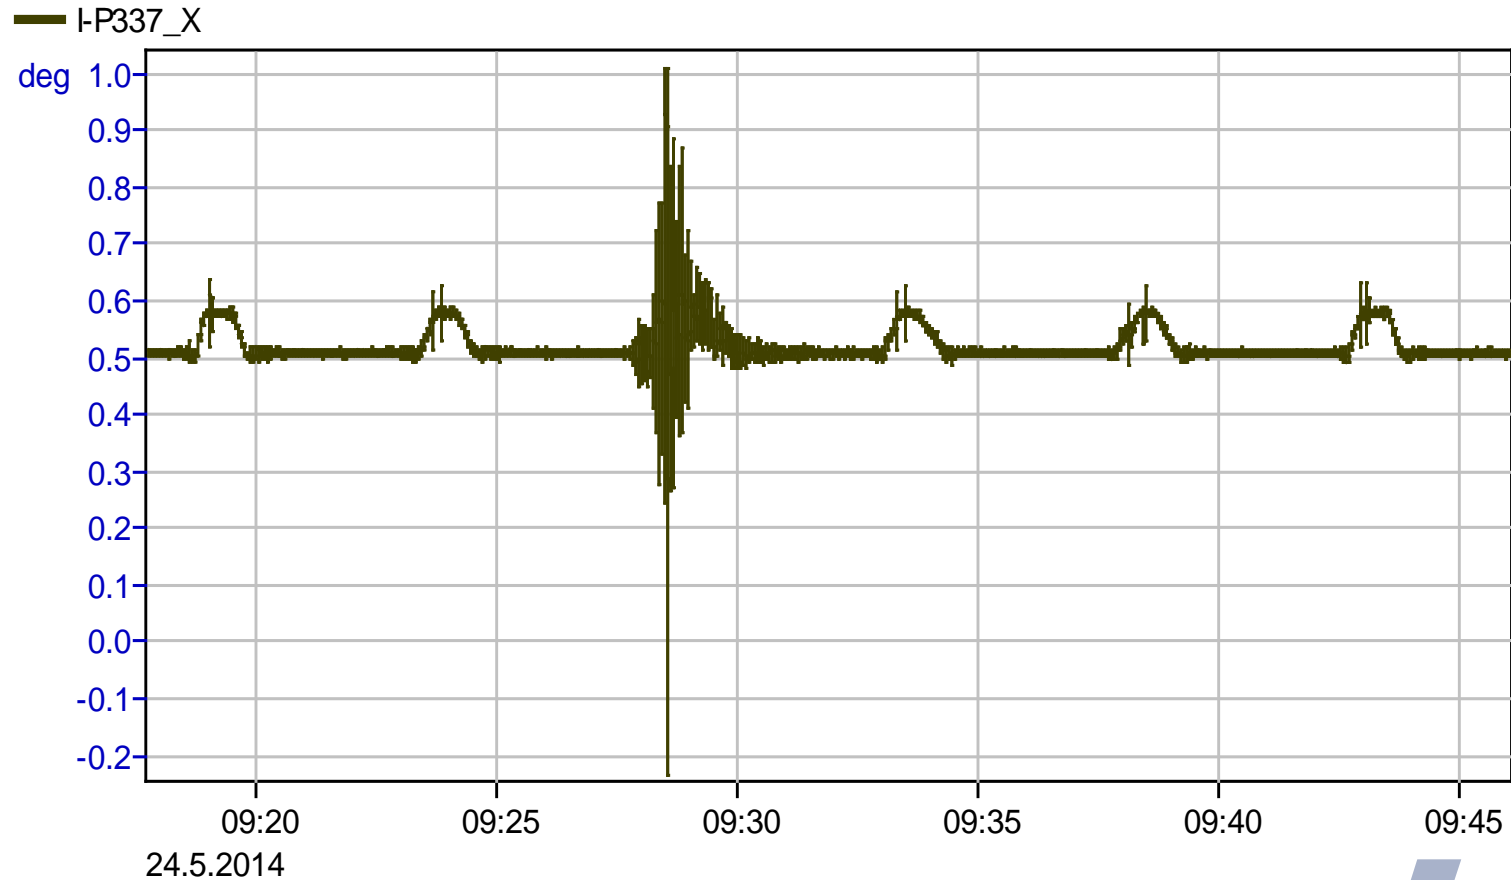
# Halic Metro Bridge

## Monitoring Facts and Figures
