Vienna Consulting  
Engineers ZT GmbH

# TU1402 Monitoring Case Studies

Relevant cases for the proof of concept

Helmut **WENZEL**

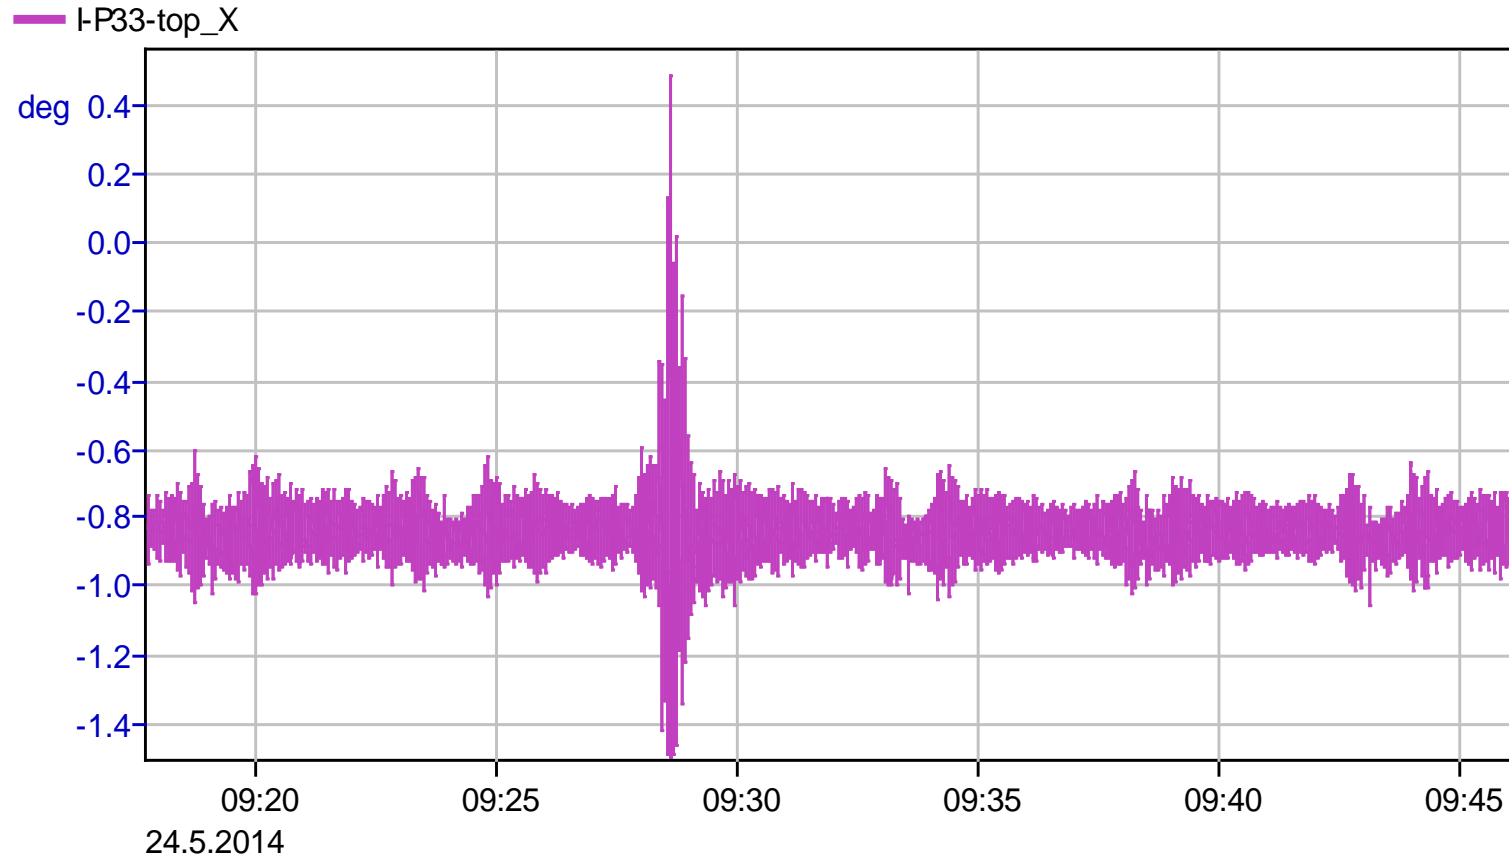
# Halic Metro Bridge

## Monitoring Facts and Figures

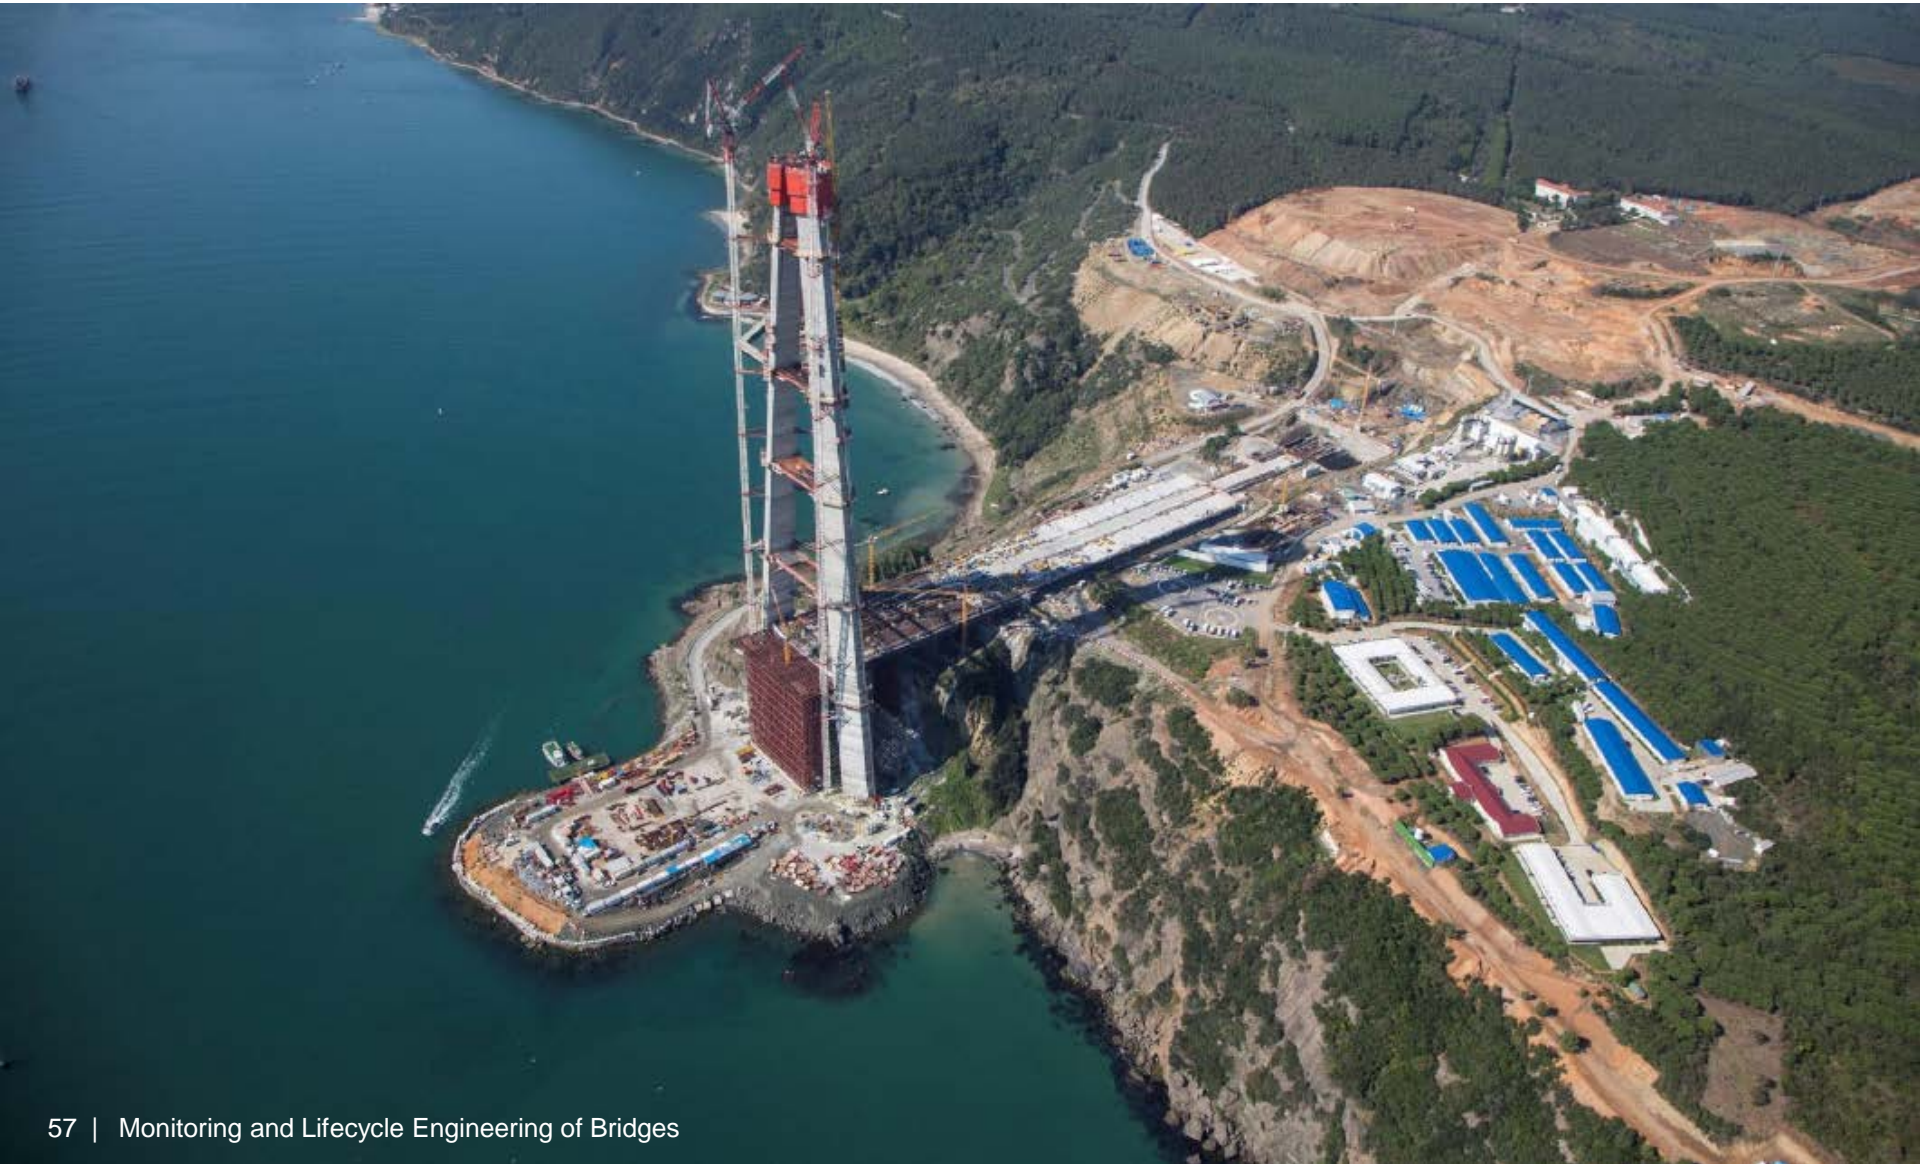
# 3. Bosphorus Bridge Monitoring

## European Side

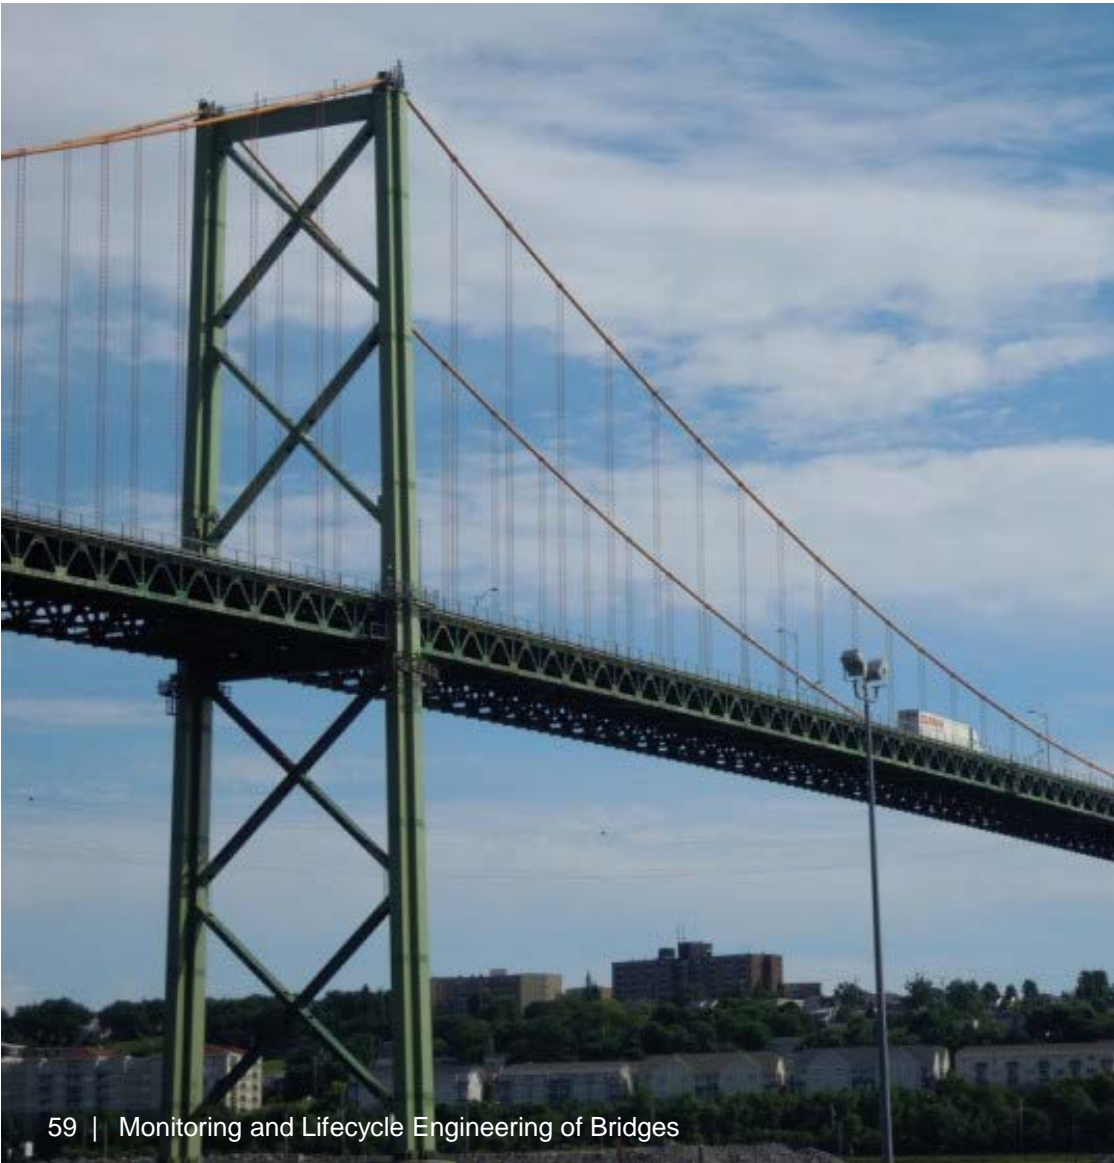
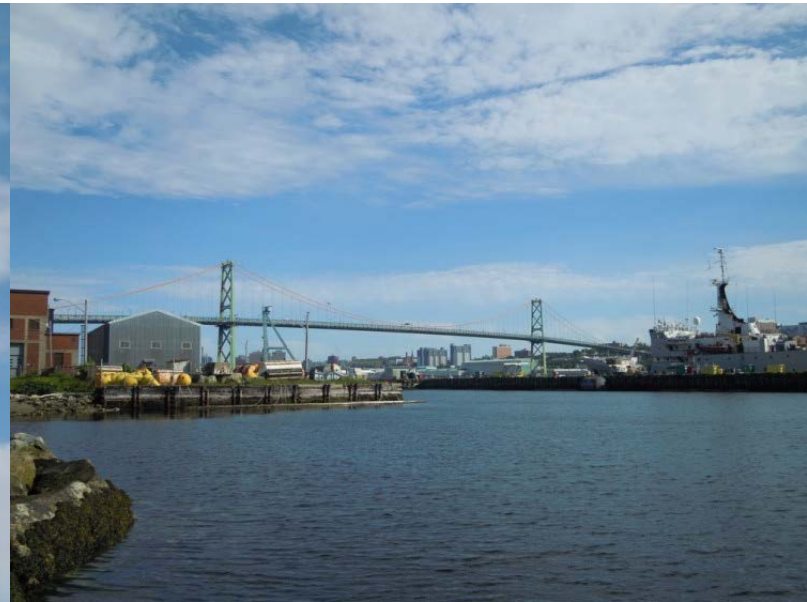
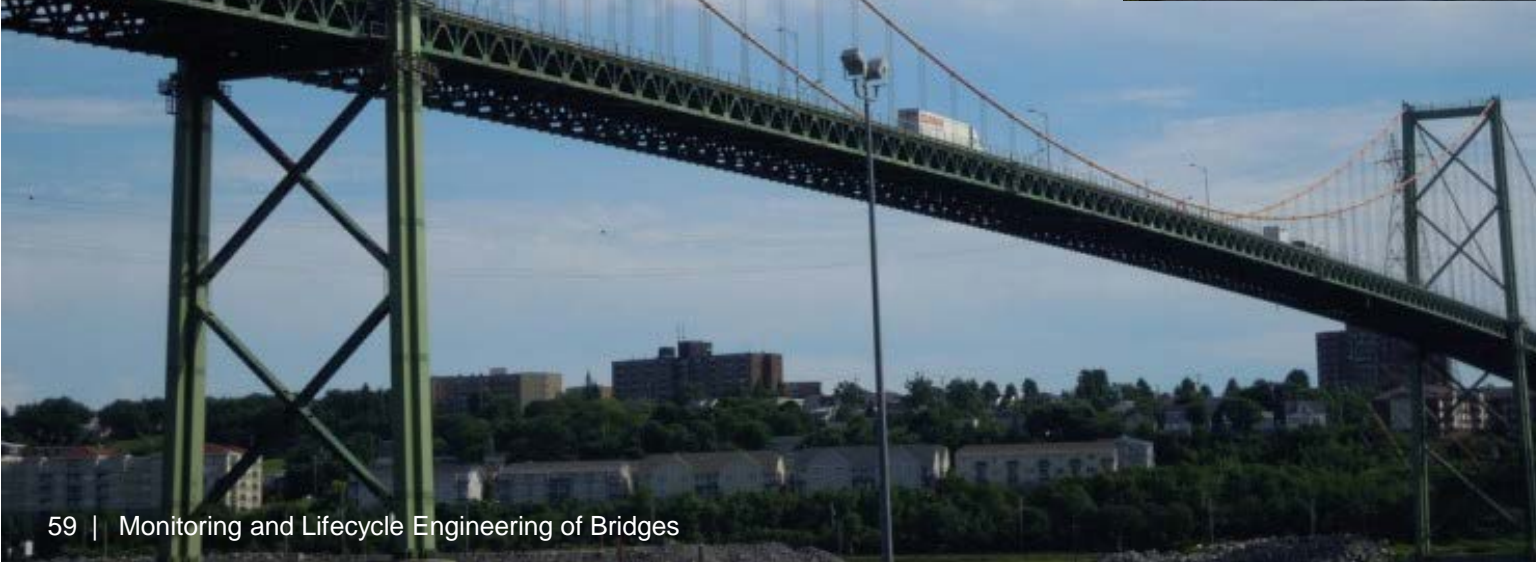
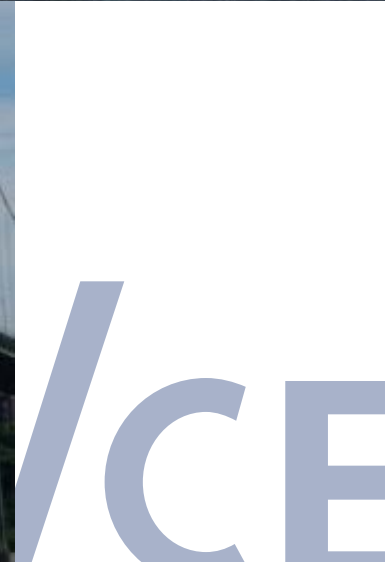
# Halifax – Joint Performance

## Two Suspension Bridges

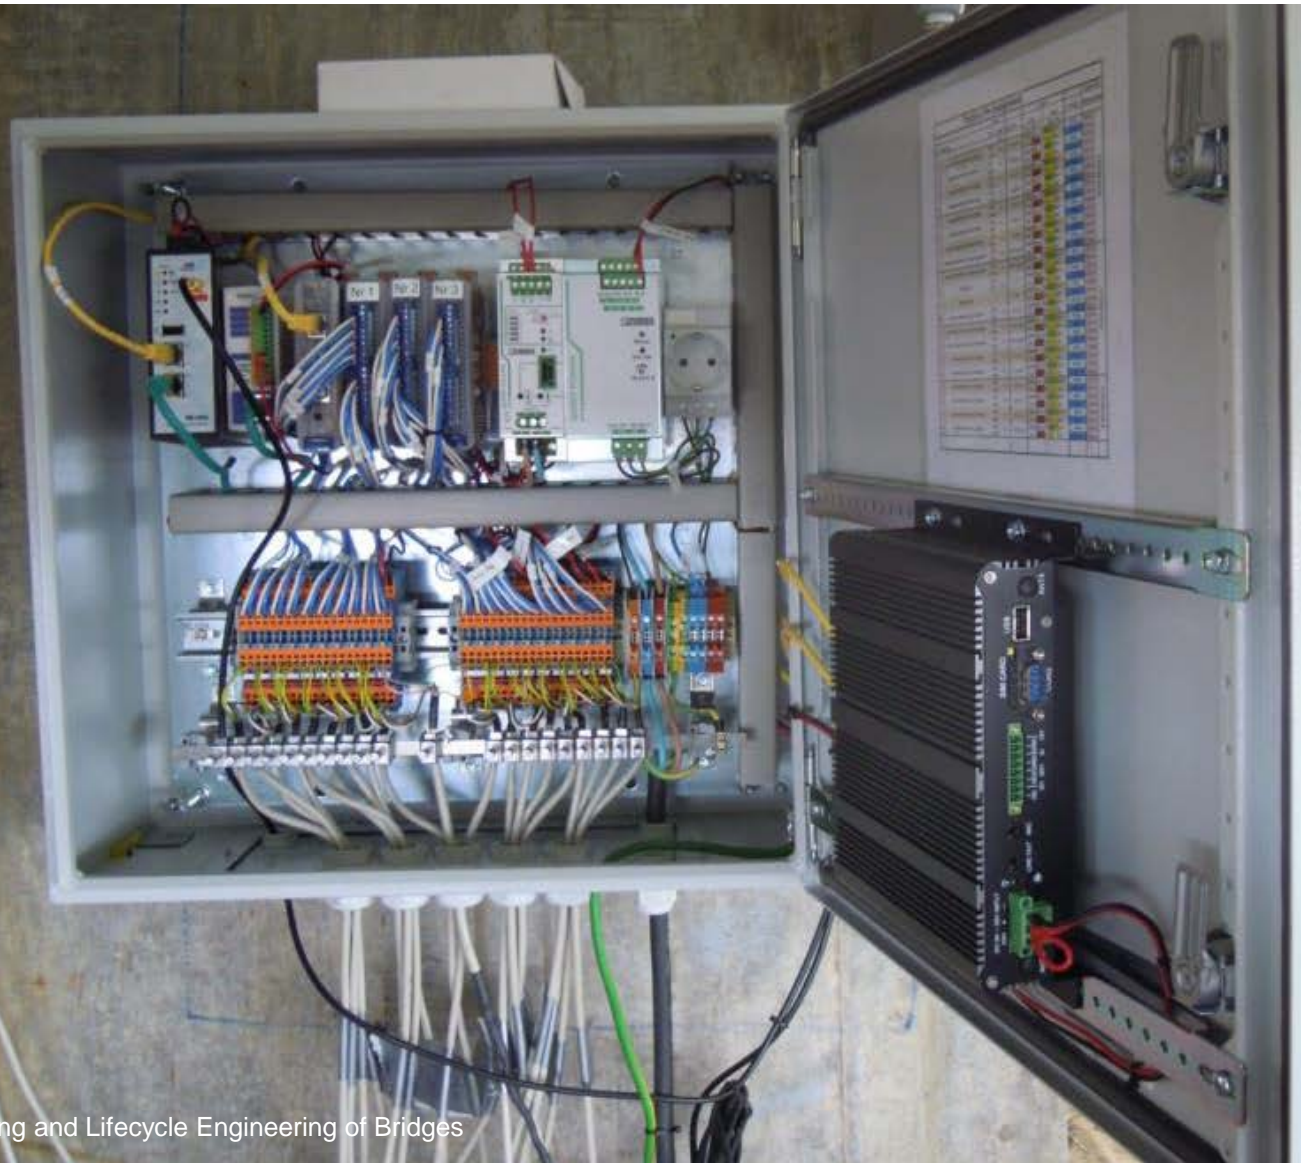
# Typical Monitoring Cabinet

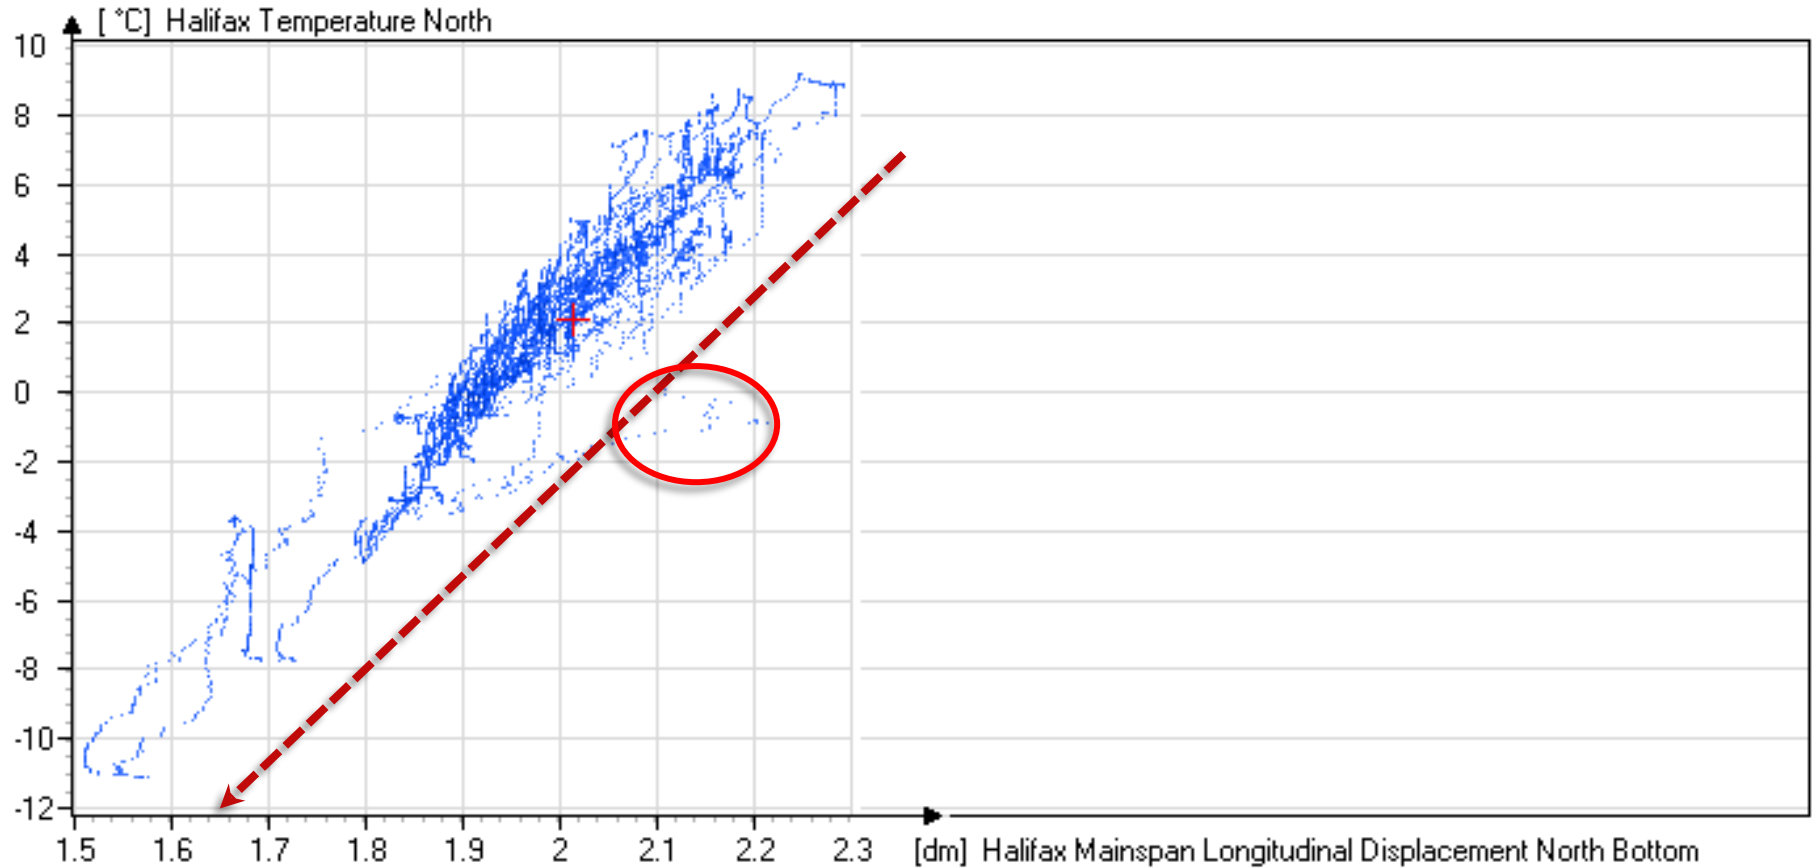
# Alarm from outliers in correlation functions

Correlation Temperature - Displacement:

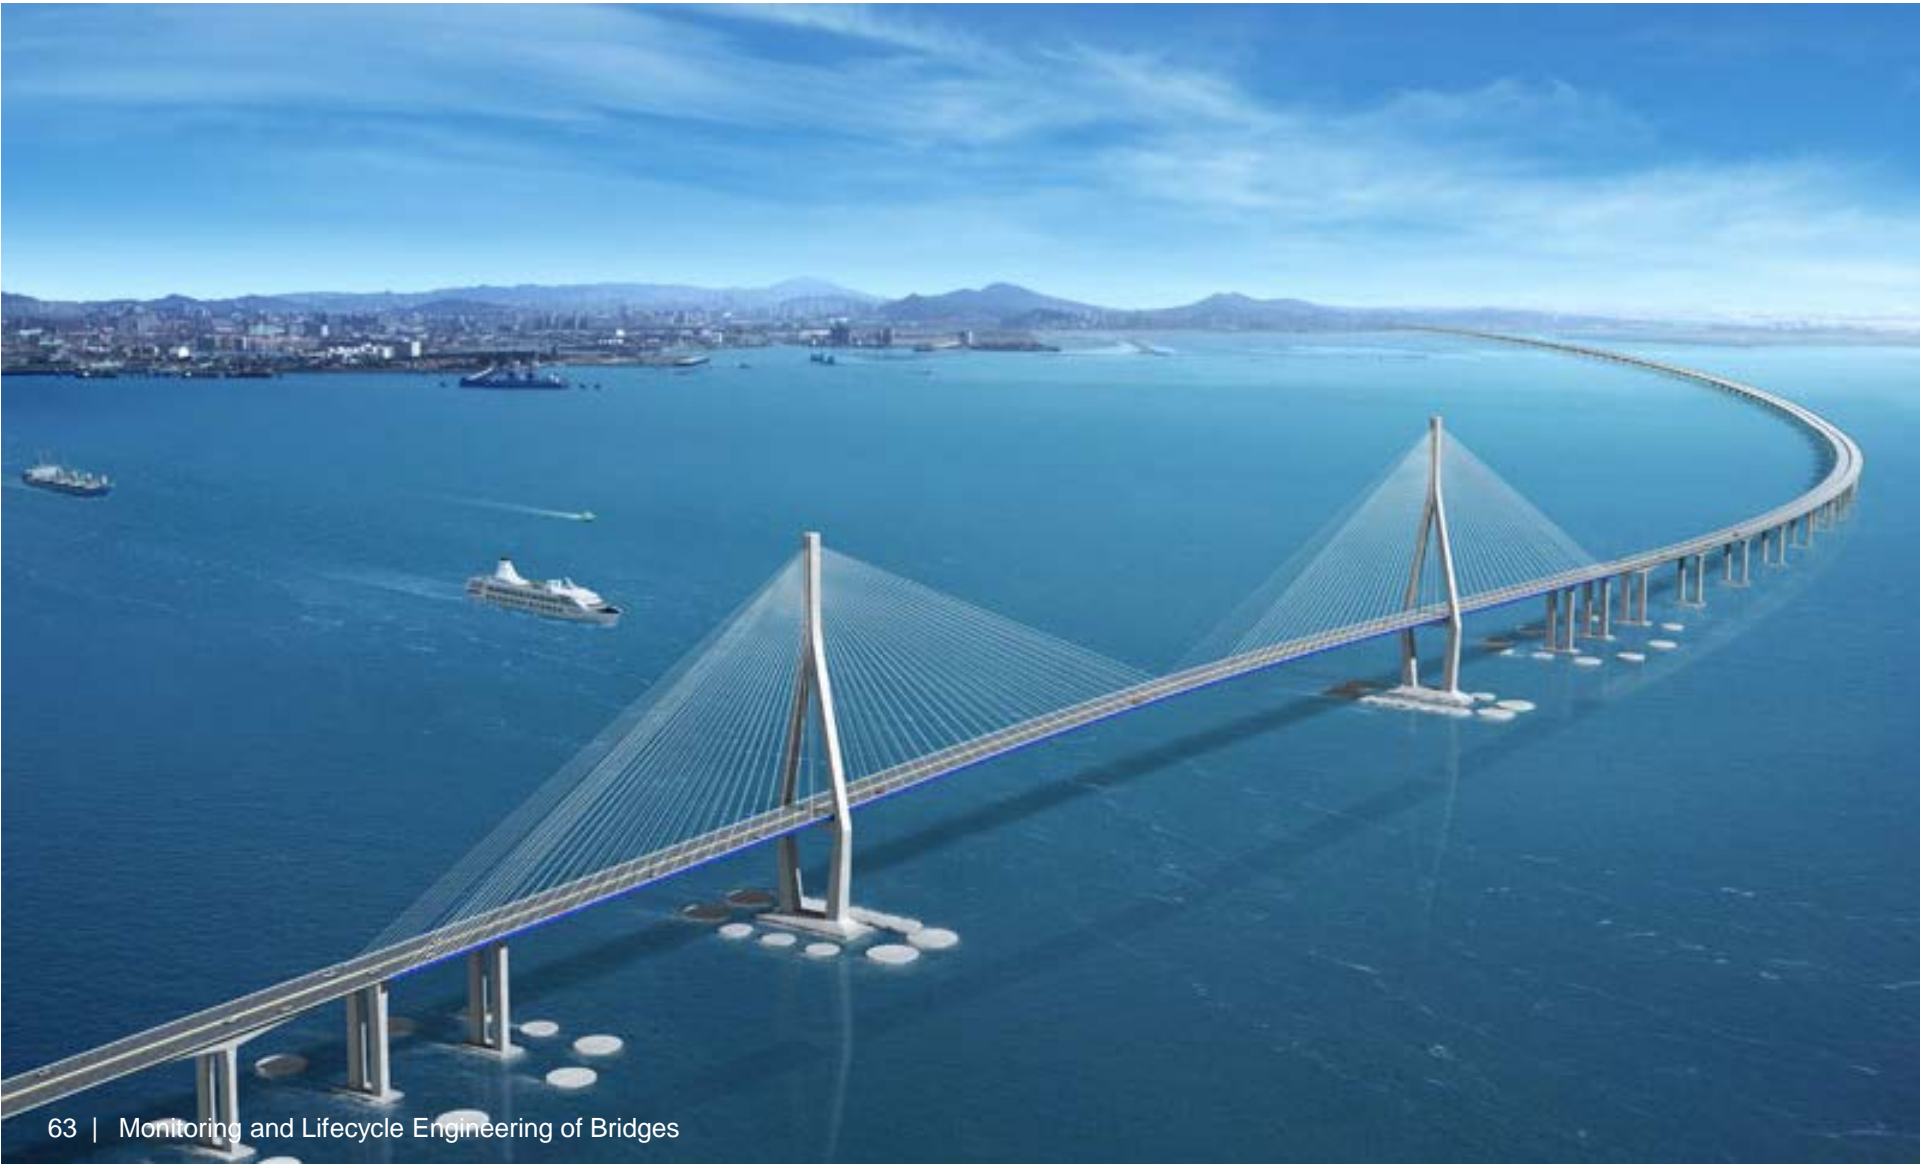
# Incheon Monitoring of Critical Joints

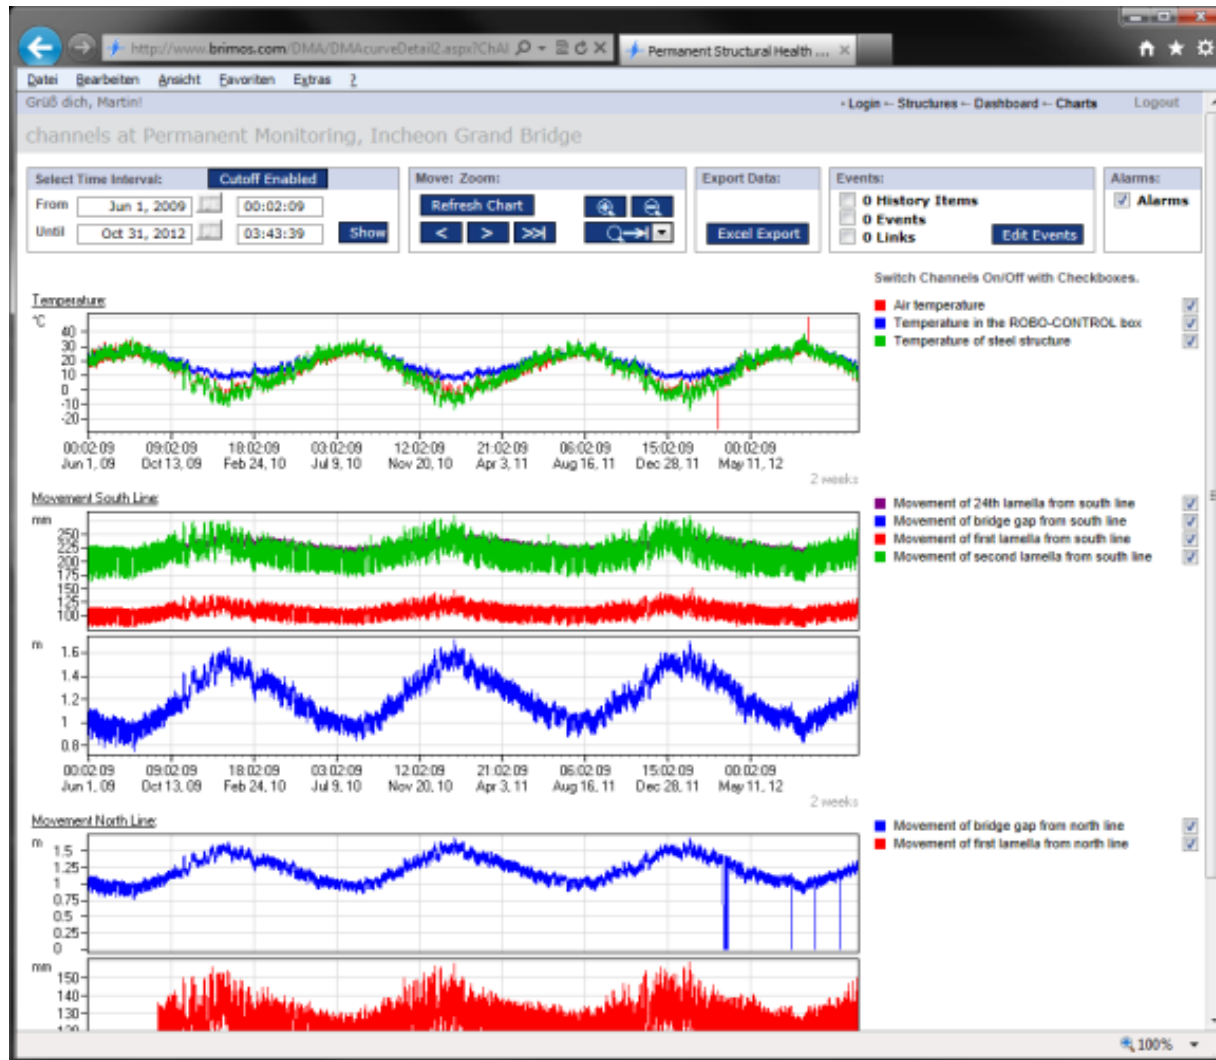
# Multi functional Web-Interface

## Inchon Bridge (Korea): Life Cycle counting and performance

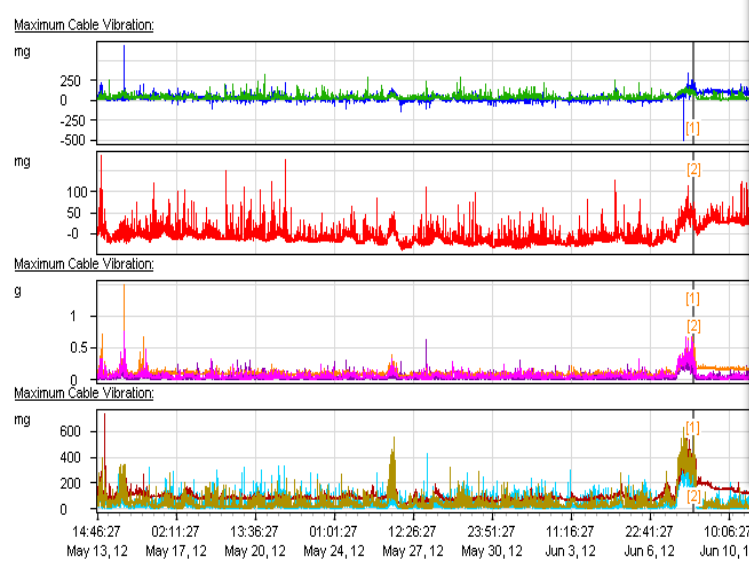
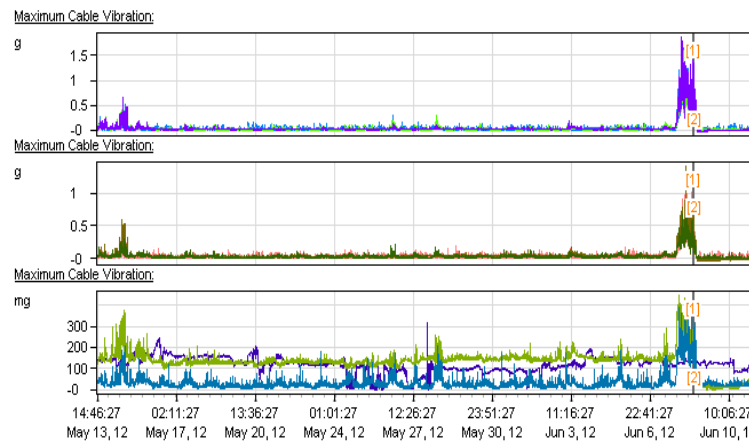
Guten Tag Peter Furtner  
All Data at Permanent Monitoring, Waterford

Select Time Interval: From May 13, 2012 14:46:27 Until Jun 13, 2012 14:42:50 Show

Air Temperature:
