MONITORING AND STRUCTURAL SAFETY ASSESSMENT OF CONCRETE DAMS

António Tavares de Castro, LNEC

Ilídio Ferreira, EDP

Juan Mata, LNEC

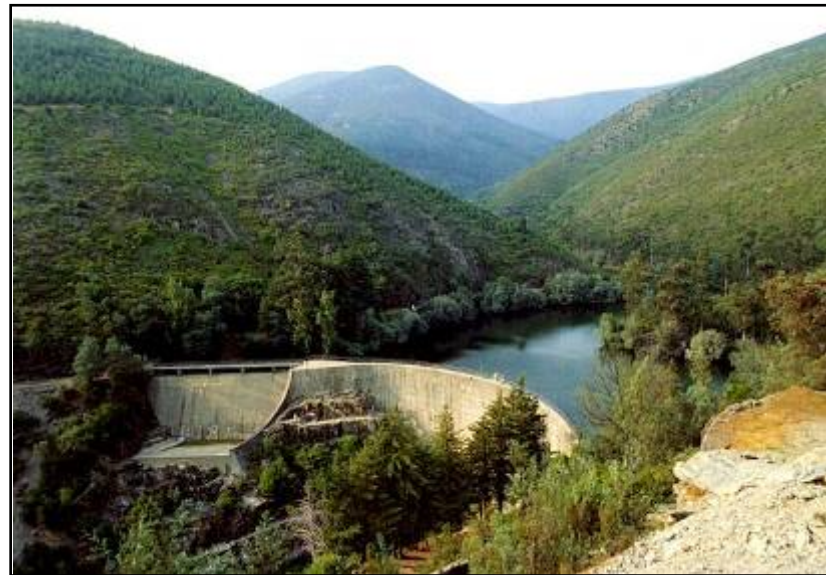
Alto Ceira dam

- Concrete arch with 37 m high
- Thickness between 4,5 m (base) and 1,5 m (crest)
- Construction in 1949

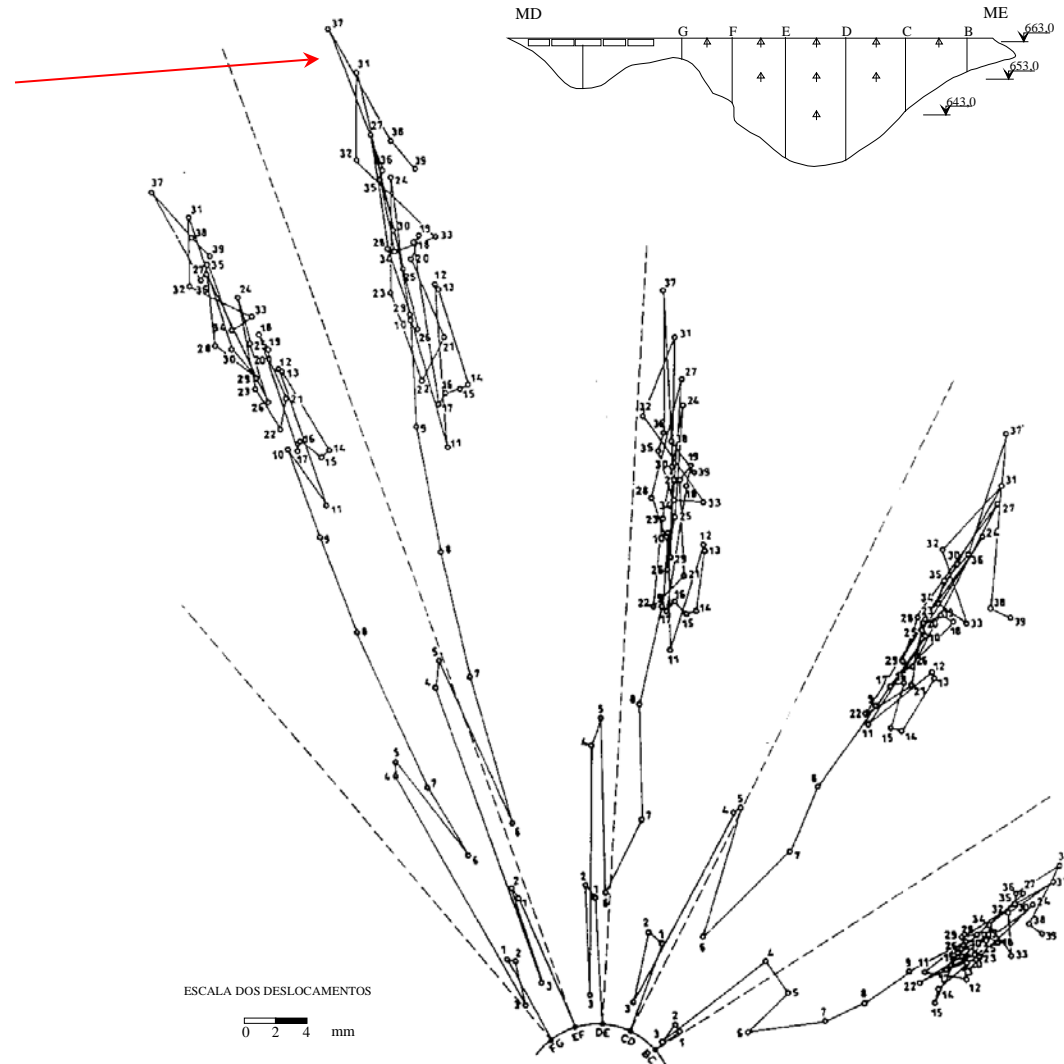
Time evolution of horizontal displacements

Time rate of upstream displacements: ≈ 1 mm/year

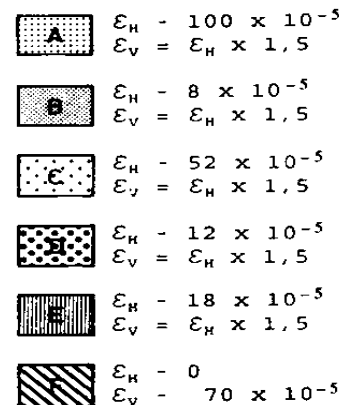
Maximum swelling values (1950-93)
H - Horizontal; V- Vertical
