VOI related to composite patch reparations

Dr. Ander Zornoza
Dr. Elena Rodríguez
Rubén de la Mano

Robotics and Control + Advanced materials
units

Collaborative Project. Call ID FP7-SST-2008-RTD-1- Proposal N° 233969. Duration: 40 Months (2010 – 2013)

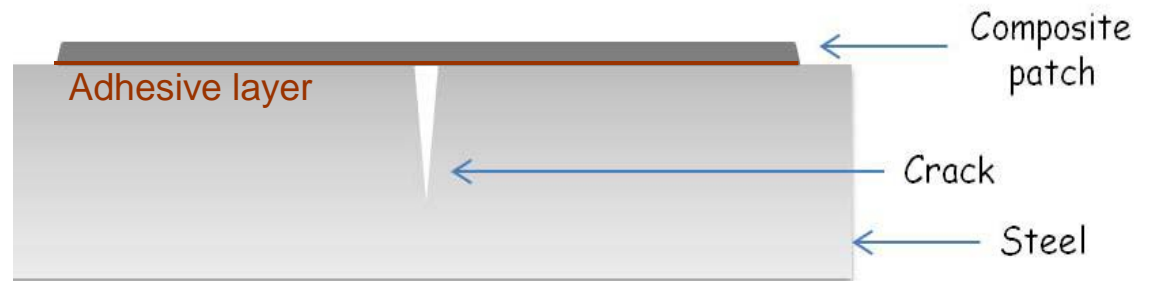
Repairing the damaged structure by a bonded composite patch

Damage: crack or corrosion

COPATCH solution works **transferring the stress** from the damaged steel to the composite patch **through the adhesive layer**. It allows **to recover** the integrity of the damaged steel to **its original state**.

Homogeneous load transfer

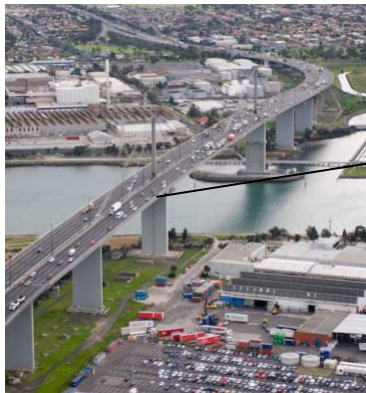
West Gate Bridge, Melbourne, 2012

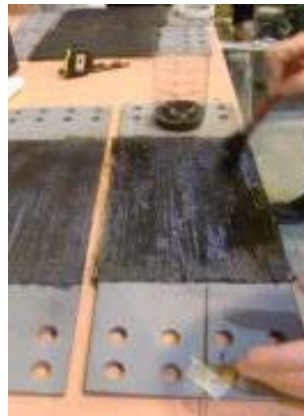
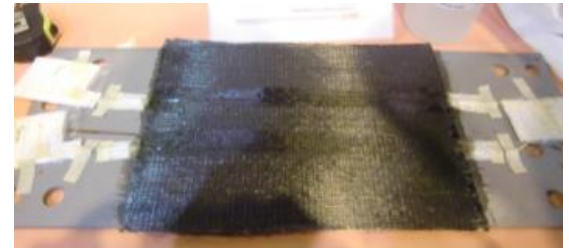
Composite laminate monitoring (Embedded FBGs)

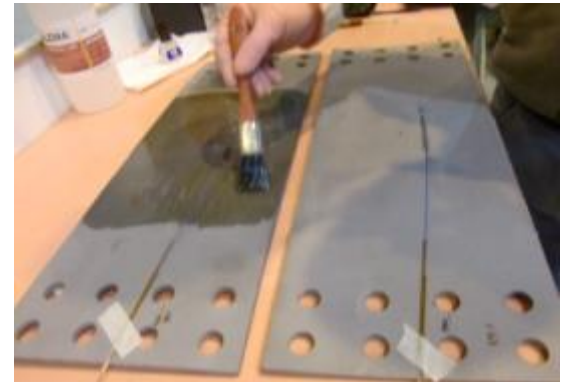
Adhesive layer monitoring

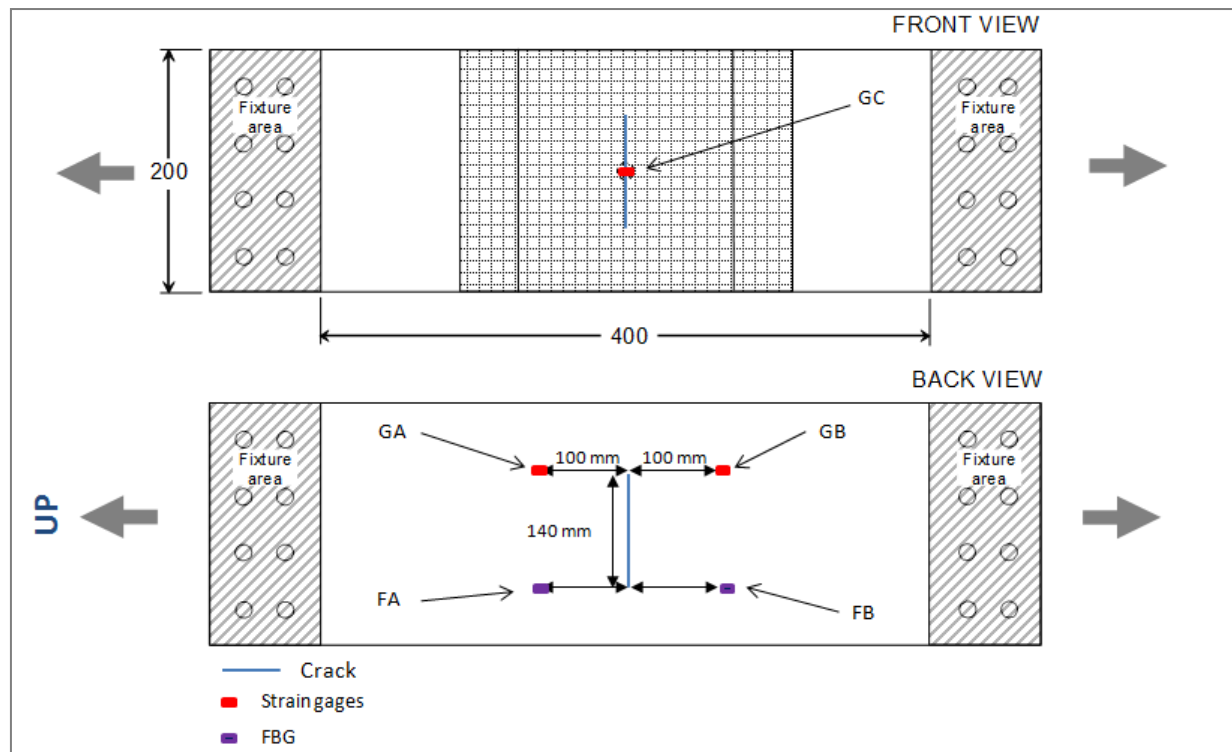
Mid-scale specimen - Static Tensile tests

Comparative study: Conventional strain gages vs FBGs measurements

FBGs (FA, FB) and strain gages (GA, GB) bonded in steel and one strain gage bonded in the top of the patch (GC)

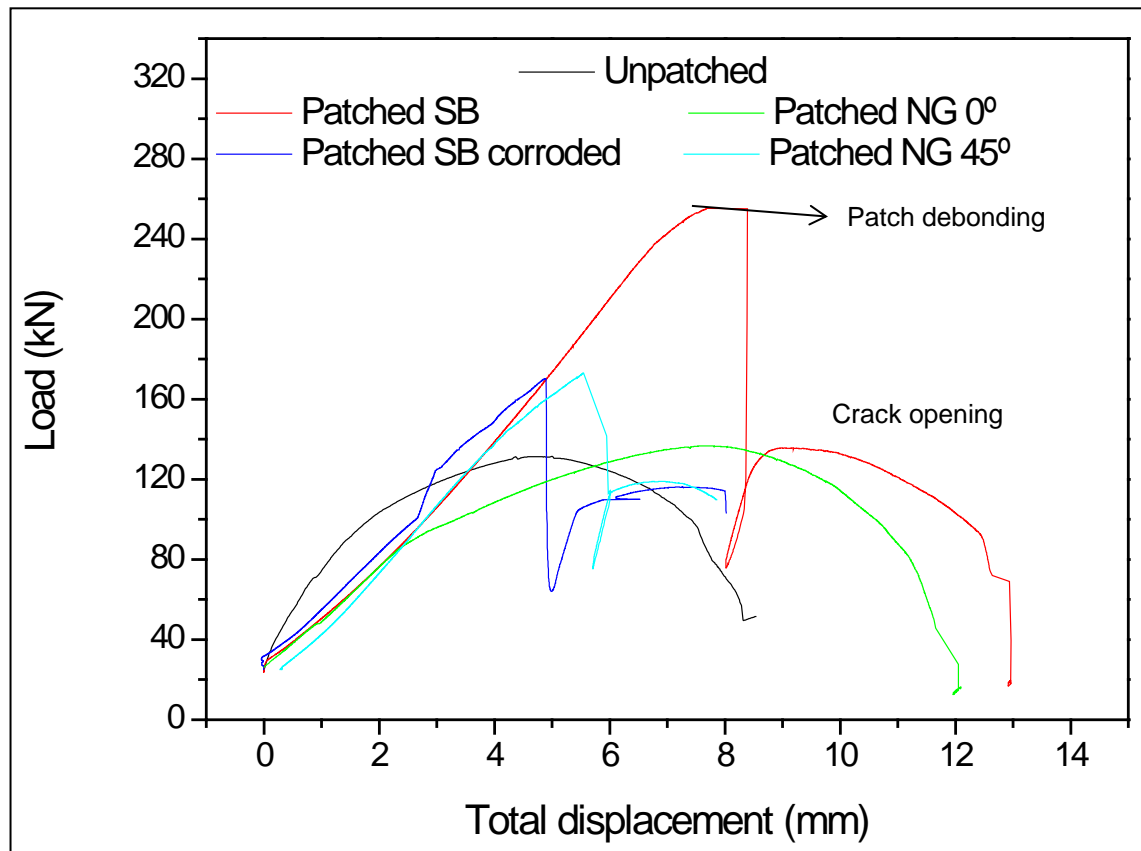
Mid-scale specimen - Static Tensile tests

Preliminary tests to select patch materials and steel surface treatment

Global Load vs Displacement curve. FAILURE: patch debonding.

Patch effectiveness:
greatly increase the stiffness of the structure and the maximum load

Max load
Unpatched	125 kN
Patched	260 kN

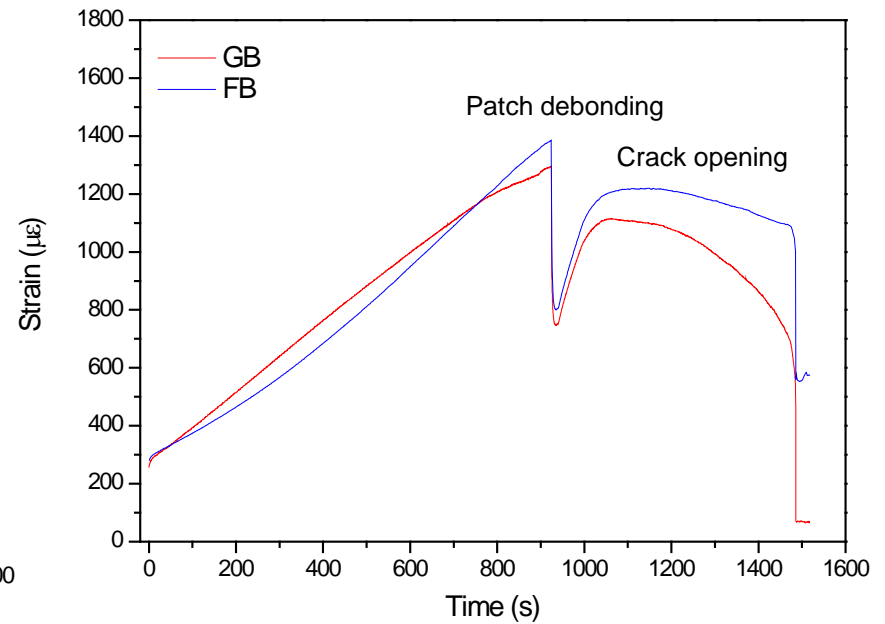
Mid-scale specimen - Static Tensile tests

Comparative study: Conventional strain gages vs FBGs measurements

FBGs same behavior than conventional gages

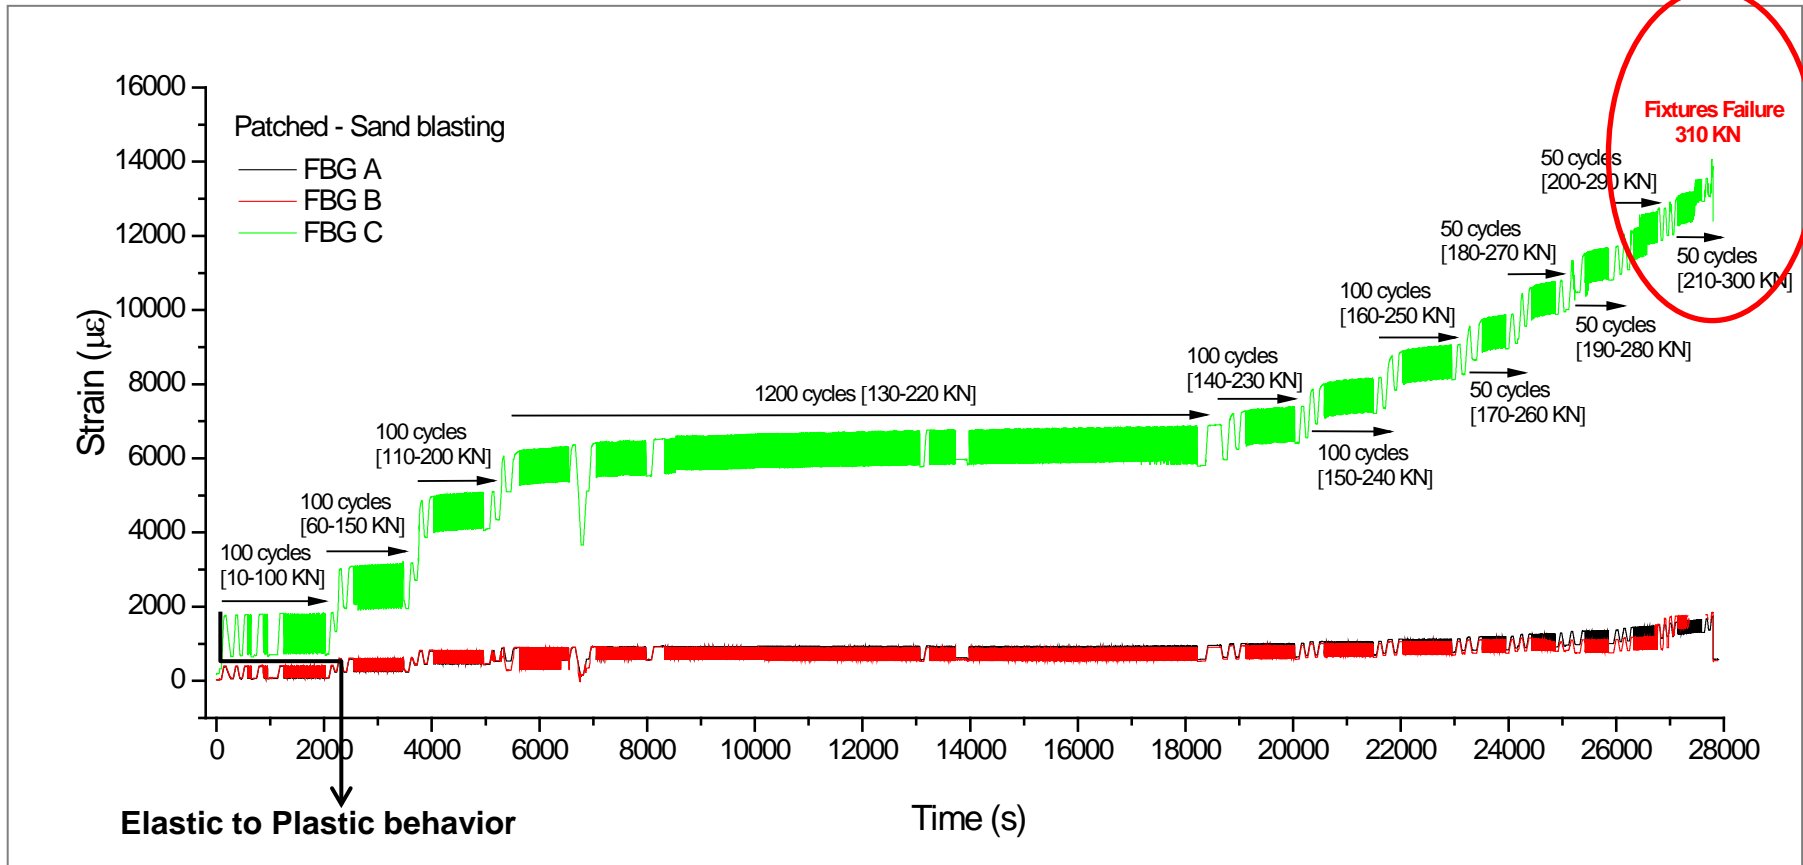
Mid-scale specimen - Cycled Tensile tests

A, B: adhesive layer
C: steel (back side)

Good patch adhesion

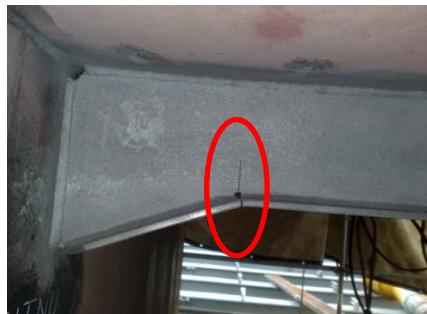
2. Vertical, length= 40mm

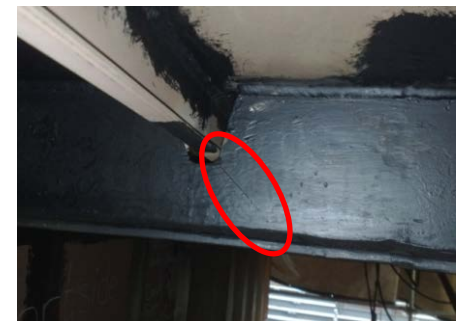
3. 45°, length=60mm
